Repairing of an Engine Block Through the Cold Gas Dynamic Spray Technology

Antonello Astarita^a, Fabrizio Coticelli^a, Umberto Prisco^{a,*}

^a Dept. of Chemical, Materials and Industrial Production Engineering, University of Napoli Federico II, Piazzale Tecchio 80, 80100, Napoli, Italy

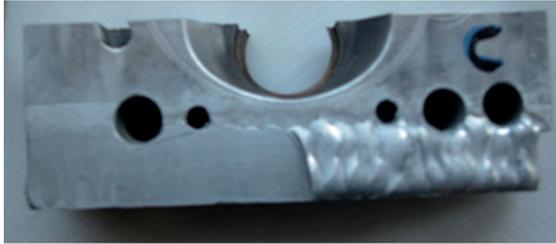
A sample repaired using TIG welding is shown in Figure 2, with a section of the welded repair machined to obtain a flat surface. Before the welding, the sample was preheated

**Figure 2:** Macrograph of a sample repaired through TIG welding.

at 100 °C. TIG welding was performed under the following parameters: direct current straight polarity, 100-130 A; voltage, 11 V; welding speed, 100-140 mm/min and argon flow rate, 8 LPM. The temperature was controlled after every pass with a thermocouple to limit the base metal alterations. The chosen filler metal was an AA4047 in form of wire, widely used in industry for repairing worn surfaces of hydraulic components, see Table 1. After welding, the sample was protected with mineral wool, to reduce the cooling rate and to avoid an excessive alteration of the base metal.

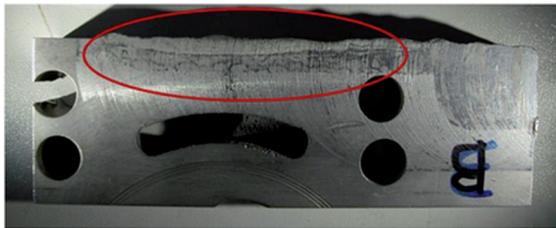
**Figure 3:** Macrograph of a sample repaired through CGDS; the red circle highlights the repaired zone.

A sample repaired by using CGDS is shown in Figure 3. Before the CGDS a grit-blasting was carried out on the sample to improve the adhesion of the coating on the substrate material. A commercial white corundum grit of 0.6-0.7-mm diameter was used. The blasting pressure was 0.6 MPa. An Al-12% Si powder, with a composition very similar to the same Al-Si alloy used in the TIG process, was chosen for the cold spray repair, see Table 1. The powder is characterized by a mean particle diameter of 40 microns. A SEM micrograph of the powder used is shown in Figure 4.

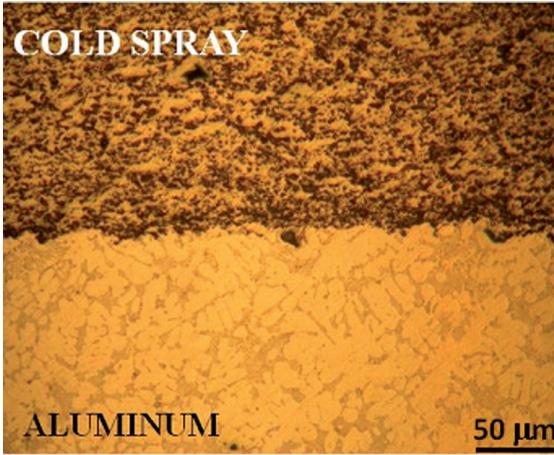
Figure 6 shows the cross section of a cold spray repair. As expected the aluminum substrate is not affected by the cold spray process, even in the bonding zone the base material preserve the initial microstructure. This initial solidified morphology consists of large dendrite grains, which is a typical structure obtained by casting at higher superheating in absence of subsequent grain refinement processes.

Figure 6: Cross section macrograph of the cold spray repair.

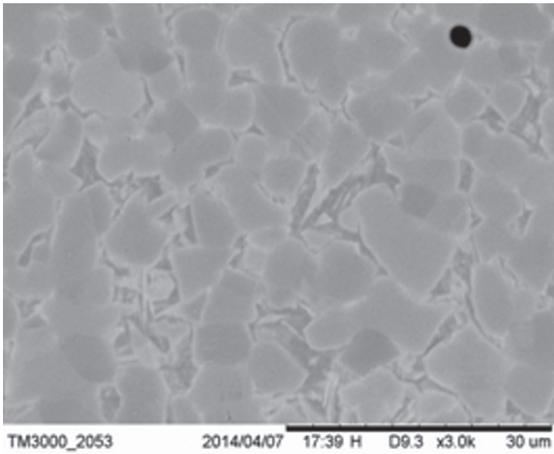
From Figure 7, which shows a SEM micrograph of the repair cross section, it is possible to observe that the cold spray coating is quite compact and free from porosity.

Figure 7: SEM micrographs of the cross section of the cold spray repair.

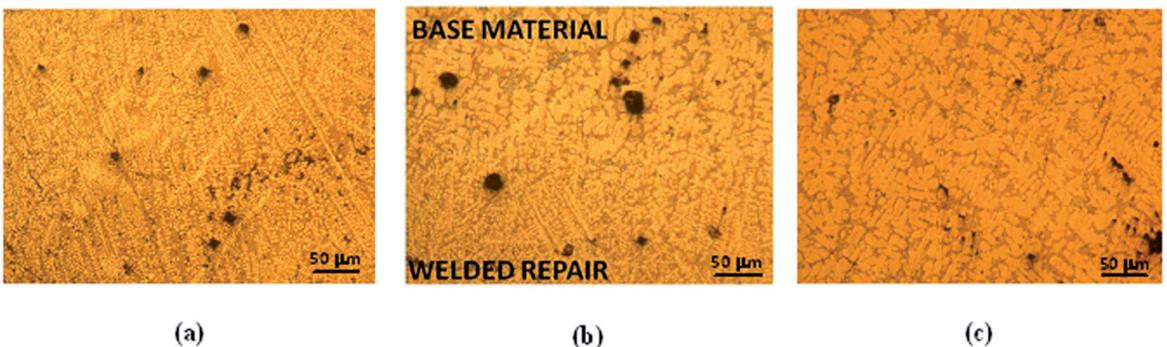
Concerning the TIG repair detailed microstructural analysis are reported in Figure 8. In the repaired zone it is possible to observe a microstructure made of very small and thin lamellae, this is due to the very fast cooling experienced by the molten material in this zone. Are also visible the

directions of the heat flow because the lamellae nucleate and grow up along this direction. The microstructure of the base material is coarser; in Figure 8(b) is clearly evident the interface between the base material and the welded repair. The substrate retains the initial microstructure also in this

case; this suggests that the repairing method (described in the previous section) was effective in preserving the properties of the base material of the engine block. It is very difficult to identify the heat affected zone; in fact such a zone is not visible in the reported micrographs.

Figure 8: (a) Microstructure observed in the cross section of the welded repair; (b) microstructure of the welded repair near to the base material; (c) micrograph of the base material near to the repair.

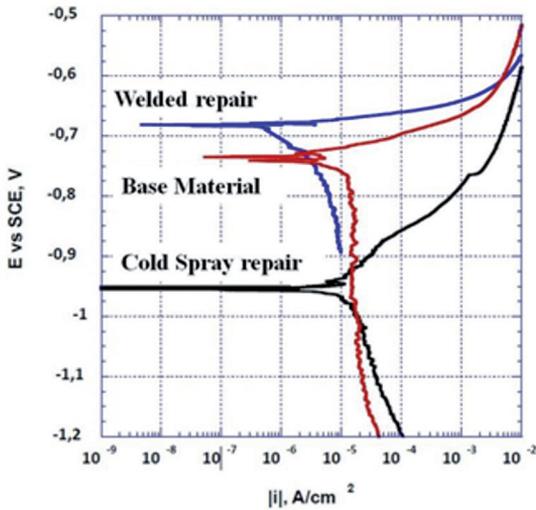
The polarization curves are reported in Figure 9. It is clear that the corrosion potential value of the base material is more positive than that of cold spray repair. Thus, the corrosion of the cold spray repair can take place in preference to the corrosion of base material. Furthermore, it is possible to assess from Figure 9 that the welded repair showed an electrochemical behavior similar to the one of the base material while the OCP potential of the cold spray repair is noticeably lower than the previous ones. This result suggests an anodic behavior of the cold spray repaired zone with respect to the material of the engine block⁸. The general trend of the curve is similar for all the three samples under investigation.

Figure 9: Results of the potentiodynamic polarization measurements.

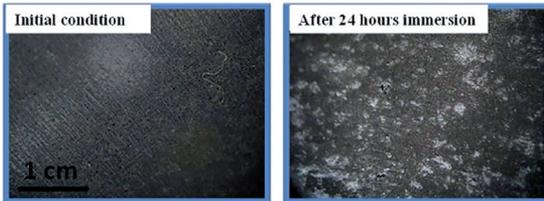
Photographs of the top surface of the specimens after the immersion test are reported in Figure 10 (welded repair) and 11 (cold spray repair). In particular, in both cases it is possible to observe the occurrence of classical pitting^{8,13}. The cold spray repair shows a better behavior with respect to the welded repair, in particular very few pits are appreciable.

Figure 10: Macrograph of the top surface of the welded repair before and after the immersion test.

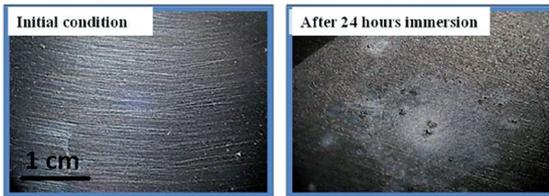
Figure 11: Macrograph of the top surface of the cold spray repair before and after the immersion test.

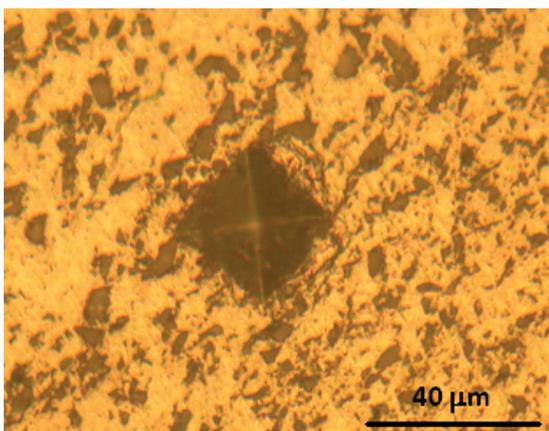
Lastly the results of the microhardness measurements are reported and discussed. An image of the indentation carried out in the cold sprayed repair is reported in Figure 12. The regular shape of the indentation is a clear indication that the deposited material is isotropic. Indeed, it is well known the relationships between the material anisotropy and the resultant indentation shape¹⁸. In particular, it was experimentally observed an increase of the distortion of the indentation with the anisotropy. The observed behavior is due to different plastic flows with regard to the crystals orientation and to differential elastic recovery on withdrawal of the indenter. Both effects can critically influence the sizes and shapes of hardness indentations. The results of the hardness measurements are given in Table 2. The cold spray repair showed the same hardness of the base material, conversely the welded repair showed a higher hardness than the base material. This is due to the very fine grain structure of the welded zone, structure caused by the fast cooling of the same area.

Figure 12: Vickers indentation on the cold sprayed repair.
