Failure analysis in heat exchanger tubes from the top system of the regeneration tower of the hydrotreatment unit in an oil refinery: a case study

This work presents a failure analysis performed on tubes of a condenser of the top system of the diethanolamine regenerating tower of the oil cracked naphtha hydrotreating unit. The tubes are subjected to the aqueous flow of H_2S and diethanolamine in the external region and cooling water in the internal region.

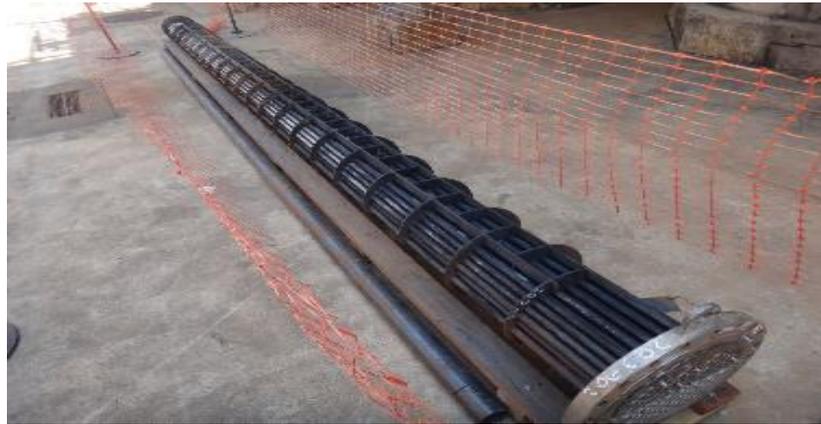
Figure 4: Tubular bundle analyzed.

The data analyzed were obtained from maintenance and inspection files of the inspection management of equipment and facilities at an oil refinery during maintenance shutdown activities. Figure 4 shows the tube bundle analyzed. The initial failure analysis of the tubes was performed by using external and internal inspection. Chemical analysis of tubes was performed by using X-ray spectroscopy, using the Niton Analyzers alloy analyzer, model XL3t-800 Thermo Scientific.

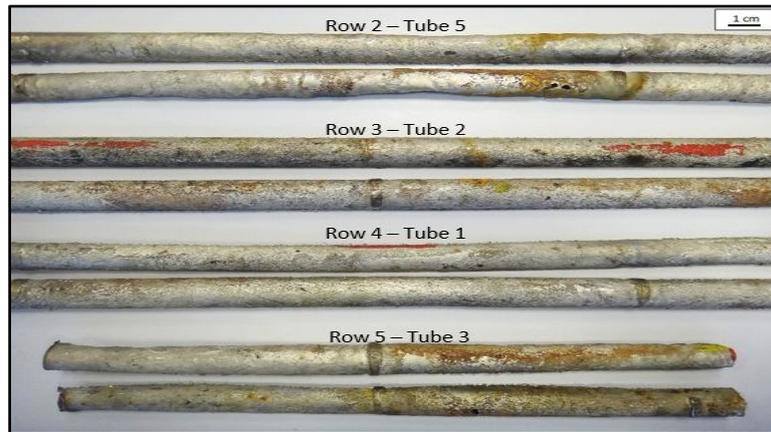
Figure 7 shows the external surface of the tubes after cleaning and cutting in the longitudinal section (half-cane). An extensive area of corrosion is observed on the outer sides of the beam tubes, the contact area of the metallic material and the fluid of the hull (H₂S + DEA).

Figure 7: External visual inspection of the heat exchanger tubes.

At pH values lower than 6.5, which is the case with the DEA and H_2S solution that has pH 5, mackinawite has a high solubility and reaction (5) dominates, resulting in enhancement of the corrosion rate [20]. The deleterious action of the bisulfide ion was observed, attacking the protective layer of chromium and iron oxide of AISI 316L steel, probably forming iron sulfide parallel to the iron and chromium oxides and causing the localized corrosion observed in the Figures 7 and 9.

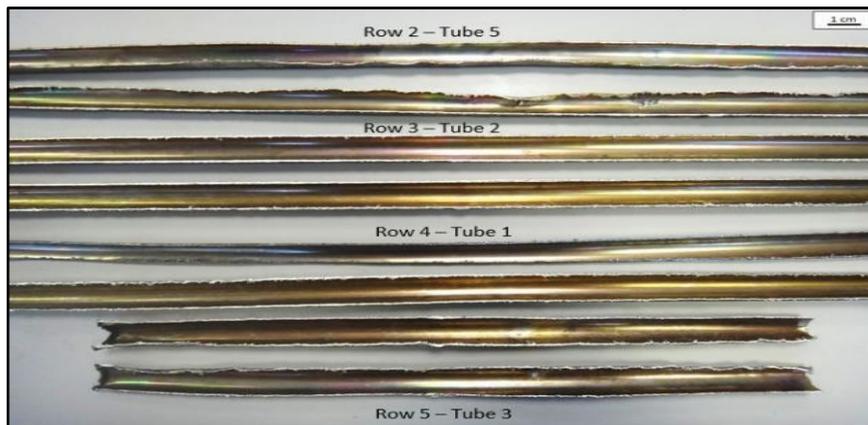
Figure 8 shows the inner surface of the tubes after cleaning and cutting in the longitudinal section of the tubes (half-cane). Visually, the inner surface of the tubes is unchanged, without evidence of a corrosive process, the fluid inside the tubes is cooling water. Therefore, it is proved that the corrosive process in these tubes occurred from the outer surface to the inner surface.

Figure 8: Internal visual inspection of the heat exchanger tubes.

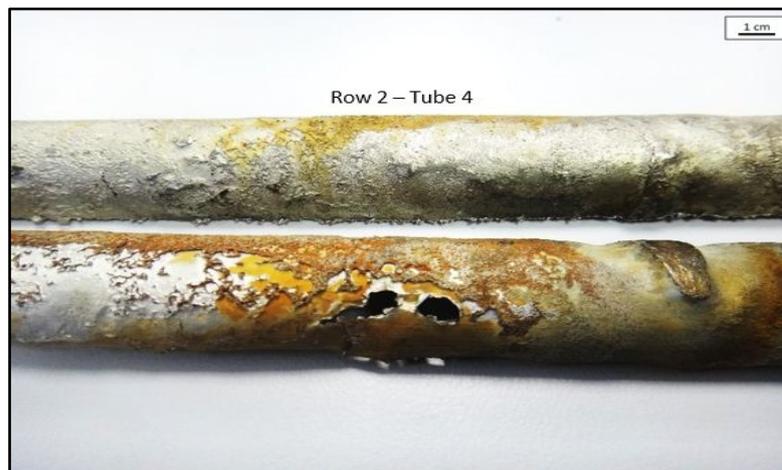
Figure 9 shows a detail of a hole found in one of the tubes in the upper pass region of the heat exchanger. This is the tube located in row 2 and column 4, detected by the IRIS ultrasonic test.

Figure 9: Detail of tube punctured in the heat exchanger beam.

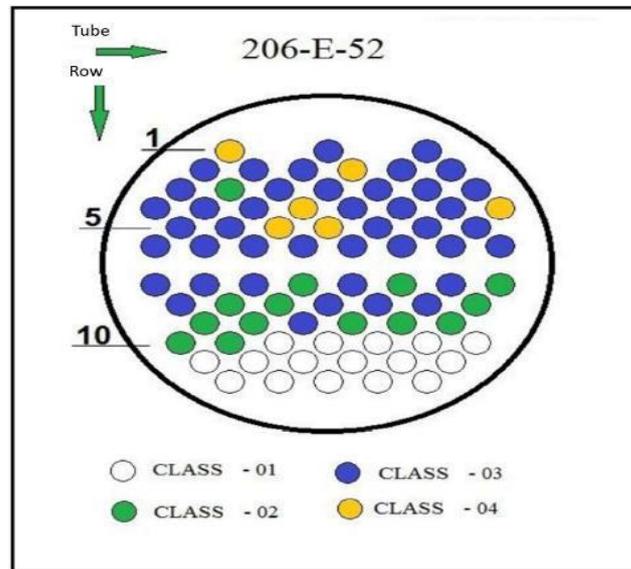
Figure 10: Spatial distribution of tubes tested by eddy currents.

The exchanger's inspection history reveals that during the first programmed general stop in September 2017, the tubular beam was submitted to non-destructive tests by Eddy currents, which, by means of microstructural variations with different magnetic properties, and, consequently, different impedances, allowed the detection of cracks and holes in tubes. Figure 10 shows the spatial distribution of tubes tested by Eddy currents.

The definition of inspection class depends directly on the thickness loss. The four inspection classes were defined in the test. As observed about 53% of the tubes (42 out of a total of 78) presented a thickness loss between 41% and 60% in September 2017, with the nominal diameter of the tube being 19.05 mm and wall thickness of 1.65 mm when installing and starting the heat exchanger (July 2011).

The smallest residual thickness was 0.45 mm; thus, a corrosion loss of 1.20 mm was identified in thickness. In this way, the tubular beam of this heat exchanger was classified with a remaining useful life of one-year operation, considering a corrosion rate calculated for this situation of 0.1677 mm/year. The six tubes showed a thickness loss between 61% to 80% due to operational safety measures were plugged in this maintenance stop. No cracking processes were observed in the tubes, but corrosion process with mass loss.

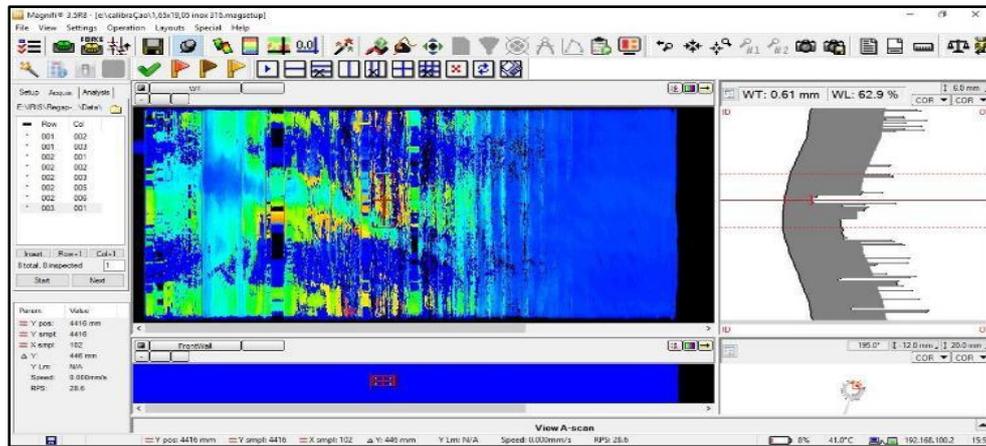
Figure 12: Internal Rotation Inspection System results for the Row 3 and Tube 1.

The Internal Rotation Inspection System results for the Row 3 and Tube 1 are shown in Figure 12.

The test indicated the location of each tube of the bundle, concerning the total length of 6,096 mm. There was the greatest thickness loss or hole along the tube length. It also shows the remaining wall thickness found and, finally, the percentage of thickness loss, considering the wall thickness used in the equipment design, or about 1.65 mm. Regarding the Eddy current test, an increase in the corrosive process of the material was identified, with more significant thickness losses and even with the detection of tubes with loss of containment. With these results, the action implemented was the complete replacement of this tubular bundle. Again, no cracking processes were observed in the tubes, but a corrosion process with mass loss.

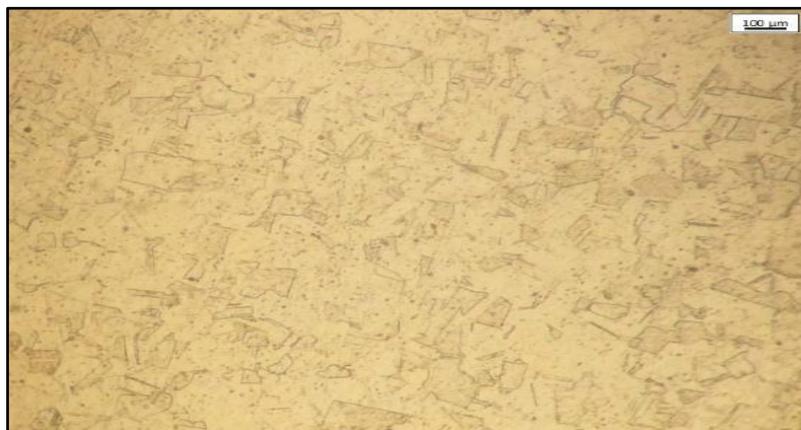
Figure 13: Optical micrograph of ASTM A213 Grade 316L.

After analyzing the metallographic structure of the samples extracted from the tubular beam, of specification ASTM A-213 Grade 316L and applying the recommendations of the standard ASTM A-262 practice-A, the presence of a typical structure for this steel was observed, with well-defined grains and grain boundaries, and the presence of twins as show in Figure 13. There is no evidence of intergranular corrosion. The observed corrosive process was caused by DEA and H₂S fluid that attacked the stainless steel surface of the tubular beam of the heat exchanger.
