Hazard Mapping in Urban EnvironmentalProtected Areas: Tijuca National Park

How to cite: Santos, R. B., Dourado, F., & Schumm, L. (2023). Hazard Mapping in Urban Environmental Protected Areas: Tijuca National Park. *urbe. Revista Brasileira de Gestão Urbana*, v. 15, e20220210. https://doi.org/10.1590/2175-3369.015.e20220210

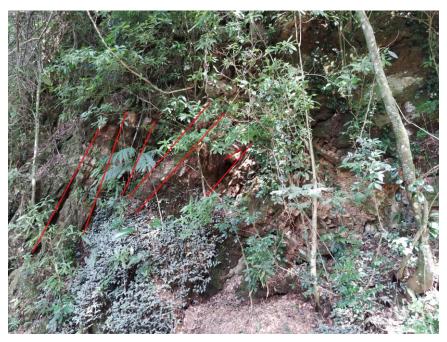
There are two types of road cuts: rock and soil. In most cases, the rock cuts have a high density of fracture families, which favors the fall of blocks (Figure 4).

Figure 4 – Biotite-Gnaisse outcrop in an advanced stage of weathering with its high angle bedding leaning towards the road. Source: Authors (2022).

This fracturing pattern, which reflects the regional geology, can also be seen in the banding of the biotite-gnaisse, presenting a sagging to the road. The landslides might happen because of consolidated material characterized by a high degree of fracturing and friability. Ideally, the cuts in banded rocks should always be done perpendicularly, thus avoiding cutting the layers, resulting in a lower probability of debonding. If this is not possible, as was the case at some points on Redentor Road, the correct thing to do is to apply some kind of containment structure, avoiding greater damage. In addition, these exposed rocks are highly susceptible to weathering (Toledo, 2014). This, added to the ease of weathering, increases the hazard in the area. According to Highland & Bobrowsky (2008), oriented structural discontinuity is one of the triggering mechanisms of landslides.

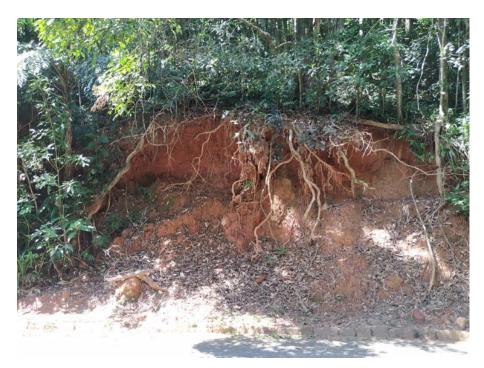
On the other hand, soil cuts often present a high erodibility rate, and record small mass movements, resulting in destabilization of the cut, exposure of roots (Figure 5). All these consequences result in increasing even more the erodibility rate, especially in periods of high rainfall, since the rain has the ability of causing erosion due its kinetic energy of the raindrops summed to the area slope and soil characteristics (Roose,1978).

Figure 5 – Road cut in soil with a small mass movement and roots exposure, culminating in the increase of erodibility rate and hazard level. Source: Authors (2022).

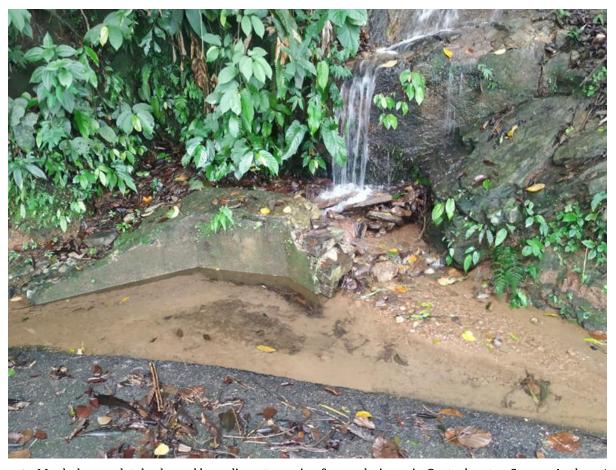
Figure 6 – Manhole completely clogged by sediments coming from a drainage in Central sector. Source: Authors (2022).

Most clogged manholes are in sectors with higher water presence. The reason for clogging is the presence of several drainage channels, which may be intermittent or not, and end up carrying many sediments of the most varied types, from silty fraction to rolled blocks. Therefore, the water is not properly drained by the drainage system, thus flowing through the road and its cracks. These cracks, as shown in Figure 6, sometimes present long extensions, reaching up to 30m in length.

- (a) Periodic surveys along the Road to evaluate the conditions.
- b) Development of a study and application of this methodology on Sumaré Road.
- c) Evaluation of the danger in the highlighted areas and start mitigation plans.
- d) Cleaning of the manholes during rainy periods.
- e) Maintenance of the existing containment structures.

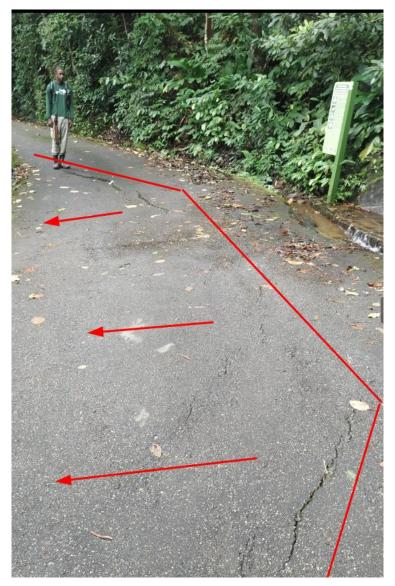
Figure 7 – Road cracks with significant displacement nearby a clogged manhole, indicating subsidence towards downstream. Source: Authors (2022).

These asphalt displacements, in most cases, had a vertical variation of up to 5 cm, which indicates a creep, and eventually may culminate in a landslide. Most likely, the relationship between these two features, clogged manholes and cracks in the asphalt, are because water infiltrates into the soil layer below the asphalt, and also because of the intense flow. These two processes cause the carrying of these supporting sediments, thus causing the asphalt layer to settle.

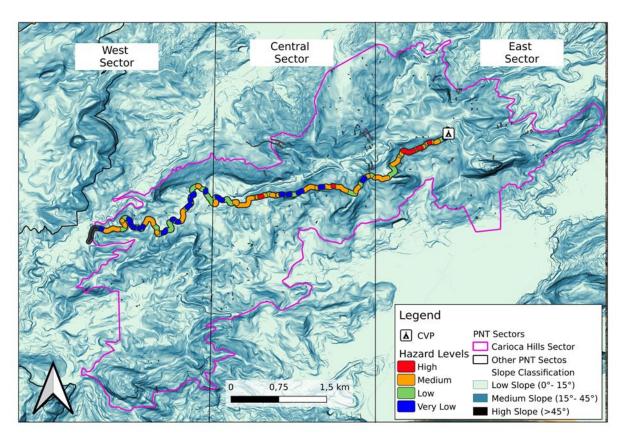
All data analyzed resulted in the Hazard Map for the Redentor Road, with locations where there is danger, divided into three sectors (West, Middle and East), in order to facilitate data interpretation. The East and Middle sectors have longer zoned in which the danger level is medium or high, in relation to the West sector (Figure 8).

Figure 8 – Slope and Hazar Maps around Redentor Road. The slope classified as low is represented by a light blue color; medium slope is in blue and high slope in black. The classification for slopes is presented in Table 2. The colors and hazard classifications are described in Table 2. The road was segmented in three sectors in order to facilitate the interpretation. Source: Authors (2022).

In Redentor Road, there are 3784.3m of low hazard zones (47.46%), it is the longest length classification. Then, the second longest is the medium hazard zone, with 2743.7 meters (34.42%). The least common hazard classes in length are very low with 1091m (13.66%) and high with 353.2 meters (4.46%).
