Post mortem analysis of burned magnesia-chromite brick used in short rotary furnace of secondary lead smelting

E. Prestes¹, A. S. A. Chinelatto¹, W. S. Resende²

Abstract

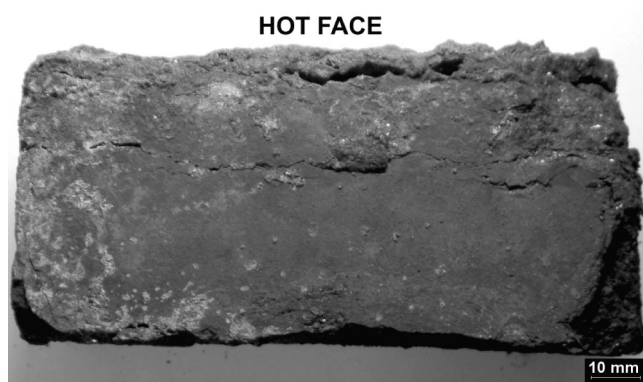
The used brick shows parallel cracks to the hot face, indicating damage due to structural spalling. This damage is due to microstructural changes in the refractory superficial layer, by porosity reduction or reaction with solids and liquids in contact. Properties of this superficial layer differ from unaltered refractory microstructure. Temperature fluctuations, by cycles of cooling and heating, can lead to detachment of this layer.

Figure 3: Visual appearance of used magnesia-chromite brick after use in short rotary furnace of secondary lead smelting.

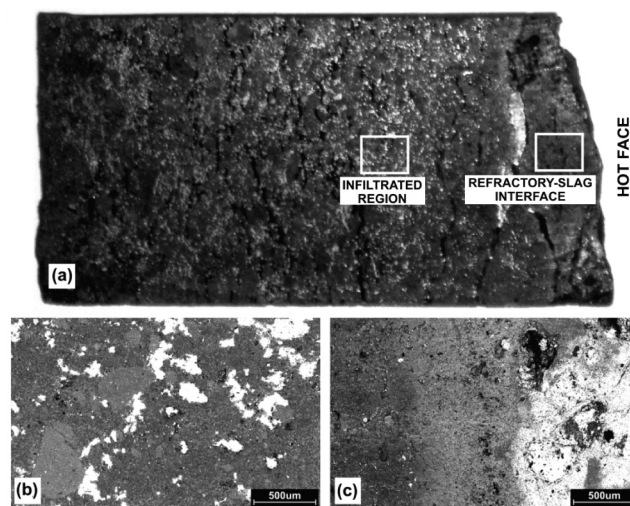
Fig. 4a shows the cross-sectioned profile of the refractory sample. Figs. 4b and 4c show the backscattered electron image of infiltrated region and the refractory-slag interface, respectively.

Fig. 4b shows the presence of a bright phase in the microstructure of infiltrated region. The resulting densification (by infiltration of this phase) promoted the damage by structural spalling. Chemical composition analyzed with EDS for the infiltration and refractory-slag interface regions is given in Table V.

Figure 4: Cross-sectioned profile of the refractory sample (a) and backscattered electron image of infiltrated region (b) and the refractory-slag interface (c).

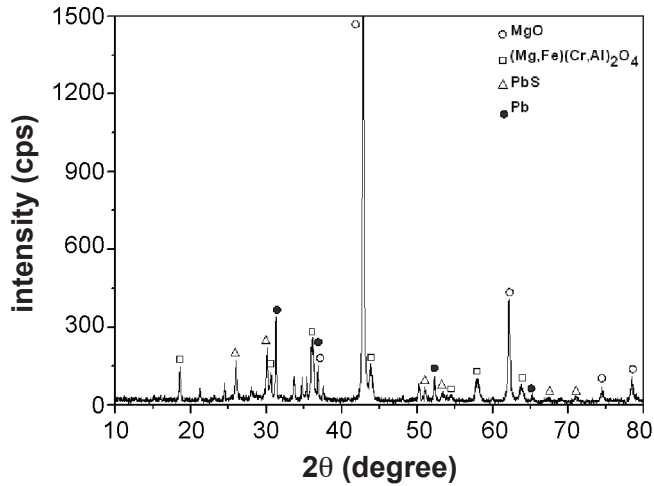
The high content of PbO in the infiltrated region shows that strong Pb-infiltration of refractory microstructure occurred. The XRD pattern of the infiltrated region (Fig. 5) shows that the Pb-infiltrated (bright phase in the microstructure of infiltrated region) is present in the metallic lead and lead sulphide phases. These are components of the furnace bath during the reduction process of the battery scrap.

Figure 5: XRD pattern of infiltrated region.

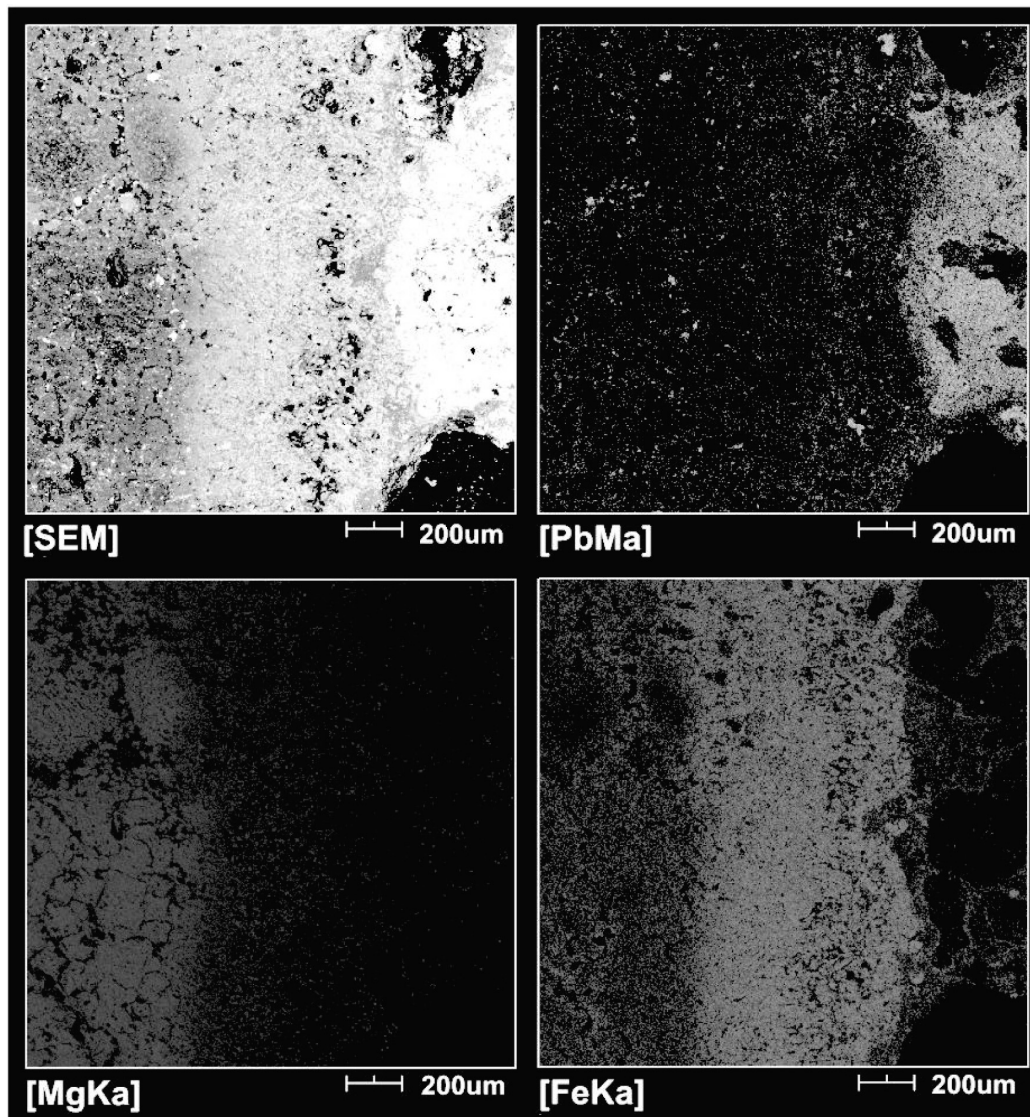
The EDS compositional maps of Fig. 6 indicate the low slag infiltration (Fe-element) at the refractory-slag interface, therefore the structural spalling is due to strong Pb-infiltration, as shown in Fig. 7.

Figure 6: EDS compositional maps for Pb, Mg and Fe of the refractory-slag interface.

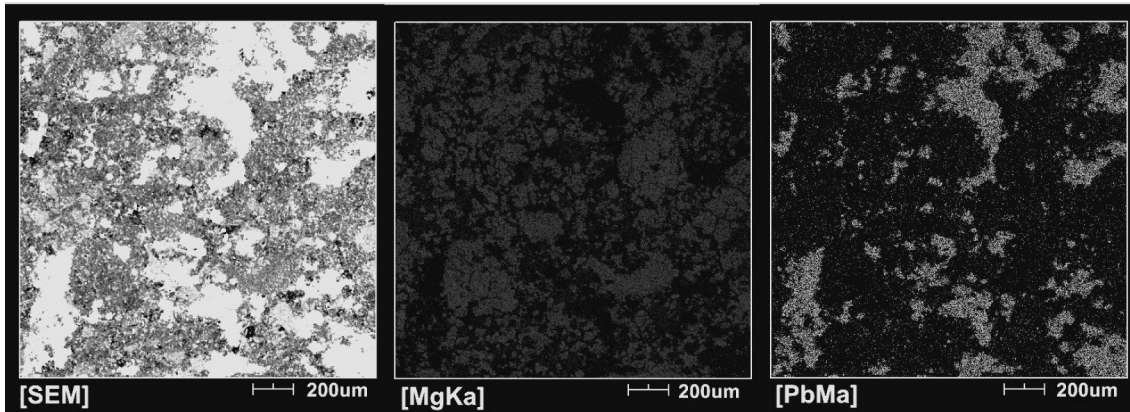
Figure 7: EDS compositional maps for Pb and Mg of the infiltrated region.
 [Figura 7: Mapeamento de raios X para os elementos Pb, Mg e Fe da região infiltrada.]

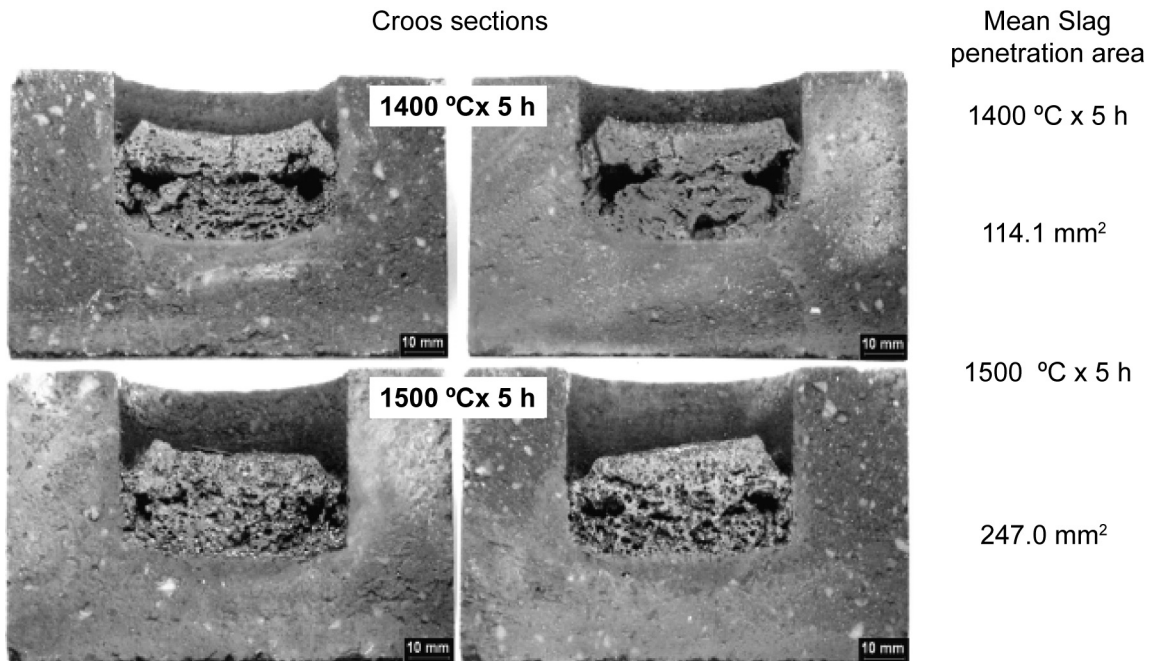
Fig. 8 shows the cross sections of used sintered magnesia-chromite brick after the cup test for 5 h at 1400 °C and 1500 °C.

The low slag infiltration shows the good resistance to FeO rich slag attack of the used sintered magnesia-chromite brick, due to the good resistance to solvent action of FeO by MgO phase and the $MgCr_2O_4$ which improve hot mechanical resistance and chemical corrosion [3, 4]. Therefore the slag attack had little contribution on structural spalling, as observed in Fig. 6 in the post mortem analysis (low Fe-infiltration at the refractory-slag interface).

Figure 8: Cross section of used sintered magnesia-chromite brick after the crucible corrosion test.
 [Figura 8: Perfil seccionado do refratário de magnésia-cromita sinterizados após o teste de ataque por escória.]
