## Physical chemistry research of a concrete dam with over 50 years of operation

Guaricana hydroelectric power plant concrete dam, located in the South of Brazil, was investigated after 49 years of operation. A part of the mortar was altered to ettringite, and other by-products. The inner defects in the fracture and polished sample surfaces were detected by CT and SEM. The samples were extracted from two parts of the dam from top to valley. Elemental chemical composition and phases were determined by EDS and XRD analysis. The reservoir water showed that it was less aggressive to the concrete structure. Percolated dam water analyses revealed a mortar-mass loss of 3 kg/year. Onsite visual inspection, mechanical tests, and other usual forms of investigation confirmed concrete deterioration, such as leaching, stalactites and stalagmites formation, alkali-aggregate reaction and ettringite. Furthermore, mortar damage was detected in a particular area according to the dam depth, and autogenous healing of cracks were visible in some parts of the inspected galleries.

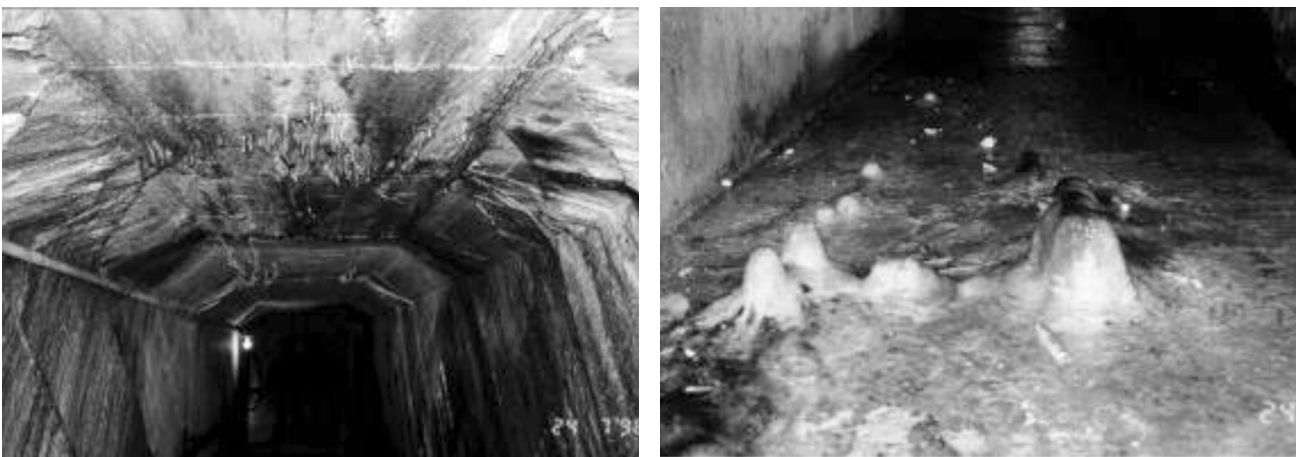
Visual inspection of the surface of the concrete gallery confirmed the influence of leaching after 50 years, showing carbonation from cracks under stalactite and stalagmite forms. Some observed cracks were found to have stopping leach owing to the impurities in the reservoir water (clay materials), and principally, by precipitation of calcium carbonate, as shown in Fig. 3. These results correspond to the dormant cracks obtained by Edvardsen in samples exposed to similar conditions for shorter times [17]. The

Figure 3: Emerged carbonation as stalactites and stalagmites from concrete cracks in the inspection gallery.

aspect of the cracks (geographic maps) indicates possible expansive reactions.

XRF and XRD patterns of the samples extracted from these structures showed 54.65% of CaO or CaCO<sub>3</sub> in calcite form as the main phase, as shown in Table II.

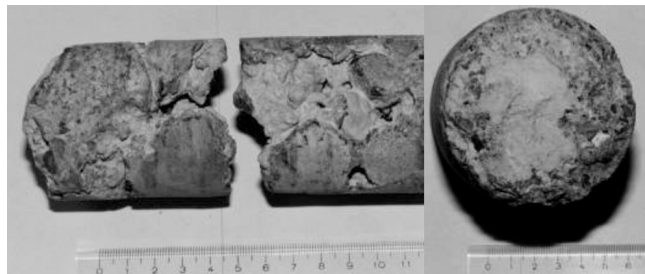
The surfaces of the concrete core samples revealed imperfections, such as voids and desegregation of the particulate materials (dislodged with probe) in specific

Figure 4: Concrete core samples from the GHPP dam.  
[Figura 4: Amostras de testemunhos de concreto da barragem Guaricana.]

regions of the depth of the dam, mainly between elevations of 688 and 700 m, as shown in Fig. 4. The concrete deterioration was found to be owing to leaching and formation of chemical by-products. However, because of concrete fragility and superficial defect, it was impossible to develop mechanical tests in this kind of samples.

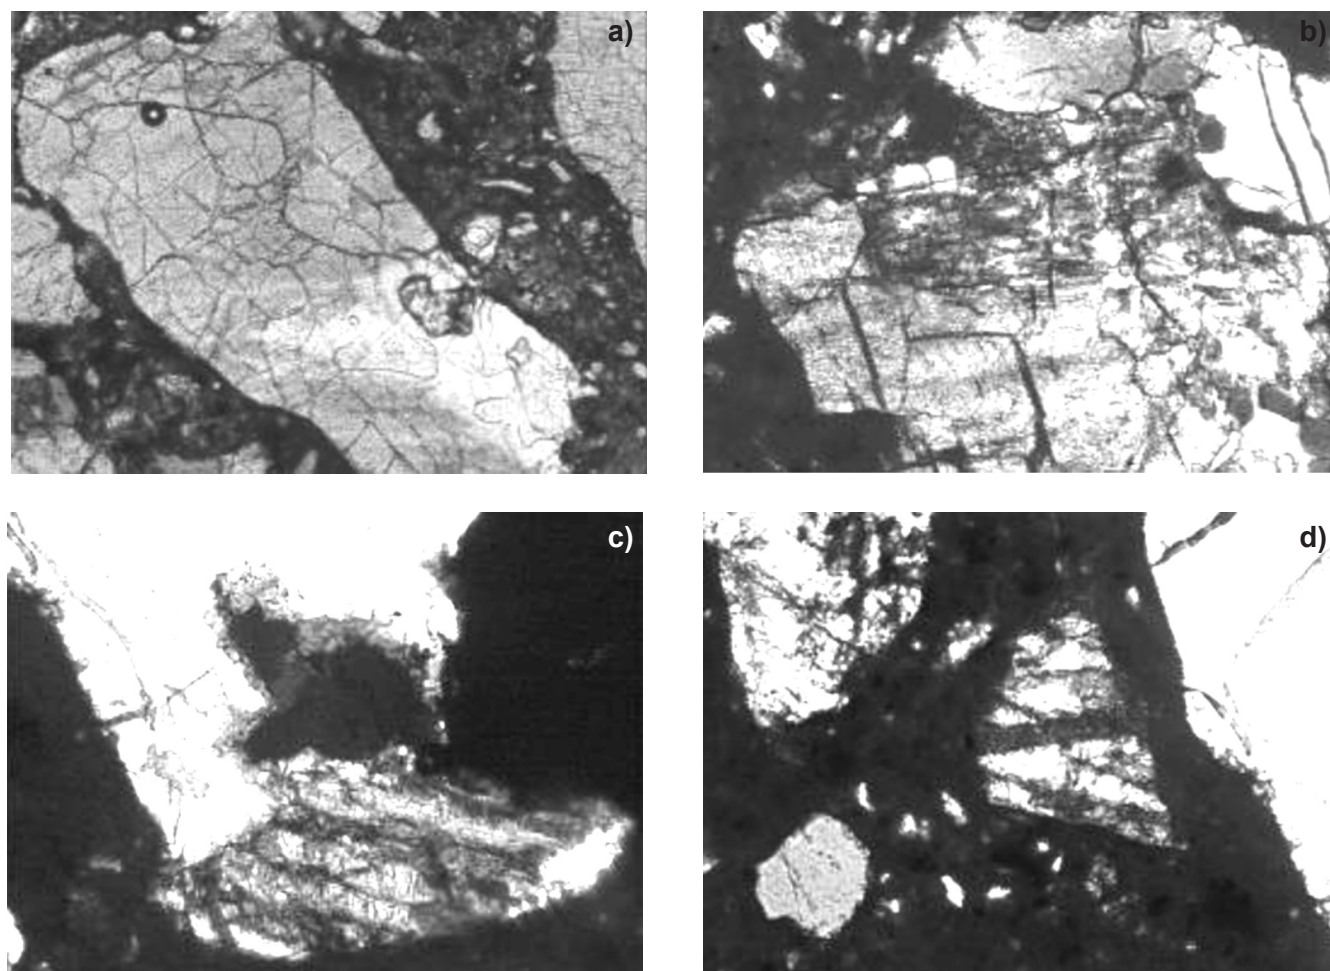
OM aggregate images from concrete structures shown in Fig. 5 reveal surface deterioration of alkali feldspar, such as microcracks, gel reactions, and boundary reactions, corroborating with the results obtained [13, 14].

Figure 5: OM feldspar images: a) microcracks under natural and b) polarized light; c) boundary reactions; and d) AAR.  
[Figura 5: Imagens de feldspato por MO: a) microtrincas sob luz natural; b) luz polarizada; c) reações nas interfaces; d) reação álcali agregado, RAA.]

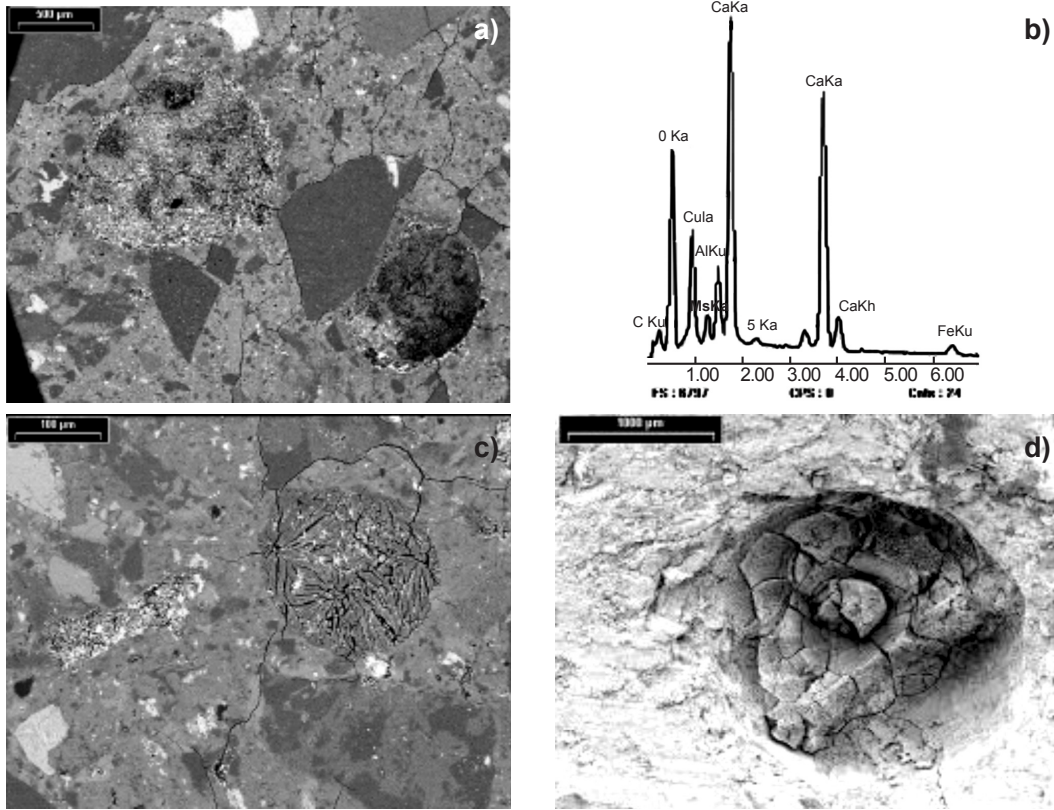
The concrete alteration was confirmed by SEM images of polished and fractured concrete sample surfaces, as shown in Figs. 6–8. The images revealed cracks as well as gel and ettringite byproduct crystals in the pores and voids. Fig. 6

Figure 6: SEM micrographs of the a) polished concrete surface and b) EDS analysis of the void (X region); c) ettringite phase (arrow); and d) gel.

also shows the images of the chemical elemental analysis of the crystals, showing Ca, Al, O, C, S, ettringite crystals (arrow), and gel phases [18].

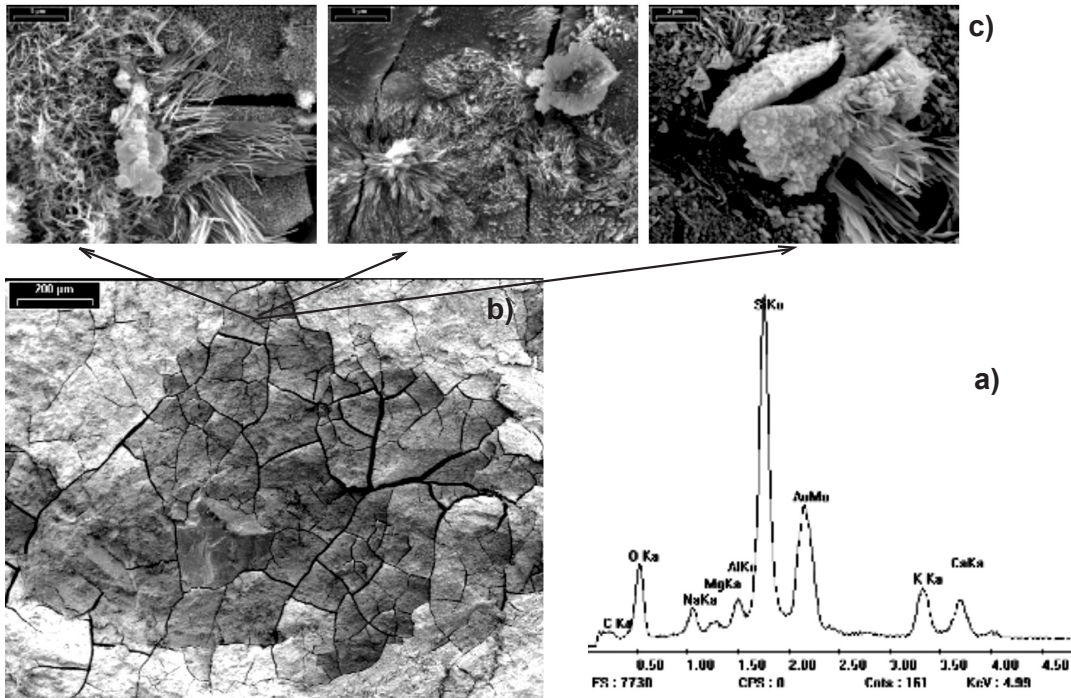
Figure 7: Massive gel graded concrete core fractured surface. (a) EDS elemental analysis; (b) SEM image of the surface of the concrete sample; and (c) detailed crystal images.

Elemental analysis of the crystals by EDS revealed crack pattern in several parts of the samples, as illustrated in Fig. 7. This result demonstrates an equivalent proportion of  $\text{Ca}^{2+}$  ions and alkalis, which is typical of the gel composition. The details of this grated surface are also shown by increasing the magnification.

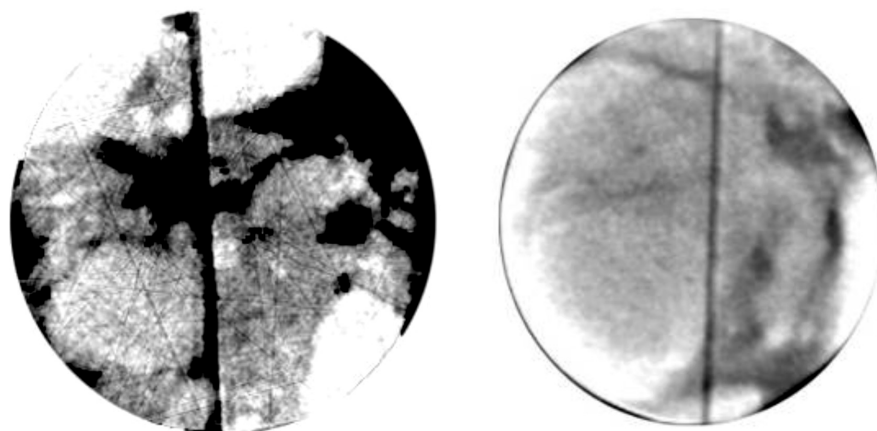
Figure 8: CT images. The darkest areas are the possible water leaching path.

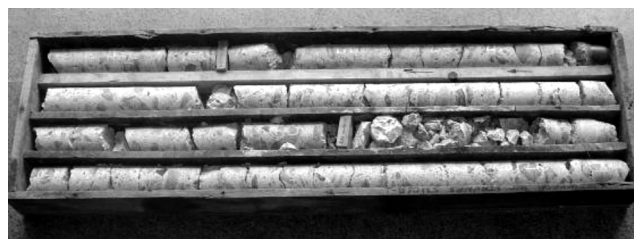
Tomographic reconstruction images of different sections of the sample showed large discontinuities in all cross-sections of the sample, as shown in Fig. 9, by contrast resolution. The darkest areas in the image signify the voids. The core samples were cut (vertical black line) to insure image interpretation. Both the images were reconstructed from different sample parts, which confirmed water percolation.

All the mechanical test results revealed a concrete mass in good condition for the main purpose, but as seen in Figure 8, some parts in the core samples extracted from 697 to 694 m depth of the dam demonstrated real sign of degradation, and could not be tested.

Figure 9: Core samples from 697 to 694 m depth of the dam.

concrete mass was in good condition for the main purpose, but some parts at the depth of the dam (mainly between 697 and 694 m, as mentioned earlier) were not tested owing to the degradation of the superficial core. Nevertheless, all these phenomena detected do not seem to be deleterious to the dam concrete at this stage of the reaction process, as no other structure manifestation was observed.
