The use of Shearography technique to evaluate polymeric composite repairs – case study

Mauro Eduardo Benedet¹, Analucia Vieira Fantin¹, Daniel Pedro Willemann¹,
Armando Albertazzi Gonçalves Júnior¹, Claudio Ramos Schmitz¹,
Ana Lúcia Fampa Seabra d'Almeida², Sérgio Damasceno Soares²,
Luiz Daniel Montenegro Lana², Valber Azevedo Perrut²

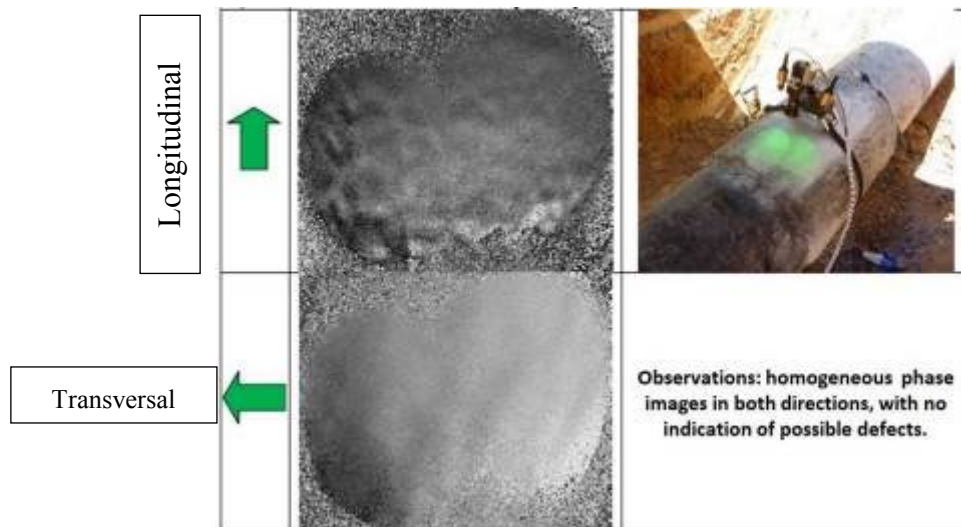
Figure 7: Shearography results from area 2. Green arrows show the directions of the lateral displacements used in the inspection device.

Figure 7 shows that, in both longitudinal and transversal directions, no significant defects were observed in the analyzed area of the Repair A since interference fringes are not present. It should be noted that due to the limited time to perform the inspection, a sample of five areas was carried out. The composite repair thickness varied between 15 and 20 mm depending on the analyzed position. However, most analyzed areas of the Repair A presented this same image aspect with no anomalies indicating the presence of subsurface flaws. After shearography inspection, the repair was removed by the maintenance team. The time

spent to remove the Repair A from the pipeline was about 120 minutes. After the removal it was clearly seen that there was no debondings between the repair and the pipeline. That is why a higher degree of difficulty to remove Repair A was faced in comparison to the removal time of Repair B.

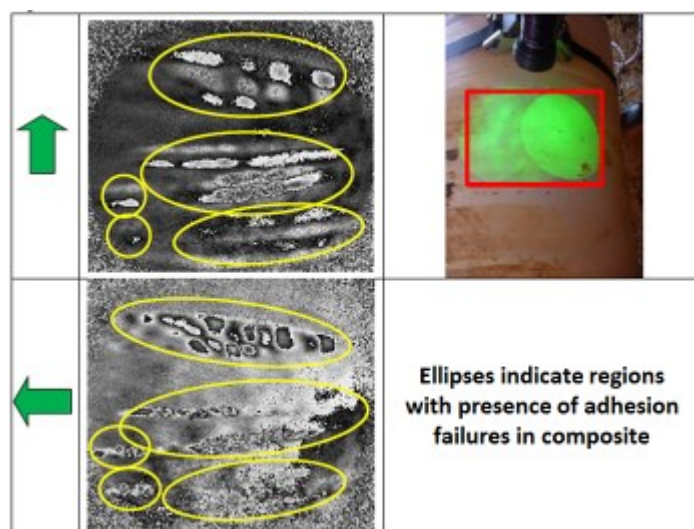
Figure 8 shows the inspection results from area 7 of Repair B and the measuring head positioned to inspection. Green arrows show the directions of lateral displacements used. As in Repair A, the vertical arrow signalizes the sense of lateral displacement in the pipe longitudinal direction. It can be clearly noted that the images caught from Repair B present several anomalies (interference fringes) in comparison to those acquired from Repair A. The defects found corresponded to more than 50% of the total area of the inspected regions, with defects up to (180 x 40) mm. For a defective area above 25% of the total area of the repair, it is recommended to replace the repair.

All areas inspected at Repair B presented several points of localized lack of adhesion between interface of composite repair and steel pipe. Since only ten points were inspected, it was not found sufficient evidence of widespread debonding. However, the repair removal was easily performed after the shearography inspection. The time to remove Repair B from the pipeline was about 16 minutes and this reduced time corroborates the inspection results. Also, it was observed that the pipe surface presented general corrosion. Compared with Repair A, Repair B removal was very easy due to the lower adhesion between composite repair and steel pipe.

Figure 8: Shearography inspection results from area 7. These results represent also the other inspected areas. Green arrows show the directions (longitudinal and transversal) of the lateral displacements used during the shearography inspection.

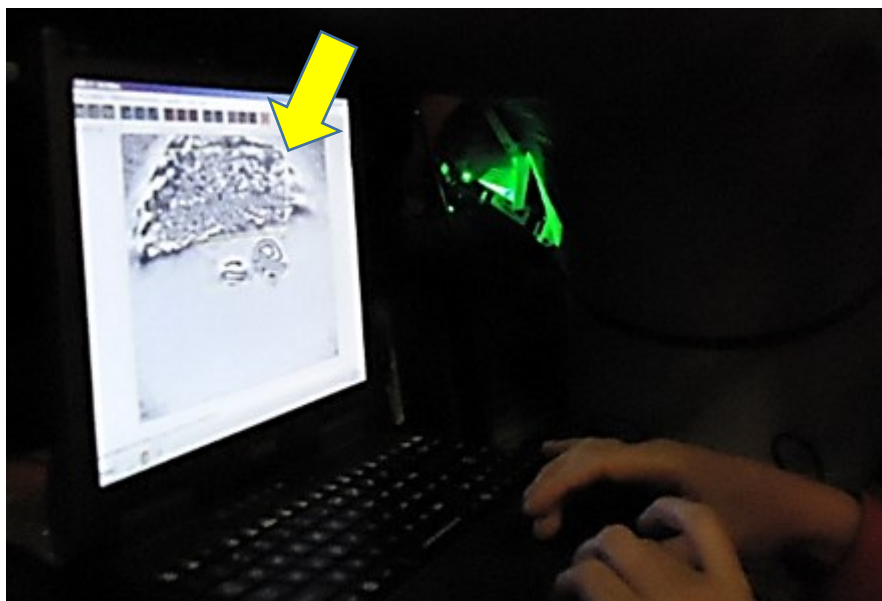
Figure 9 presents the visualization of a defective region detected during an inspection performed at night. The defect presented in Figure 9 has about (210 x 80) mm.

Figure 9: Shearography system control and data processing: visualization of a flawed region (arrow) in a composite repair.
