Case Study

Development of a risk mapping along a railway

Keywords Risk mapping Semi-empirical method RHRS Railway risk

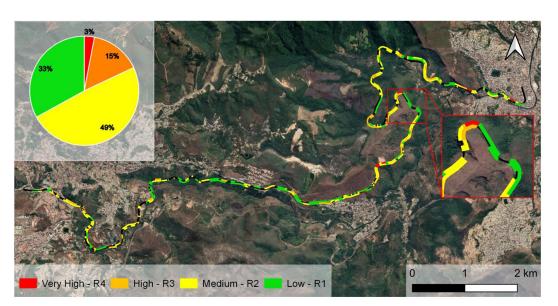
The mapping along the railway resulted in the registration of 286 slopes (polygons in Figure 3), which were grouped according to the risk classes. The distribution of the risk levels (Table 6) of all registered elements is presented succinctly in Figure 3, graphically, by the distribution of slopes according to the risk class assigned to each of them and a map.

Figure 3. Risk classification of the slopes (numbers and percentage) and the risk map.

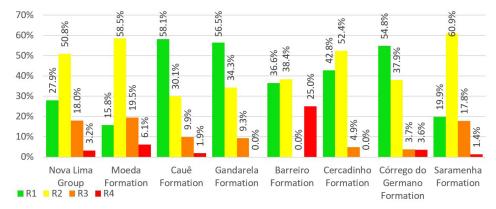
The chart presented in Figure 4 show the *RL* parameter for each lithology to the present study.

Figure 4. Chart with the lithology vs risk along the railway.

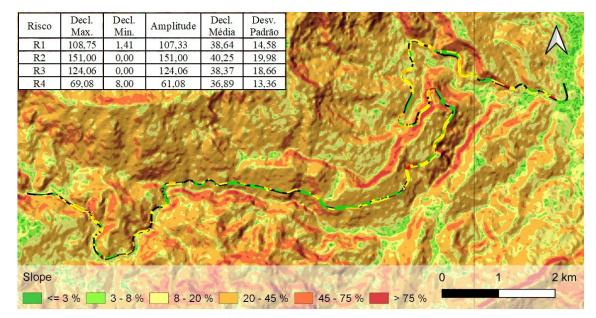
Based on the satellite Digital Elevation Model (MDE), a slope map in percentage was generated, with classifications following the recommendations of Embrapa (1979). Based on the geoprocessing values, the maximum, minimum, and average slopes were extracted, as well as the range for each risk class. The MDE with the percentage distribution per risk class is presented in Figure 5.

Figure 5. Slope map and % with the risk polygon on the railway.
