Corrosion Resistance of a Steel Under an Oxidizing Atmosphere in a Fluid Catalytic Cracking Regenerator

In the present work, the corrosion resistance of an ASTM A 387 G11 steel was evaluated under two conditions: an oxidizing atmosphere in a fluid catalytic cracking regenerator of a petroleum processing unit and a simulated atmosphere in the laboratory, at temperatures of 650 °C and 700 °C. The characterization of the phases present in the oxidized layer was carried out by X-ray diffraction (XRD), optical microscopy (OM) and scanning electron microscopy (SEM) with X-ray energy dispersive analysis (EDS). Severe corrosion was observed after exposure to both the real and simulated conditions, with formation of several iron oxides (Fe_2O_3 , Fe_3O_4 and FeO) in the product scale layer, as well as a slight inner oxidation and sulfidation of chromium in the substrate. Internal nitridation of the silicon and the manganese was observed only in the real condition, probably related to the long-term exposure inside the regenerator.

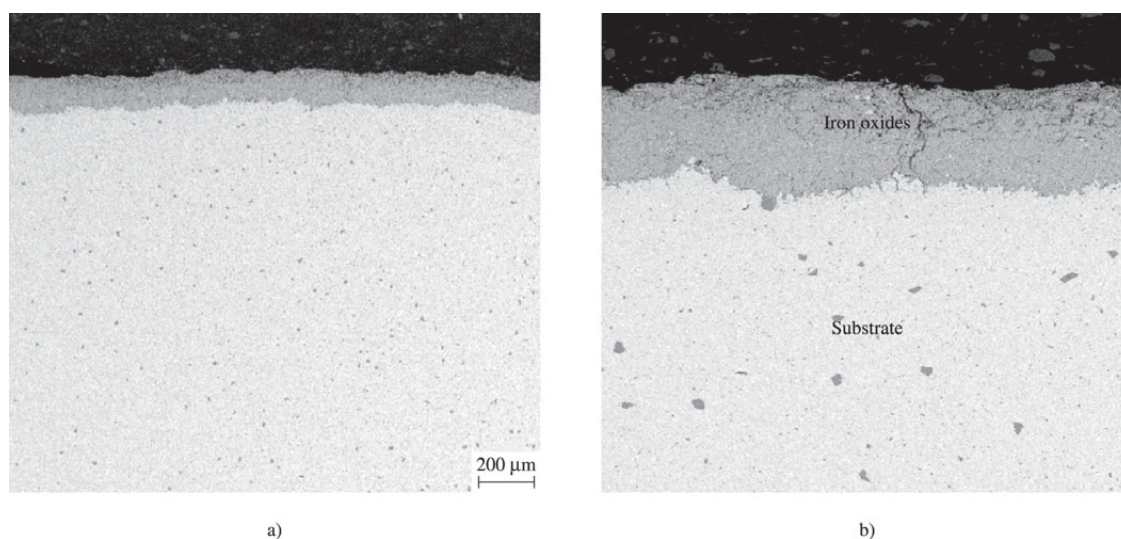
Figure 3. SEM cross-section of the G11 steel sample subjected to the real condition at 650 °C, with different magnifications. a) General view of the corroded layer and substrate; b) Expanded view of the corroded layer/substrate interface, showing in details the fissure in the corroded layer and the presence of precipitates in the substrate.

Figure 3 shows the morphology in cross-section of the G11 steel sample subjected to the real condition inside the regenerator, in the standpipe well region at 650 °C.

Fe-O phase diagram for the temperature studied. The corroded layer was very homogeneous (Fig. 3a), with a thickness around 100 μm . The fissure present across the layer, extending from the surface to the corroded layer/substrate interface (Fig. 3b), may have formed during the cooling or metallographic preparation. This thickness value is very low if one considers the long time of sample exposure (2 1/2 years). However, the original thickness of the corroded layer might be larger. It is possible that during the campaign time of the processing unit, the corroded layer detached due to

the intense wear present in the standpipe well region.

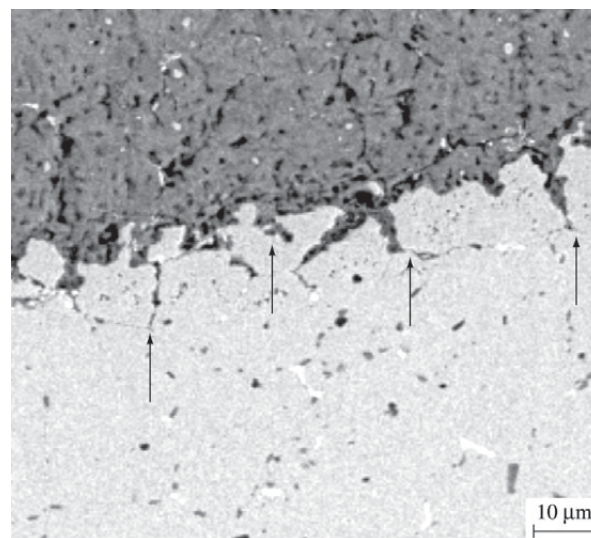
Figure 4. SEM micrograph of the corroded layer/substrate interface, showing the internal oxidation and sulfidation of the G11 steel sample subjected to the real condition at 650 °C.

Figure 4 shows, at higher magnification, the corroded layer/substrate interface of the G11 steel in the real condition at 650 $^{\circ}\text{C}$.

The X-ray energy dispersive analysis -EDS confirmed the presence of oxygen, sulfur, chromium and iron, suggesting a slight internal oxidation and sulfidation of chromium and iron next to the interface. The porosity present in the corroded layer allowed quick oxygen and sulfur diffusion into the alloy, promoting the formation of iron and chro-

mium oxides and sulfides beneath the layer. In those internal regions, the oxygen activity becomes very low while sulfur activity becomes relatively high, leading to the formation of chromium and iron sulfides⁶⁻¹¹.

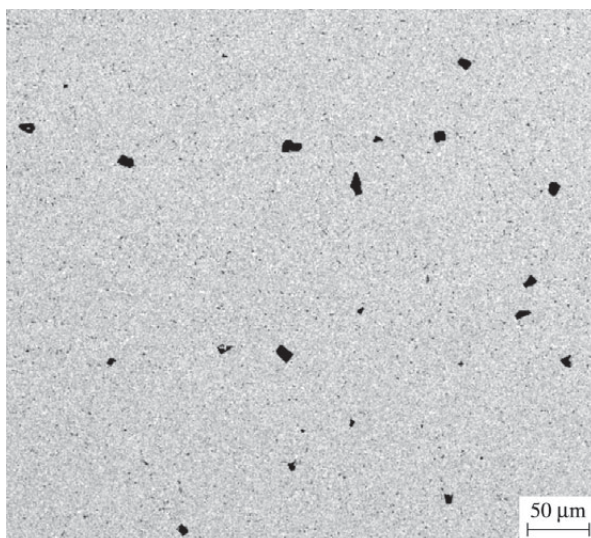
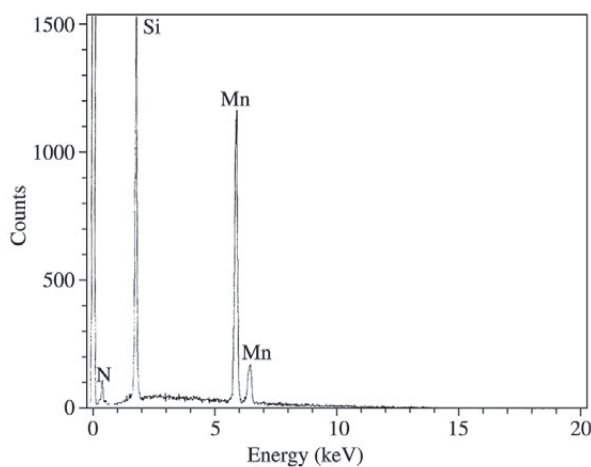
Figure 5. Detail of the internal precipitation of the G11 steel sample at 650 $^{\circ}\text{C}$ in the real condition. a) SEM micrography illustrating the morphology of the precipitates; b) EDS spectrum of the precipitates.

Figure 5 shows the internal precipitation found in the G11 steel subjected to the real condition at 650 °C. There was significant internal precipitation (Fig. 5a) throughout the entire substrate. The morphology of the precipitates was irregular both in size and geometry. An EDS spectrum (Fig. 5b) confirmed the presence of nitrogen, silicon and manganese suggesting an internal nitridation of the silicon and the manganese present in the alloy. The long time of exposure in the real service conditions (2.5 years), in which the temperature could reach 1000-1100 °C due to the burning of abnormal amount of coke in the catalyst surface, allowed nitrogen diffusion into the alloy and the reaction with less noble metals (Mn, Si), leading to the formation of manganese and silicon nitride¹²⁻¹³. In this case, the oxygen activity becomes very low (around 10^{-28} atm) while nitrogen activity becomes relatively high (around 10^{-3} atm), leading to the formation of silicon and manganese nitrides (Si_3N_4 and Mn_4N), according to phase stability diagrams for Si-Mn-O and Si-Mn-N systems¹⁴.

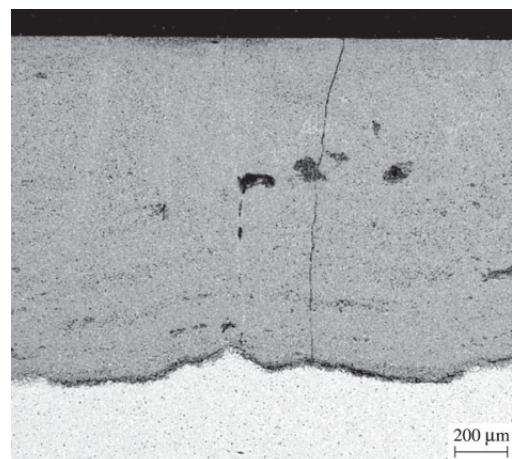
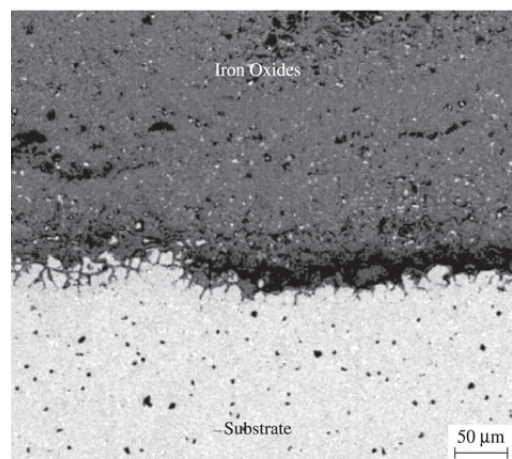
Figure 6. SEM cross-section of the G11 steel sample subjected to the real condition at 650 $^{\circ}\text{C}$, with different magnifications. a) General view of the sample, showing the fissure in the corroded layer; b) Expanded view, showing the corroded layer/substrate interface and in detail the internal oxidation and sulfidation of the chromium and the iron.

The G11 steel sample subjected to the real condition at 700 °C showed a similar corrosion behavior to that at 650 °C. This can be seen in the Fig. 6 and 7. However, the thickness of the corroded layer, approximately 1000 μm , is compatible with the long time of exposure during the campaign of the processing unit (2.5 years).

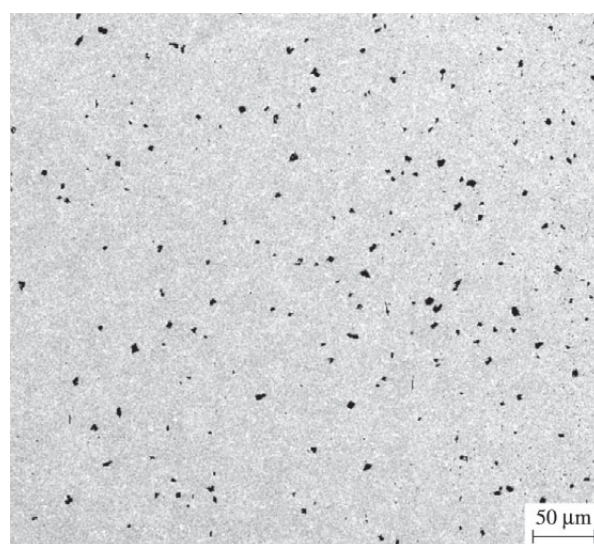
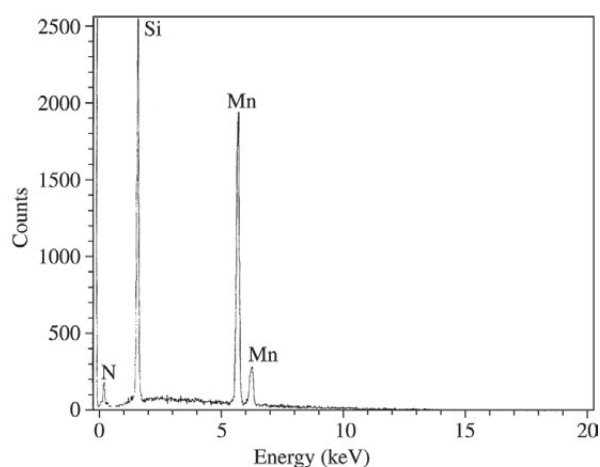
Significant internal nitridation of the silicon and the manganese was also observed, with the long time of exposure in the real condition undoubtedly being responsible for the intense precipitation. The amount of precipitates in the G11 steel subjected to the higher temperature (700 °C) is larger when compared to the sample exposed to the lower temperature (650 °C), indicating the occurrence of higher nucleation rate which is a contradiction with the theory. This apparent contradiction can be explained because the sample subjected to the higher temperature was fixed in the orifice chamber region (Fig. 1), where the temperature changes during the abnormal FCCU operation conditions were not so significant when compared to the sample fixed in the stand pipe well region, where the temperature could reach 1000-1100 °C. Another feature that could contribute to increase the amount of internal precipitates is the higher solubility of nitrogen in the alloy at 700 °C, 1685.4 ppm vs. 1335.8 ppm at 650 °C.

Figure 7. Detail of the internal precipitation of the G11 steel sample at 700 °C in the real condition. a) SEM micrography illustrating the morphology of the precipitates; b) EDS spectrum of the precipitates.

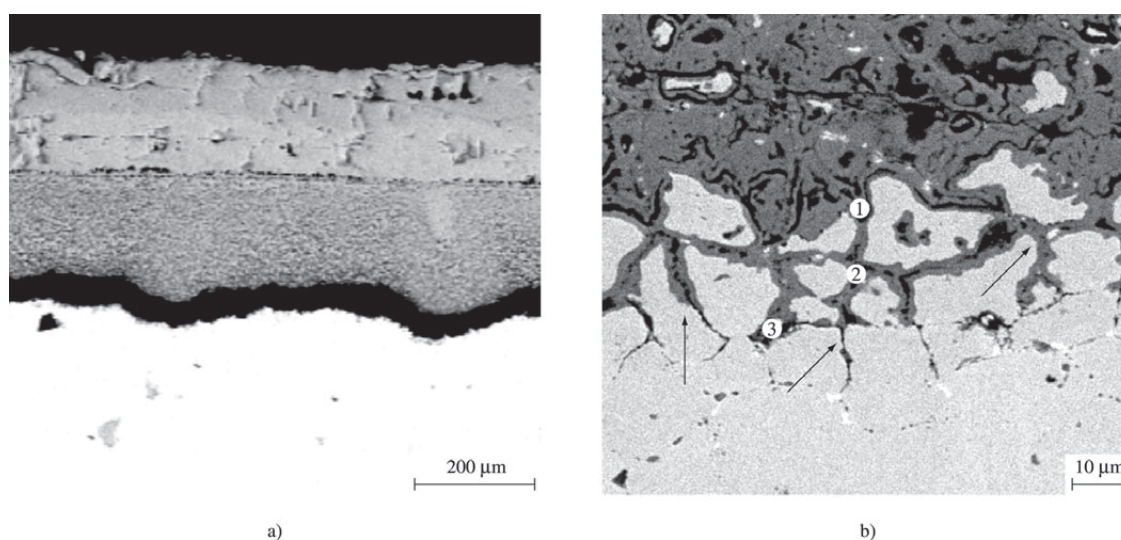
observed in the sample subjected to the simulated condition at 700 °C. However, the corroded layer was not homogeneous when compared to those resulting from the real condition, presenting two distinct layers: the smoother external one, constituted predominantly by Fe_3O_4 and the inner layer with great porosity, where the EDS analysis detected primarily sulfur and chromium, leading probably to the formation of Cr_2S_3 . The corroded layer was detached from the substrate along their interface.

Figure 8. SEM cross-section of the G11 steel sample subjected to the simulated condition at 700 °C. a) General view of the corroded layer and substrate showing in detail the detachment of the layer from the substrate; b) Detail of the corroded layer/substrate interface, showing the internal oxidation and sulfidation.

Figure 8a shows the general view of the corroded layer and substrate. One can observe clearly the presence of two distinct layers and the detachment of the corroded layer from the substrate. In Fig. 8b, the internal oxidation and sulfidation of the substrate are indicated by arrows.

No sign of internal nitridation of the silicon and the manganese was observed in the G11 steel sample subjected to the simulated condition at 700 °C during 70 h. This may be an indication that the internal precipitation is related to the long time of exposure inside the regenerator (2.5 years) in the real service condition.
