# Metallurgical and Mechanical Examination of Fatigue-Induced Fracture in a Conveyor Drum Shaft

This work investigates the fatigue failure mode of a shaft used in a conveyor system for mining applications through visual inspection, metallographic examination, fracture analysis, and mechanical testing. It was observed that a misalignment of about 5° between the shaft and the conveyor drum system promoted intensive contact with the parts. The combination of misalignment and overload was the leading cause of the localized plastic deformation, which resulted in the shaft fracture. A metallurgical examination revealed ferritic and pearlitic microstructures for an AISI 4140 grade steel. This suggested that the heat treatment on the steel was not adequate for the application. Therefore, it can be inferred that no preventive or corrective maintenance inspections were performed during the shaft's operational production period.

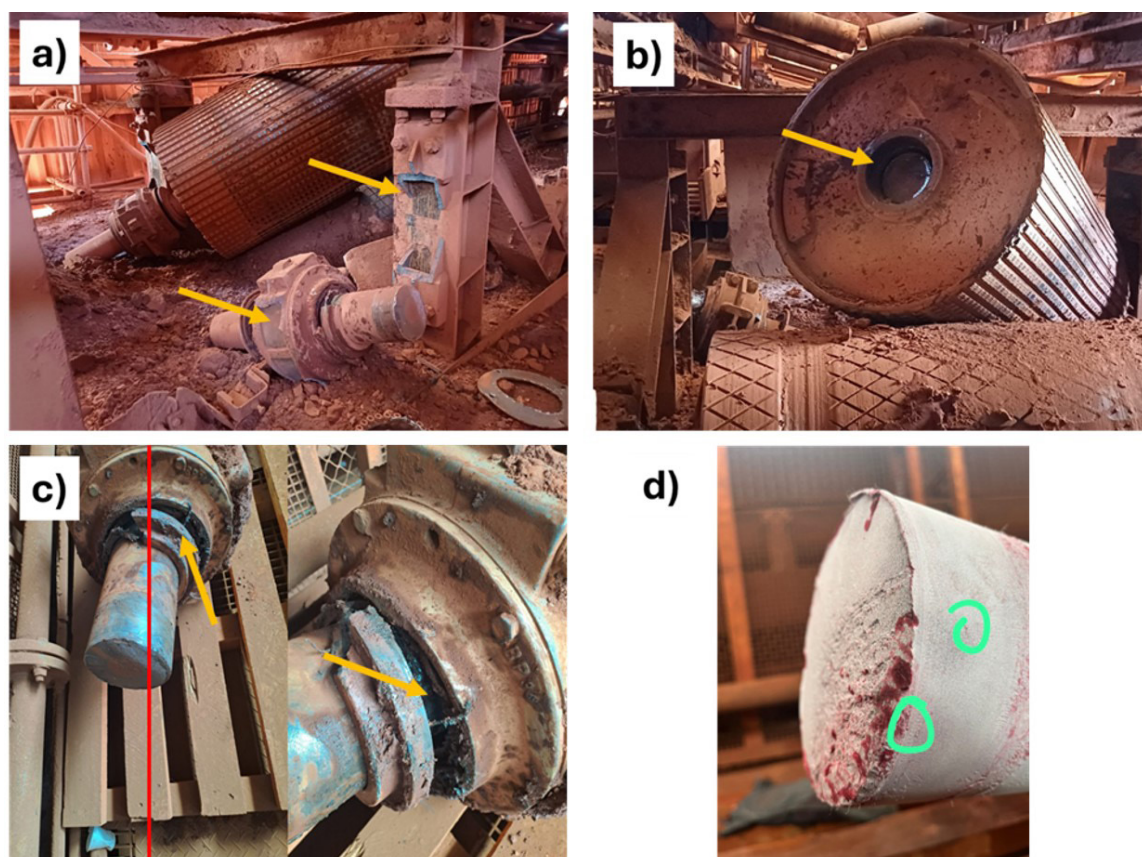
**Figure 1.** Images of the failure of a conveyor belt drum shaft, causing a production shutdown at the moment of failure. (a) Damaged assembly structure due to the failure, (b) fracture region of the shaft inside the drum, (c) damaged shaft bearing and misaligned shaft in the bearing, and (d) initial visual analysis using liquid penetrant revealing multiple potential fracture initiation points.

Figure 1b shows that the shaft fractured inside the drum. Figure 1c reveals that the shaft bearing also suffered damage, and the shaft bowed to the left, as can be observed in the vertical axis of the figure. Figure 1d shows an initial liquid penetrant inspection on the fractured part and the region near the shaft failure. The test revealed an accumulation of red penetrant liquid, primarily on the outermost diametrical part of the shaft, indicating a potential fracture initiation site.

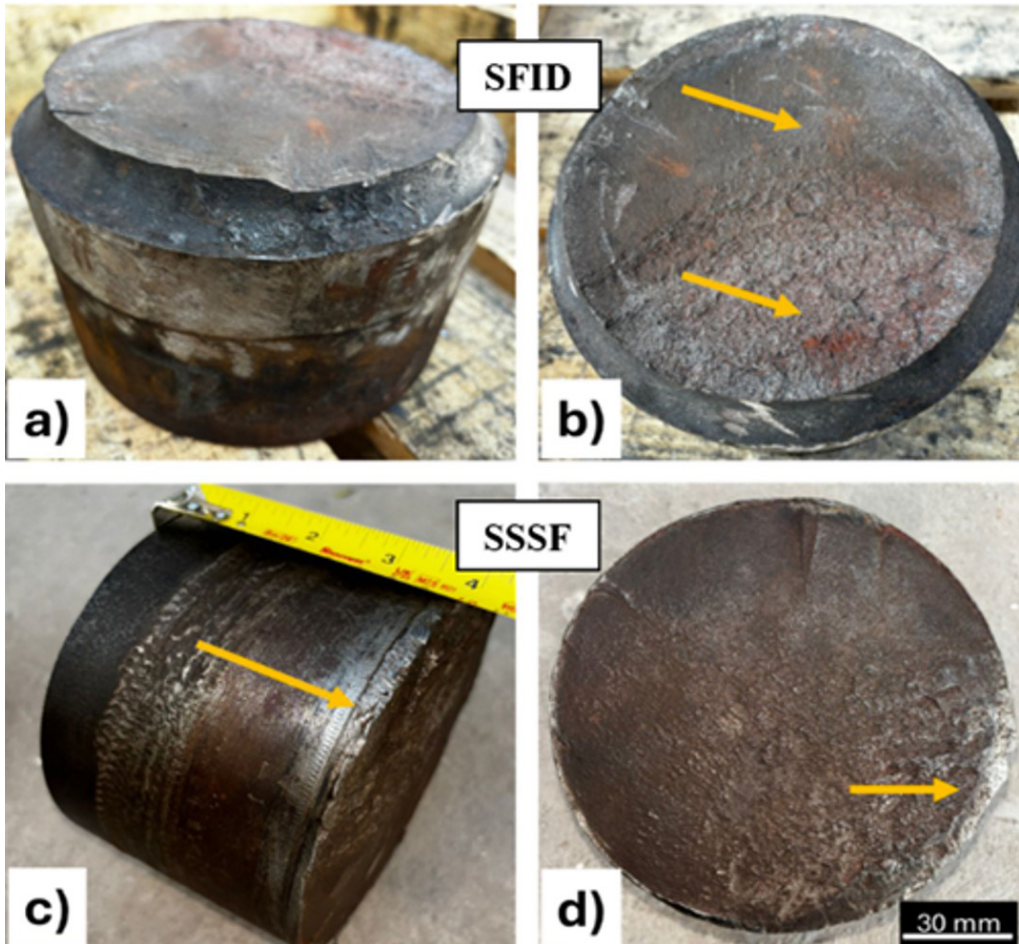
As shown in Figure 2, two fractured shaft samples were received at the Mechanical and Thermomechanical Testing Laboratory (LabEnsaios) of the Federal Institute of Maranhão – IFMA, Brazil. As a first activity, samples were identified as the internal side of the fracture to the drum (ISF), Figure 1 (a-b), and the side separated from the shaft by the fracture (SSF), Figure 2 (c-d). After this, both fractured surfaces were visually inspected. It can be observed that the ISF exhibits a diametral transition zone from 180 to 150 mm in width, and at the end of the curvature radius of 20 mm, the fractured shaft, as shown in Figure 2a. Also, Figure 2b shows that, despite the oxidation over the fracture, there are two regions in the failure surface: one that had high roughness, occupying approximately half of the perimetral area of the fracture, and another region with

a visually smoother appearance. Regarding the SSF, intense wear was observed with a thickness of approximately 40 mm (see Figure 2c). Additionally, Figure 2d shows the fractured face with the fractured surface dented due to the possible impact of the shaft with both the support structure of the conveyor system and ground contact. The sections of the fractured parts do not identify the material characteristics.

**Figure 2.** Images of the conveyor drum shaft samples received at LabEnsaios for failure analysis: a) Side of the fracture internal to the drum (ISF), b) Regions of the failure plane (ISF), c) Intense wear and plastic flow of the metal (SSF) and d) Fractured and dented surface (SSF).

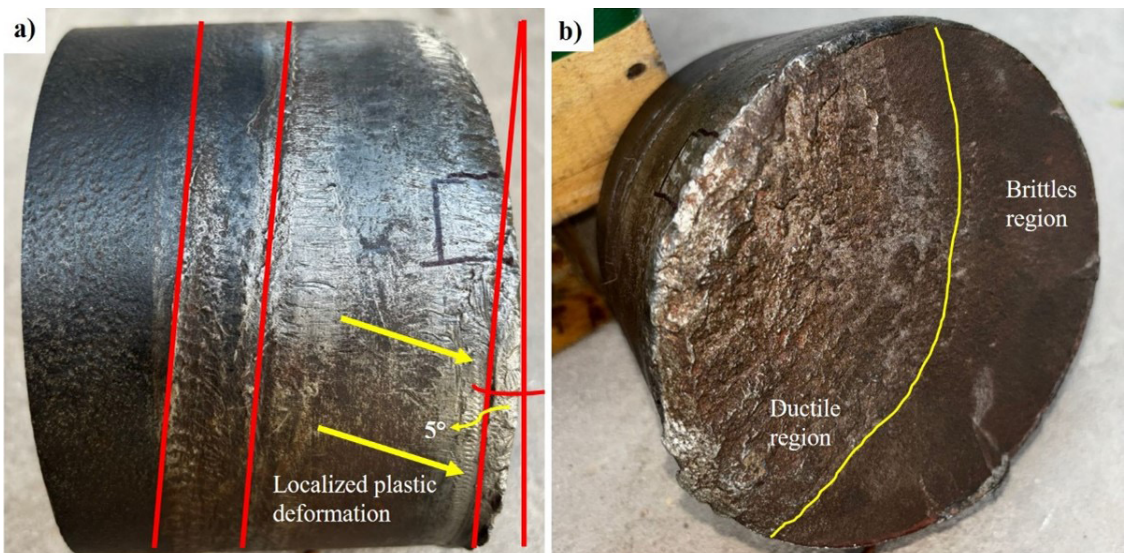
Figure 5 presents the macroscopic visual inspection of the drum shaft fracture surface. It reveals signs of irregular wear and metal flow (i.e., localized plastic deformation) due to the intense contact of the shaft with the internal part of the conveyor drum over the time, as indicated before in the experimental methods section. It is also observed that the worn contact track presents a misalignment of approximately 5° perpendicular to the length of the shaft (see Figure 5a). In addition, Figure 5b shows the complete region of the fracture of the shaft's perimetrical face, indicating that in one moment, the fracture behaved as ductile and then brittle. Although the area is crumpled, some traces suggest fatigue failure propagation, where almost half of the shaft's cross section underwent this process and subsequent catastrophic failure.

**Figure 5.** a) Visual profile of shaft wear and b) Macroscopic shaft fracture surface appearance after catastrophic failure.

In most drum shaft applications, damage created by shaft deflection often occurs<sup>9</sup>. Shaft deflection is the bending or flexing of a shaft caused by the sum of the loads on the conveyor system. However, in the current case, the shaft was misaligned, as the localized plastic region has indicated. Due to the continuous working and overloading of the drum shaft at a specific point of contact with respect to the support conveyor system, cyclic loading has caused the shaft to fatigue and rupture. Under typical operating conditions, the influence of cyclic loads on shafts causes fatigue fracture, which is the most frequent mechanism of shaft failure<sup>5</sup>. Thus, fatigue is understood as the progressive process in which a material is subject to some conditions that introduce stresses and strains after sufficient time fluctuating events, culminating in cracks or complete fracture.

area. Finally, it is stated that the failure of the shaft occurred through a fatigue process, passing through a ductile region until reaching the transition zone, resulting in a catastrophic brittle failure. Notwithstanding, it is always recommended to review the assembly and continuously monitoring the alignment of the shafts in the conveyor drum. Mechanical components used in the assembly of industrial equipment need to undergo quality control regarding the mechanical and metallurgical properties, keeping low economical and/or environmental losses.

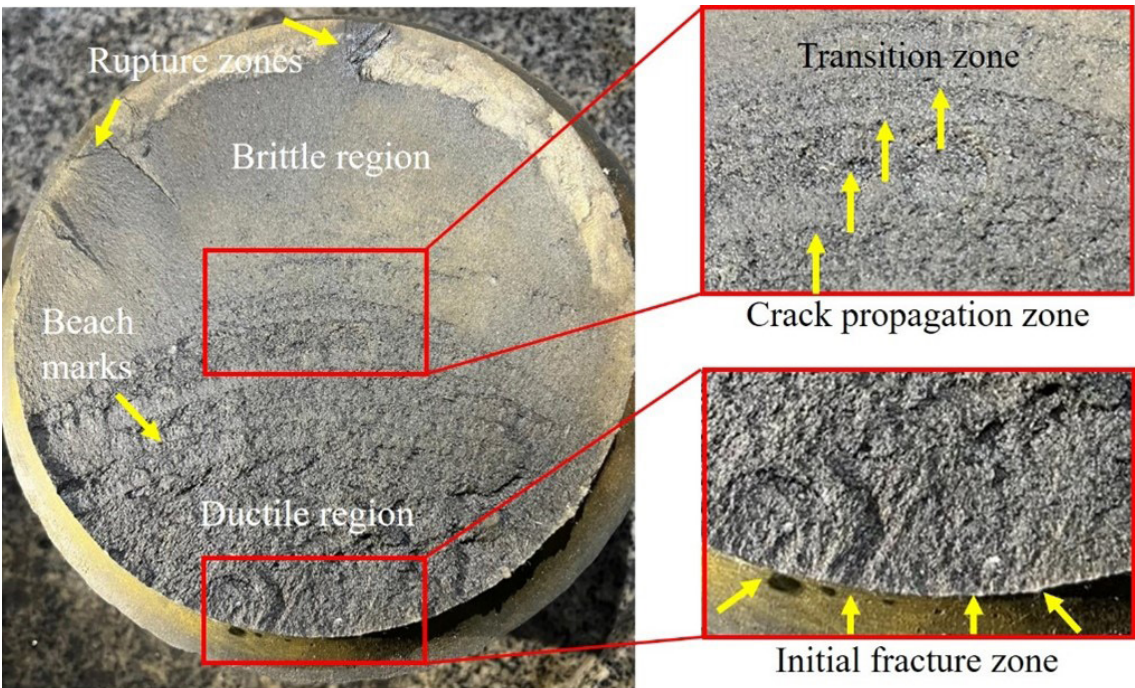
The principal fracture surface features of the failed shaft are displayed in Figure 6. The image reveals in more detail the start region of the fracture, containing multiple crack nucleation sites and propagation striations. It can be observed that the propagation of fatigue failure occurred in a ductile manner. Beach marks are evident up to the transition zone between the ductile and catastrophic failure regions, ending in the outermost diametrical region and showing shear lips. In the area of fracture initiation, some milling marks, highlighted by yellow arrows, are also observed that separate different fronts of initiation of propagation on the fracture surface and ratchet marks along the propagation of the

fault where two or more fatigue cracks, nucleated in slightly different planes, join, forming stepped lines on the surface.

Figure 6. Observed shaft fracture surface features indicating fatigue failure.

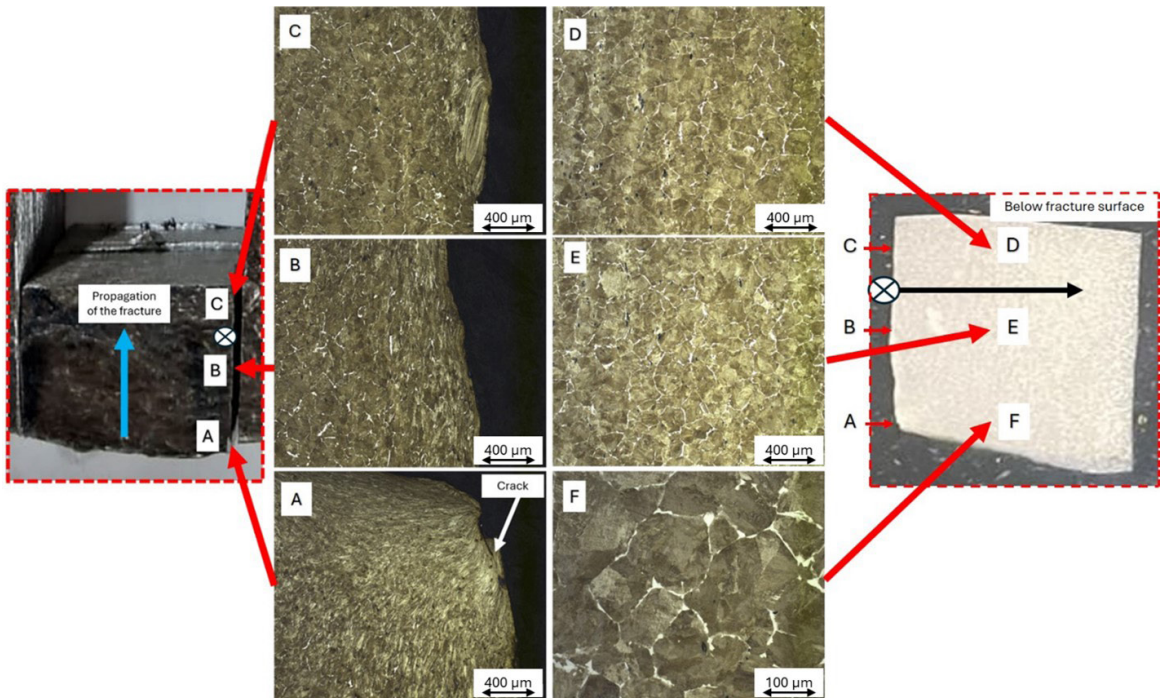
Figure 7 presents the images of the optical metallographic examination of the failed shaft, according to the observation procedure indicated by the letters A to C in the fracture propagation region and letters D to F below the proximity of the fracture surface region. Sections at the edge of samples A, B, and C present elongated grains generated by plastic deformation as well as the presence of a crack in region A. A little further from the edge, a transition zone between elongated grains and equiaxed grains is seen in region B. In an area away from the fracture surface, D, E and F, the grains are equiaxed with an average size of 230  $\mu\text{m}$ , presenting pearlite and contoured by pro-eutectoid ferrite. This

**Figure 7.** Metallographic analysis of the sample from the axis close to the edge of the fracture surface initiation and proximity from the fracture surface.

microstructure advises that the shaft was thermomechanically processed at a higher temperature (e.g., probably above 1000 °C) and then air cooled. This microstructure for an AISI 4140 steel differs from the expected one after applying an obvious quench and temper heat treatment, going far away from the material processing specifications for drum shaft applications. For mechanical cycling loading in motion systems, the AISI 4140 steel has been successfully applied, being manufactured utilizing open-die forging and specific heat treating for producing heavy parts combining outstanding strength and ductility and also good cracking resistance due to the superior impact properties<sup>12</sup> when compared to other plain carbon steels. Badaruddin et al.<sup>13</sup> have shown that the final microstructure of an AISI 4140 can be improved by modifying the quench and temper thermal processing route for manufactured products such as shafts. By applying a double quenching-tempering process, a tempered-martensite microstructure in a ferritic matrix can be obtained with a sharp increase in strength resistance and ductility.

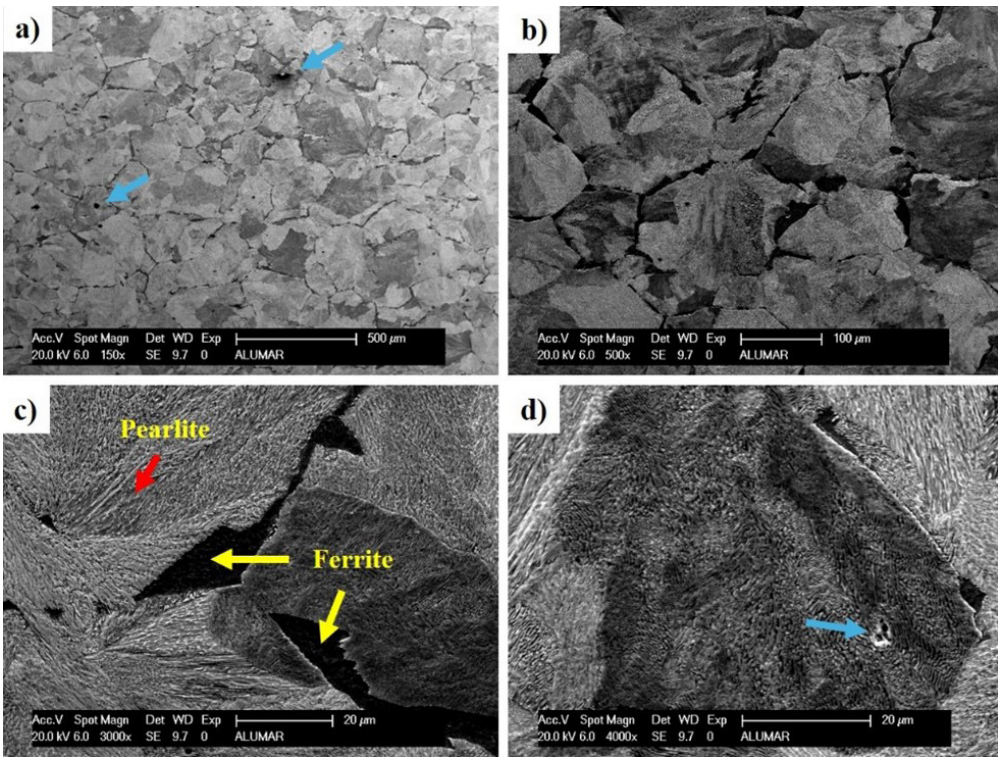
Figure 8 shows the SEM images of the central region and the proximity region from the fracture surface of the failed shaft. The microstructural features of the equiaxial pearlite grains (light regions) surrounded by pro-eutectoid ferrite (dark areas) can be seen better. Additionally, voids and/or inclusions can be verified, as the blue arrows indicate. With increasing the magnification, Figures 8b), c) and d), details of the pearlitic structure and color variations on the gray scale can be observed, a well-known material characterized by presenting different crystallographic directions of the pearlitic grains.

**Figure 8.** SEM images for the sample near the fracture surface a-d): a and d) Non-metallic inclusions observed at low and high magnification in the microstructure; b) Identification of the microstructural condition showing grains of pearlite surrounded by ferrite and c) higher magnification presenting the details of ferrite and pearlite.

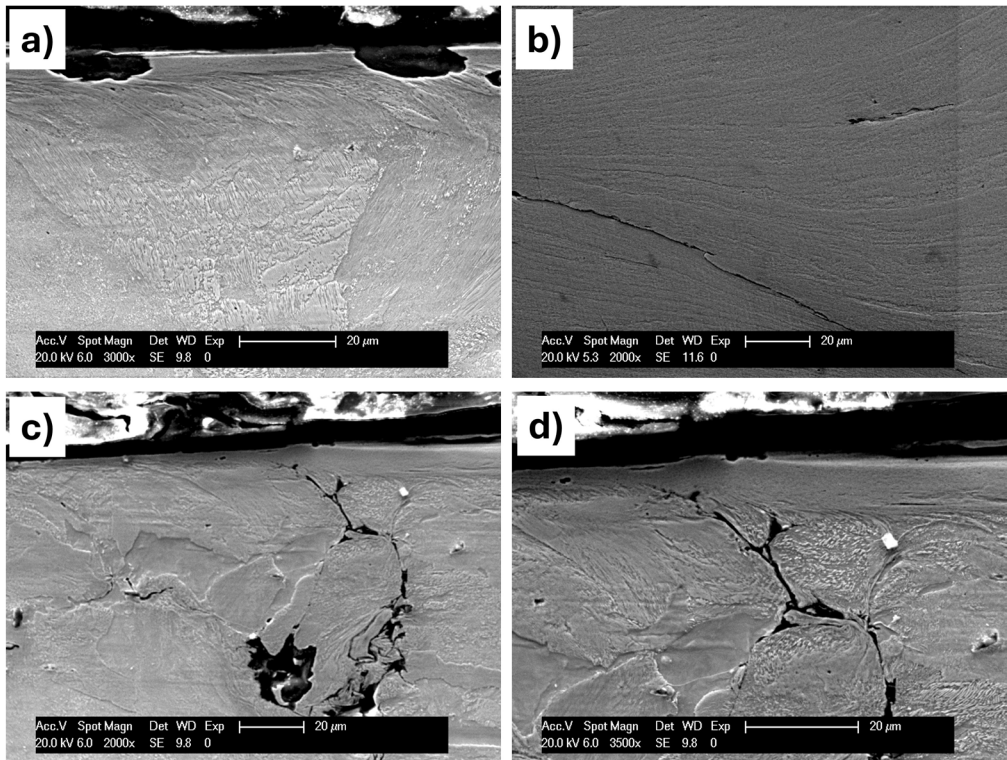
The analysis of the deformed region can be seen in Figure 9. In the case of Figure 9a, it shows a region with

pearlitic grains that underwent intense plastic deformation, as the flow lines in the microstructure allows to observe it. A long crack in the direction of deformation can be seen in Figure 9b. Figures 9 (c-d) show the propagation of a transgranular crack and a region showing the presence of pores and inclusions inside it. The intense plastic deformation that the material supported finally resulted in the nucleation of microcracks that fast propagated until the fracture was reached. When defects like microvoids or microcracks form, grow, and eventually coalesce into macrocracks, the material's mechanical properties often deteriorate. Thus, material damage is strongly controlled by a variety of metallurgical and processing factors such as alloy composition, microstructure, temperature, strain, strain rate, stress state, etc<sup>14</sup>.

**Figure 9.** a) SEM image of intense deformation region that has led to the failure of the shaft, b) Image of crack propagation along the material flow, c) and d) presence of intergranular cracks.

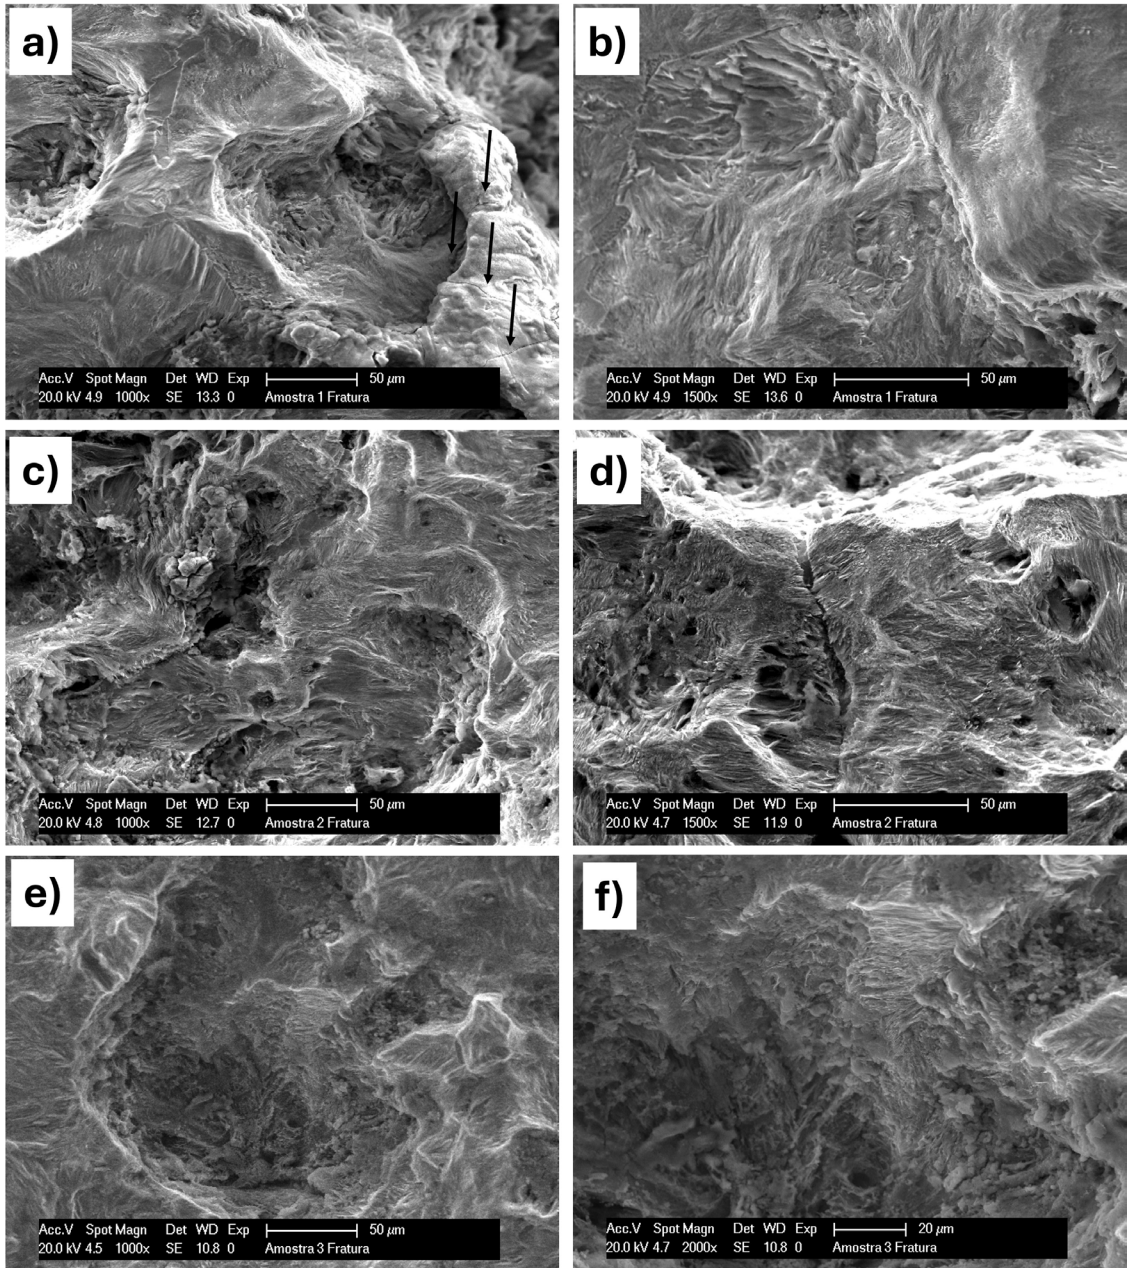
The fractography SEM images are shown in Figure 10, obtained as indicated in Figure 4. In the case of the sample 1, it characterizes the beginning of the fatigue process, in which the presence of several microcracks and dimples characteristic of ductile fracture, as well as fatigue striations, can be observed in Figure 10 (a-b). In sample 2, the transition zone between the fatigue process and the catastrophic failure is shown in Figures 10 (c-d). Also, the presence of valleys and dark spots of inclusions and/or voids and microcracks at the end of the transition zone can be seen. Finally, region 3 is characterized by the catastrophic failure zone, a smoother surface with characteristics of a more brittle fracture is observed. Along the fracture surface, the fracture propagation mechanism shifts to a mixed mechanism consisting of a few intergranular fracture regions and voids. In consequence, these SEM fractography images have shown that the main fracture mechanism is quasi-cleavage<sup>15</sup>, a possible fatigue propagation

**Figure 10.** (a-f) SEM fractographies of the samples 1, 2 and 3 in Figure 4.

mechanism for the AISIS 4140 steel<sup>16</sup>. Marcomini et al.<sup>17</sup> found that the combination of wear, contact-fatigue, impact fatigue and overload have been the causes of the premature failure of a hot-forged SAE 4140 steel kingpin truck component. They also observed that the variation and changes in loads as severe operational conditions have promoted irregular deformation in the cross section of the kingpin. Thus, a correlation between their results and present findings can be done about the failure mode of the shaft.

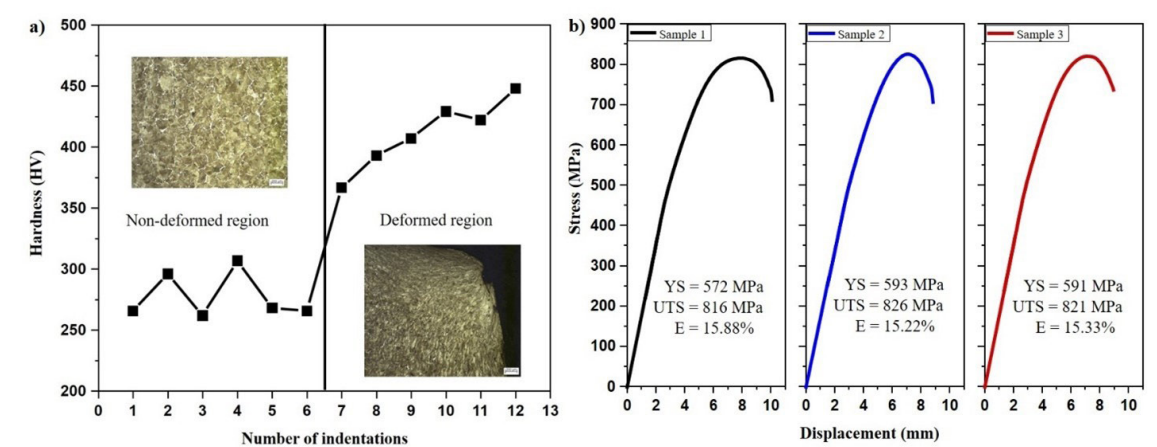
The microhardness profile of the undeformed and deformed regions is shown in Figure 11a. The measurements

were made on the surface of the sample analyzed by optical microscopy in the direction A to E of Figure 8. A significant increase in the microhardness values can be observed in the deformed region. It is known that the increase in hardness in a plastically deformed region is a consequence of the increase in dislocation density leading to work hardening of the material. High work hardening is synonymous with embrittlement and consequent facilitation of the emergence of cracks when subjected to cyclic loads. Respect to the mechanical behavior, Figure 11b presents the main values of the yield strength (YS), ultimate tensile strength (TS) and the total elongation to fracture (E), all these values were determined directly by the equipment

Figure 11. Mechanical behavior of the fractured shaft: a) Vickers microhardness profile and b) Engineering stress-strain curves.

software and checked. The average values were  $YS = 585.6 \text{ MPa}$ ,  $TS = 821.4 \text{ MPa}$  and  $E = 15.48\%$ . It is observed that this steel presented higher resistance values that are comparable with those ones for the structural steel AISI 4140, and higher than the usual carbon steel AISI 1045<sup>18</sup>. However, the elongation is considered a little lower for AISI 4140 than is expected for values of 25%. Also, it has been stated that the gradual reduction in strength and cycling softening behavior until failure in low working cycles for AISI 4140 steel is the direct consequence of the microstructure, being very sensitive the material to cyclic plastic deformation<sup>19</sup>.

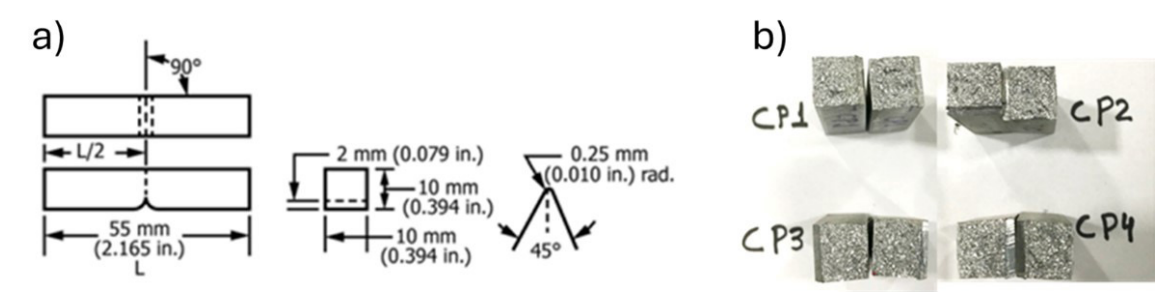
Figure 12. Charpy Impact Test: a) V-notch specimens full size dimensions, and b) appearance of shear fractures of Charpy impact test specimens.

As Table 2 shows, the energy absorption values are low, leading to brittle fractures, which show that this material cannot be exposed to excessive impacts. The fractures were similar for all samples, which correspond to the 10% fracture profile as per the guide fracture shear appearance graphs for comparison of the same according to the ASTM A370-21 standard over the sample configuration shown in Figure 12.
