# Effects of reprocessing on chemical and morphological properties of guide wires used in angioplasty

**Objective:** To investigate the influence of the reprocessing technique of enzymatic bath with ultrasonic cleaning and ethylene oxide sterilization on the chemical properties and morphological structure of polymeric coatings of guide wire for regular guiding catheter.

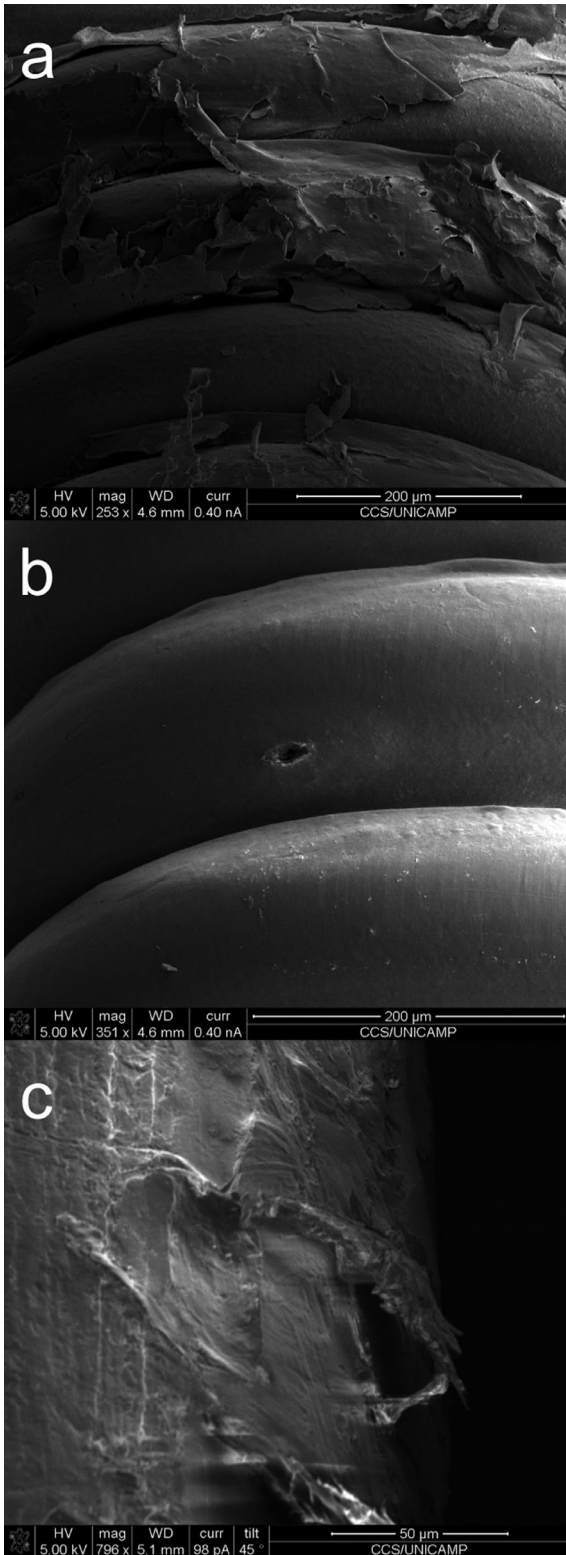
The effect of ultrasonic and enzymatic detergent cleaning treatments of the three samples can be seen in the SEM images (Figure 2), which depict the surfaces of the samples after a single cleaning. Pronounced surface damage is observed in samples AU1 and CU1 while damage is less significant in sample BU1. Sample AU1 was the most affected, as seen in Figure 2.

The persistence of debris larger than 200 µm can be observed at the surface of guide wires after the washing procedure using ultrasound. Sample BU1 shows defects in the PTFE structure, including holes and bubbles, that were not observed in the pristine material. A marked roughness in the polymer coating surface is seen in the CU1 sample, with some holes in the microstructure and micrometric flakes, smaller than those observed in sample A.

Fig. 2 – SEM images of guide wires AU1 (A), BU1 (B) and CU1 (C), washing 1X using enzymatic detergent in ultrasonic bath. Debris and holes of considerable size are observed mainly in Figures A and C, while bubbles and a non-conformal surface are observed in Figure B.

By carefully observing the SEM images (Figure 2), it becomes apparent that blocks of PTFE 40 to 300 micrometers in length were removed from the surface of the guide wire catheters after only one washing procedure. In addition to eventual occurrence of embolization of distal coronaries or other systemic arteries with surface detached debris, accompanied or not by tissue infarction [3], changes in wettability and in the electrical charge of catheter surface are major factors in additional platelets aggregation and thrombosis formation [11]. The chronic fate of this PTFE debris in tissues is also not known, but potential

The treatment of the catheters with ethylene oxide was not associated with morphological or chemical changes, and it seemed appropriate to maintain guide wire coating integrity. However, the ultrasonic cleaning was not suitable for polymer-coated guide wires, and a combination of chemical reaction with mechanical vibration may have resulted in the further deterioration observed. Therefore, the reuse of these devices is not recommended.

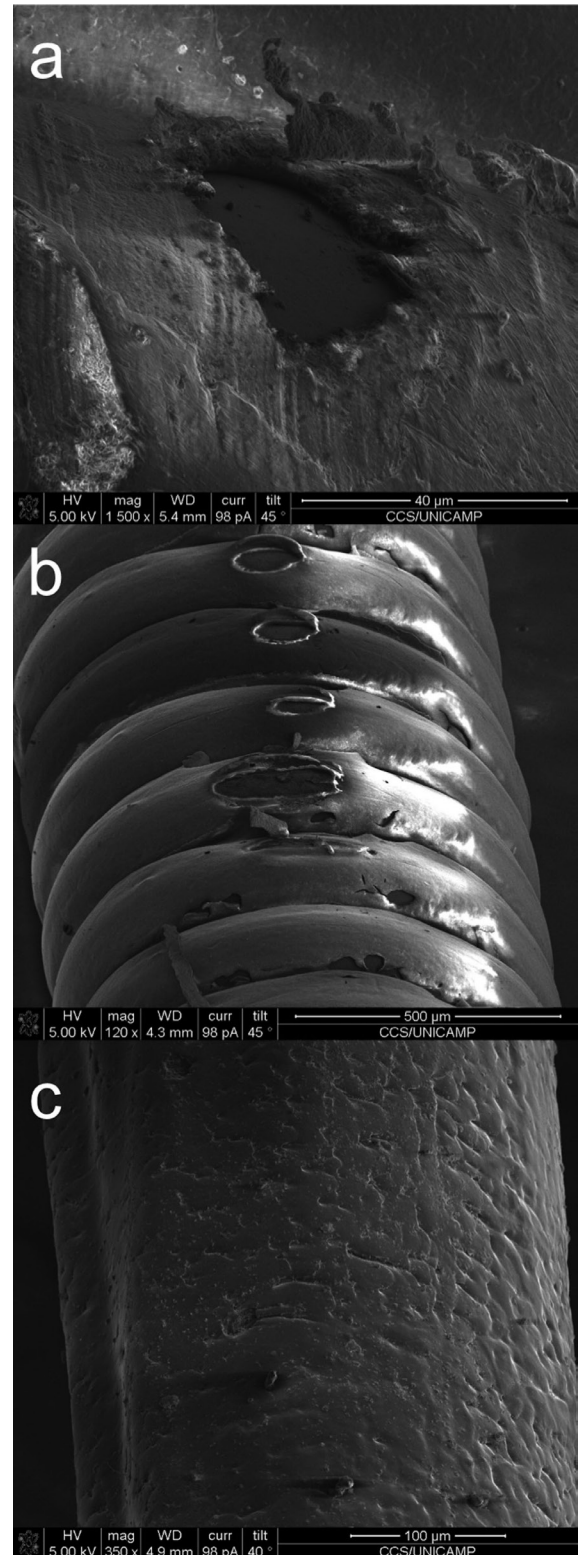
At naked eye, the catheters washed only once showed slight color changes, varying from green to a yellowish-green color, a phenomenon which is markedly observed after the second washing (samples AU2 and BU2). The intense modifications are best observed through scanning electron microscopy, which allows for viewing at the micrometric level (Figure 3).

Fig. 3 – SEM images of guide wires AU2, BU2 and CU2, washing 2X using enzymatic detergent in ultrasonic bath. Persistence of debris and holes in Figures A and B and an increase in roughness is observed in Figure C.

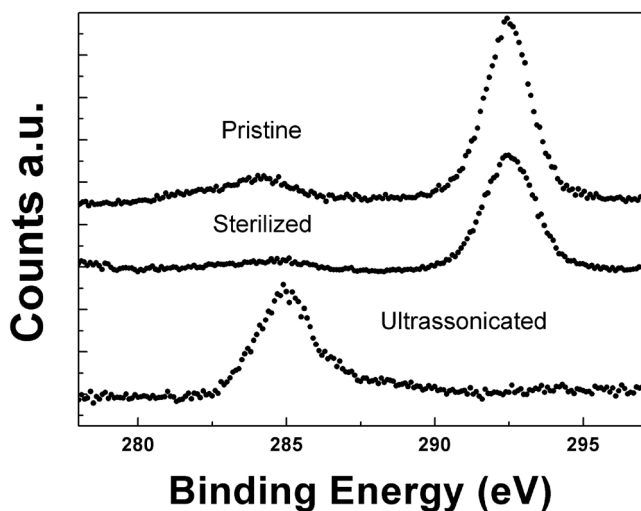
Figure 4 shows high resolution photoelectron spectra in the C1s (carbon electronic level 1s) binding energy region of three samples derived from type A guide wire (pristine - A, sterilized in ethylene oxide - AS1, and washed 1X in enzymatic ultrasonic bath - AU1). Both pristine (A) and sterilized (AS1) samples show two peaks from the C1s electronic level, i.e. (i) the C-C/C-H peak, composed of carbonaceous carbon at 285 eV; and (ii) the CF<sub>2</sub> peak, due to C bound to two F-atoms at 292 eV [9]. The higher intensity of the latter, much higher than those of the C-C/C-H peak, shows that the C atoms in the polymer coatings are predominantly in CF<sub>2</sub> groups, confirming the presence of a typical PTFE structure. The additional peak at 278 eV for the pristine sample is due to the use of non-monochromatic X-rays.

Since the spectra do not differ from those obtained with the pristine material, the XPS results suggest that the sterilization process does not induce significant changes in the chemical structure of the polymer coating, while maintaining the chemical inertness of the material. On the other hand, the washed samples displayed intense changes in the chemical structures, as verified by the complete removal of CF bonds from the material, expected at 292 eV (Figure 4), with preservation of the C-C and C-H linkages around 285 eV.

Fig. 4 – XPS spectra of samples from guide wire catheter type A.: pristine - A1, sterilized in ethylene oxide - AS1 and ultrasonically cleaned in enzymatic detergent - AU1. Suppression of CF peak related to CF bonds is observed in sample submitted to the ultrasound washing.

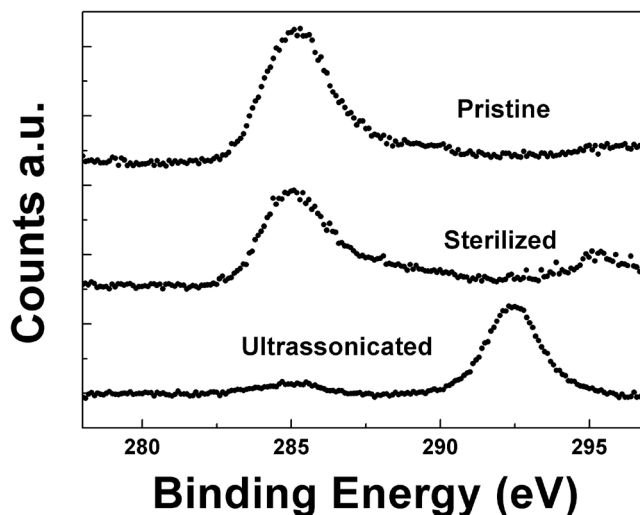
With respect to the samples from guide wire type C, the XPS spectra reveals a strong predominance of the C-C and hydrocarbon bonds, as indicated by the intense and broad peak at 285 eV (Figure 5). The similarity in the two spectra indicates that sterilization did not alter the chemical structure of the polymer. A different behavior is observed in the sample subjected to ultrasonic washing: a decrease in the C-C/C-H peak and the rise of a peak at about 293 eV, suggesting the presence of C-F bonds in CF<sub>3</sub> groups. A possible explanation for such new groups would be some chemical reaction of the polymer with a component of the enzymatic detergent, or a removal of polymer surface layers with the exposure of CF<sub>3</sub> from some other polymer underneath.

Fig. 5 – XPS spectra of samples from guide wire catheter type C: pristine - C1, sterilized in ethylene oxide - CS1 and ultrasonically cleaned with enzymatic detergent - CU1.
