Current condition of the exposed concrete façades reinforcement of the Vilanova Artigas building: modern architectural heritage

Adriana de Araujo^a Claudia de Andrade Oliveira^b Tatiana Regina da Silva Simão^{b,c} ^aInstituto de Pesquisas Tecnológicas do Estado de São Paulo – IPT, São Paulo SP, Brasil^bFaculdade de Arquitetura e Urbanismo – FAU, Universidade de São Paulo – USP, São Paulo, SP, Brasil^cInstituto Federal São Paulo – IFSP, São Paulo, SP, Brasil

How to cite: A. Araujo, C. A. Oliveira, and T. R. S. Simão, “Current condition of the exposed concrete façades reinforcement of the Vilanova Artigas building: modern architectural heritage,” *Rev. IBRACON Estrut. Mater.*, vol. 14, no. 1, e14113, 2021, <https://doi.org/10.1590/S1983-41952021000100013>

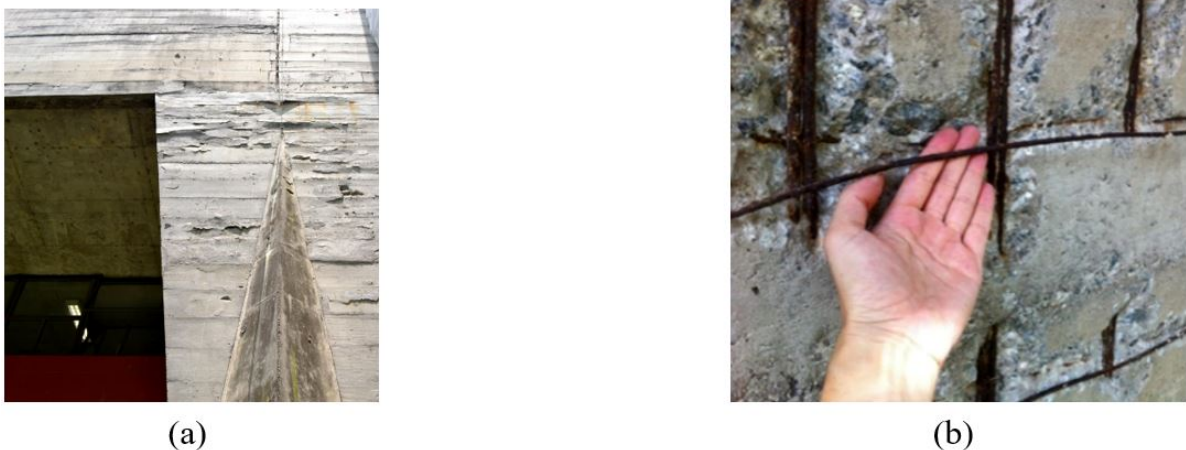
Figure 2 shows the aspect of the exposed concrete surface of the façades at the onset of the 2012-2015 intervention campaign (Figure 2a) and the disaggregated concrete areas with exposure of the corroded reinforcement (skin rebar), and with small covering thickness (Figure 2b).

Figure 2. Partial view of NE façade: (a) area with concrete disaggregation on pillar P3 and (b) exposure of corroded reinforcement steel (Photos: authors' collection, 2013).

The photographic records taken during the intervention suggest that the skin rebar of the façades is more prone to corrosion, presenting concrete cover with variable thicknesses.

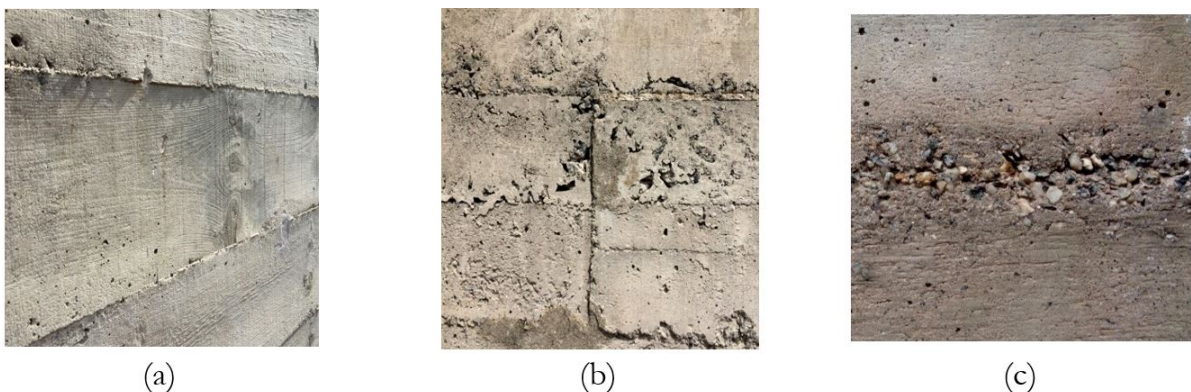
Several concrete segregation regions were identified on the construction joints and along the line between planks that composed the mold of the outer face of façades. In addition to the relief already mentioned produced by the wood grain imprinted on the concrete surface, other characteristics of the façade surfaces must be highlighted, such as air voids on the surface, resulting from entrapment air, bubbles as shown in Figure 3.

Figure 3. Characteristics of the exposed concrete of façades in Artigas building: (a) wood grain pattern on the surface (width 30cm); (b) rough surface texture and air voids; (c) segregation in construction joint. (Images: Collection of ConservaFAU, 2016).

These characteristics favor the deposition of particulate material, penetration of water and aggressive agents, which can be evidenced by dirt stains (carry of particulate material by storm water) and stains of steel corrosion products present throughout the façade extension.

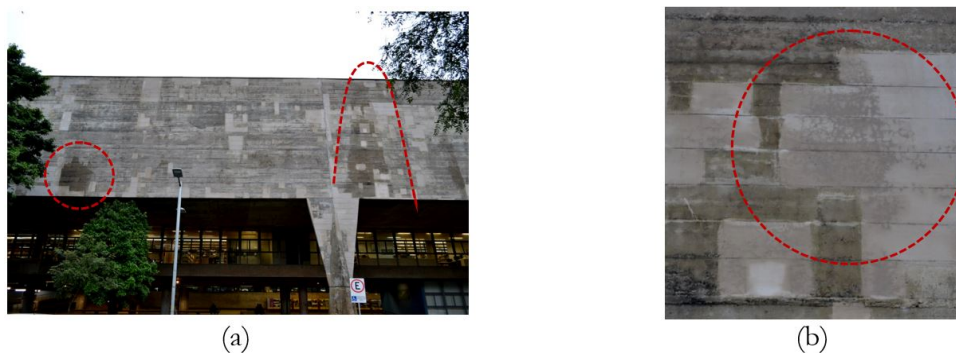
Moisture stains are present on all the façades with the most significant dimensions on the NE façade, although more dispersed on the SW façade. Figure 4 shows typical moisture stains, suggesting water repellent impregnation failure. The surface moistening also makes cracks in the patch repairs noticeable.

Figure 4. Partial views of SW façade: (a) typical moisture stains and (b) noticeable patch repair cracking after rain water penetration (Photos: Authors’ collection, 2017).

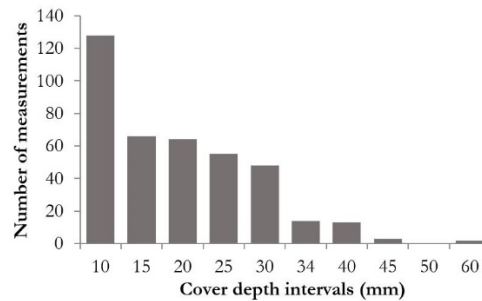
The cover depth, measured in 393 positions by metal detector, results in the distribution shown in Figure 5. Note the predominance cover within the range up to 10 mm.

Figure 5. Distribution of cover depth measured on the façades of the Artigas building.

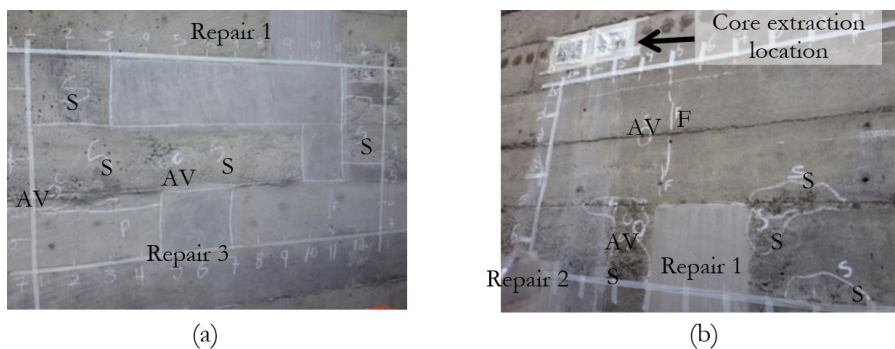
Figure 6 shows the general aspect of two areas inspected with location of patch repairs and numerical grid. Although not clearly visible in the figure, some of the concrete characteristics mentioned are indicated with white chalk, with predominance of concrete segregation regions (S) and surface air voids (AV). Black arrow in Figure 6b indicates the place where two cores were extracted in NW façade. Cracks (C) with variable opening (most ≤ 2 mm) were observed on the repair mortar; these fissures affect adversely the performance of concrete by favoring the water ingress.

Regions with hollow sound were located in all the areas inspected (in repair mortar and in concrete). Finally, some sections of the exposed reinforcement were related to stains of corrosion products (corrosion spots) observed in the preliminary inspection. Some of these spots correspond to devices (steel pin or bar) probably used for fastening wall form elements. Measurements made directly on the exposed reinforcement suggest nominal rebar diameter of 8 mm, as indicated in the review of the original design.

Figure 6. General aspect of the area inspected with identification of repairs: (a) on SW façade and (b) on NW façade (Photos: Authors' collection, 2017).

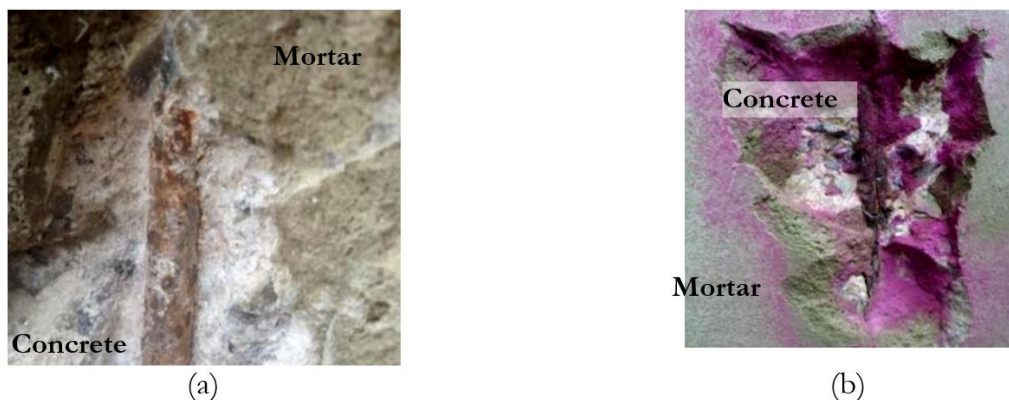
The cover, after fracture of the repair, ranged from 8 to 33 mm, which are values compatible with the intervals of the previous survey (Figure 5). The visual examination of sections newly exposed of the reinforcement indicated active corrosion state, checked by the presence of stains with typical colors of corrosion or accumulation of its products. In

most of the repairs inspected, the reinforcement is not totally surrounded by the repair mortar, but by carbonated concrete. The only reinforcement section wrapped by repair mortar was the exposed one in Repair 2 of SE façade, however the repair mortar presented a well-defined map cracking, a typical failure mode that favors water penetration. Figure 7 shows sections of exposed reinforcement in the repairs inspected. In Figure 7b, we can observe the carbonation depth in the repair mortar, and in the underlying concrete as well. The average carbonation depth in mortar was very variable (4 to 29 mm), and some values are close or greater than the concrete cover, indicating that the corrosion was caused by pH reduction.

Upon repair evaluation, the measurements suggest the carbonation depth reaches approx. 20 mm, which affects durability of exposed concrete façade given the corrosion-related pathological manifestations. The carbonation progression in the mortar - within 4 years - may have been influenced by lack of varnish coat, not applied by the reasons indicated in 2.1. The reinforcement sections with cover less than 20 mm shall be depassivated and in an active corrosion process.

Figure 7. Exposed reinforcement during inspection: (a) on Repair 3 of SW façade and (b) on Repair 2 of NW façade (Photos: Authors' collection, 2017).

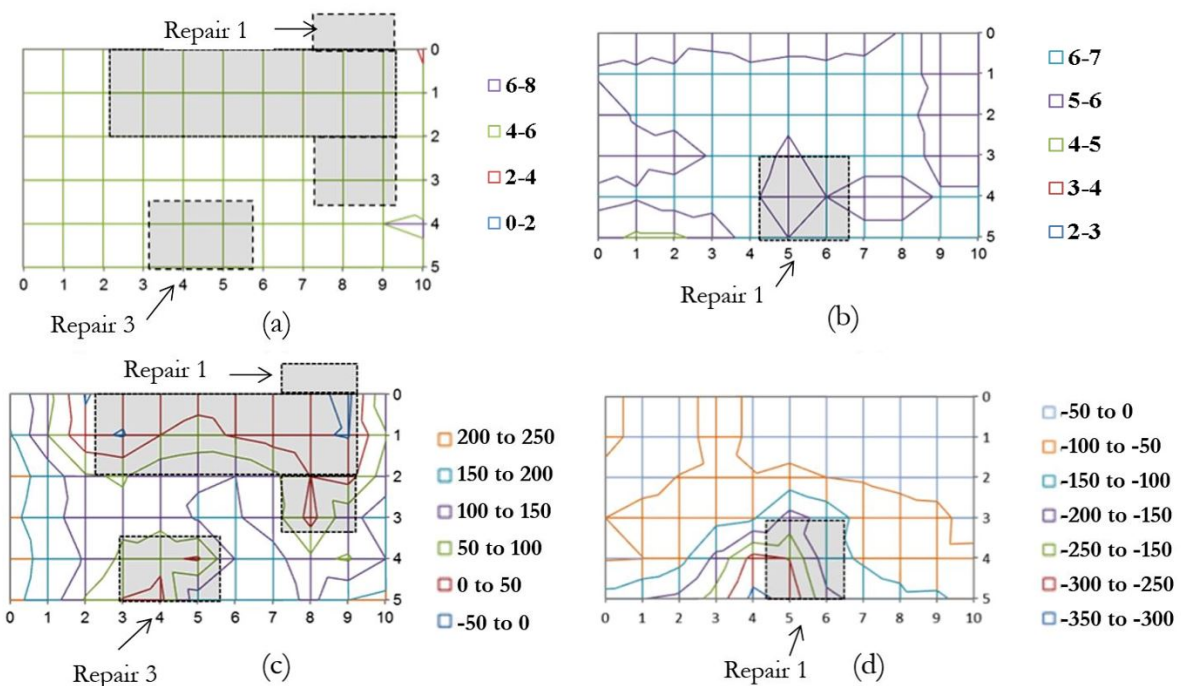
Figure 8 shows that the gradient of surface moisture, down to 30 mm depth, was not significant, prevailing the range 4 to 6% on SW façade (Figure 8a) and 6 to 7% on NW façade (Figure 8b). In addition, no change was observed in the moisture content in localized repair regions, and neither any correlation of the moisture content maps vs. corrosion potential maps (see Figures 8c and 8d) in the same inspection area.

Each corrosion potential range is represented by a color in Figures 8b and 8c. The concentration of contour lines, with potential variation equal or greater than 150 mV, indicates regions more prone to corrosion [38]. The location and frequency of these regions in the structural elements are the bases for decision-making on interventions. For both maps of Figures 8c and 8d, we observe regions with significant potential variation.

The positive values of potential for carbonated concrete of Figure 8c and 8d corroborate the results of Elsener et al. [39] and Araujo et al. [36], and enforce the importance of potential mapping in the assessment corrosion risk of the reinforcement under these conditions. Data in Figures 8c and 8d indicates significant variation of values in the repair region, which present higher risk of corrosion, i.e. electrochemical cells locations. This activity was checked by examining the reinforcement beneath the repair, which evidenced accumulation of corrosion products on its surface. Most of the values achieved for the corrosion rate were greater than $1.0 \mu\text{A}/\text{cm}^2$ (section loss $\geq 10 \mu\text{m}/\text{year}$), indicating severe corrosion [40]. However, it must be considered that values above $1.0 \mu\text{A}/\text{cm}^2$ are typical of concrete exposed to relative humidity (RH) above 90%, which is a condition not verified locally, where the average value from time serie is 81.2%. Considering the local RH between 70% and 90%, the reinforcement corrosion rate must vary, and may increase significantly only under conditions of high relative humidity content, or in periods of intense and frequent rainfall.

Figure 8. Surface moisture content map (%) in inspected area: (a) on SW façade and (b) on NW façade. Corrosion potential map (EPCP electrode) in inspected area: (c) on SW façade and (d) on NW façade. Corrosion potential values (mV).
