The collapse of Real Class building

R. J. C. RIBEIRO ^a
r2engenharia@gmail.com

D. R. C. OLIVEIRA ^a
denio@ufpa.br

Abstract

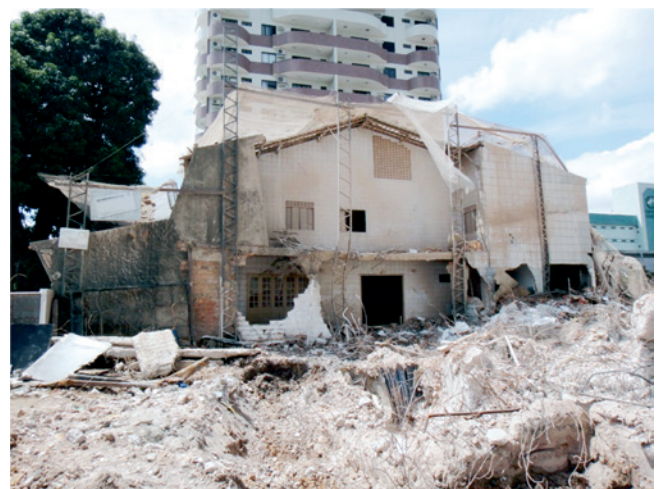
Figure 2
House damaged by the Real Class building debris

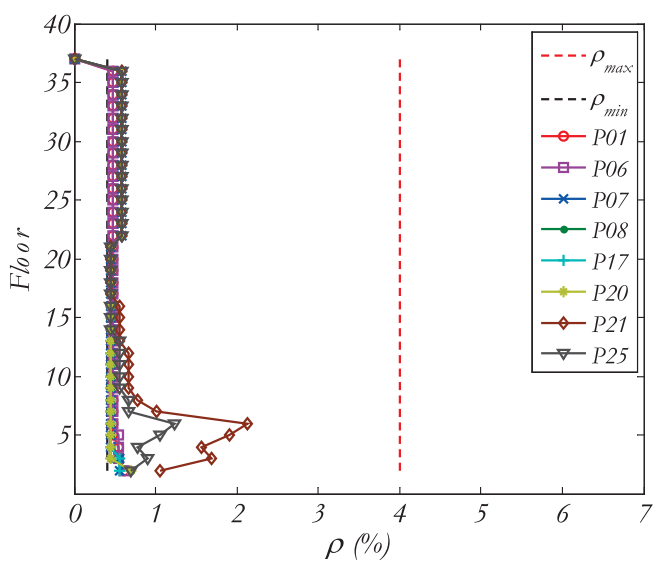
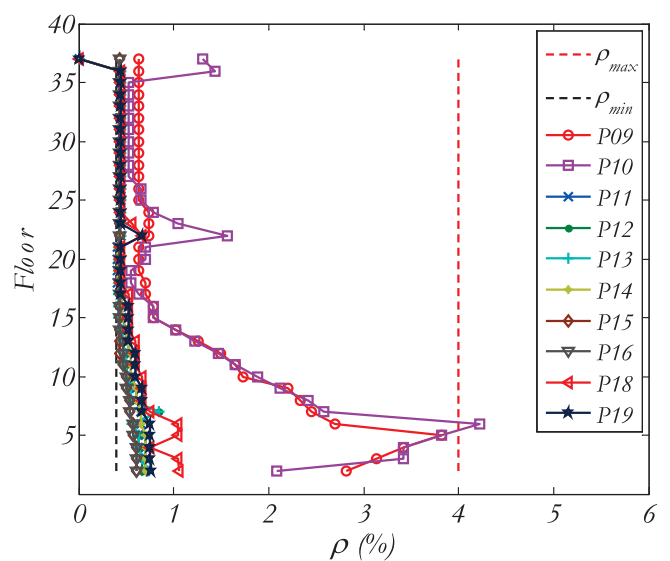
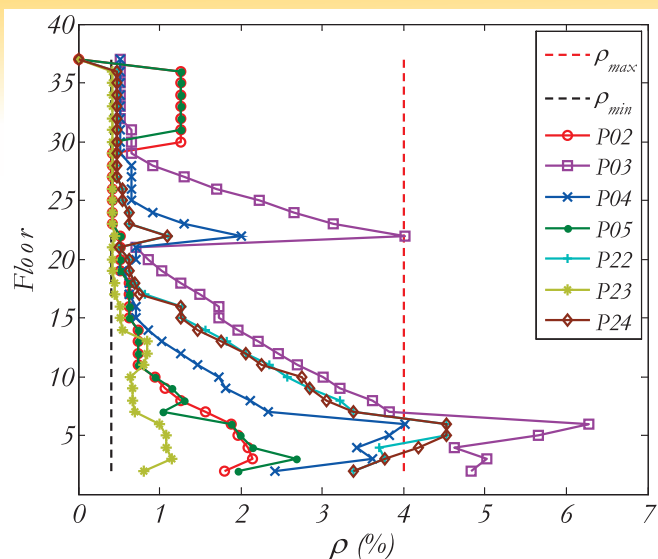
The values of the maximum longitudinal reinforcement ratio of the columns were incompatible with the design code recommendations. According to Figures 6, 7 and 8, the maximum reinforcement rate values exceeded the code value of 8% of the cross sections area of the columns P03, P04, P10, P22 and P24. Also, according to the report [9], the longitudinal reinforcement presented discrepancies between the structural design and the *as built*. The difference between the designed steel area and the executed is shown in Table 1, in which the columns P04, P10 and P21 exceeded 30%. According to the results presented by the two reports, the steel used in the building proved to be suitable, since tests indicated a

Figure 6
Corner columns reinforcement ratios

Figure 7
Internal columns reinforcement ratios

Figure 8
Peripheral columns reinforcement ratios

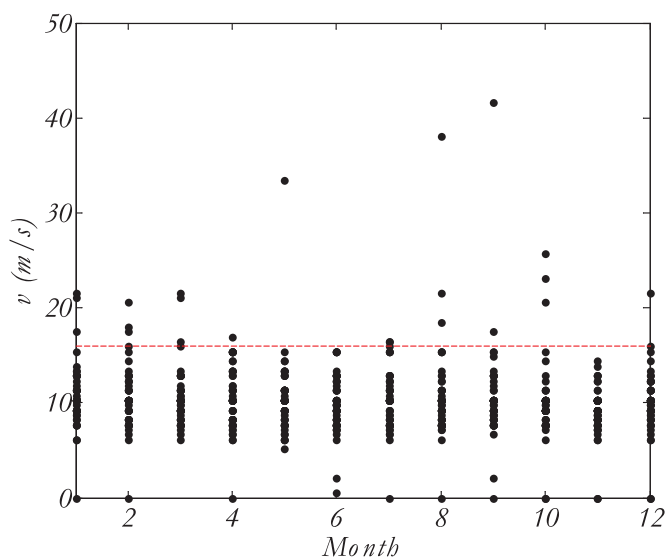
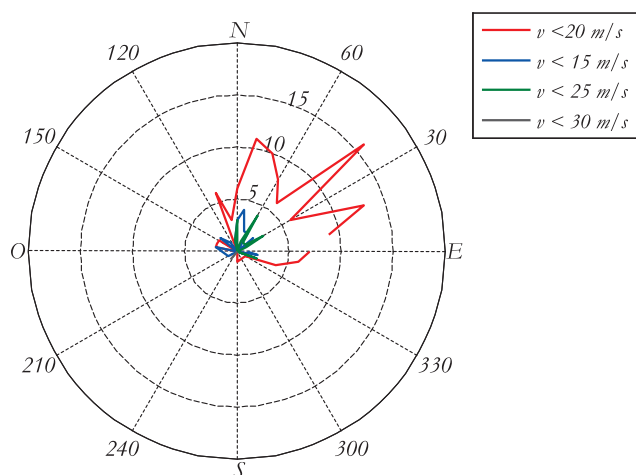
Figure 11
Characterization of wind gust velocity in Belem city (ICEA)

A velocity of 30 m/s was used to determine the design loads, as recommended by the wind design code for the building region [5]. To estimate the velocity at which the collapse occurred, the value for which the *software* did not dimension the columns cross sections was checked and this value (25 m/s) was used as the upper limit. The velocity initially used as the lower interval for analysis was recorded by the local meteorological service (weather data bank of the Air Space Control Institute) at the time of the accident ($v_o = 10$ m/s). According to the data (Figure 11), the average speed of the gust wind is 12 m/s and the average of the annual maximum values corresponds to 17 m/s.

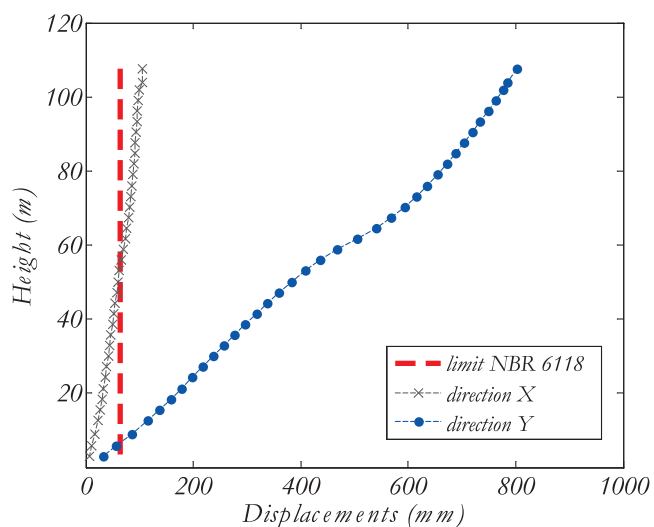
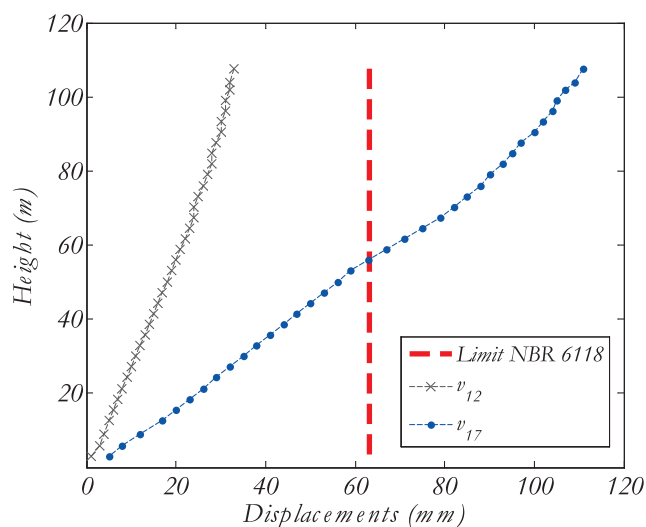
The second order moment on the structure corresponded to 24% (direction x - greater stiffness) and 37% (direction y - less stiffness) of the total bending moment of the structure when the conformity of the project was verified. The effects of second order corresponded, under construction combinations, to 17% and 27% of the total moment of the structure, showing its flexibility. The values of the coefficient γ_z came to correspond to the value of 1.7, exceeding the design code recommended values [10]. In figure 14, the structure displacements predicted for the design situation (a) and for the collapse scenario (b) are shown for the annual average wind gust velocity value ($v_o = 12$ m/s) and the mean values of maximum annual wind gust velocity ($v_o = 17$ m/s). In both cases the structure presented large displacements incompatibles with design code recommendations [10].

Figure 14
Building's horizontal displacements

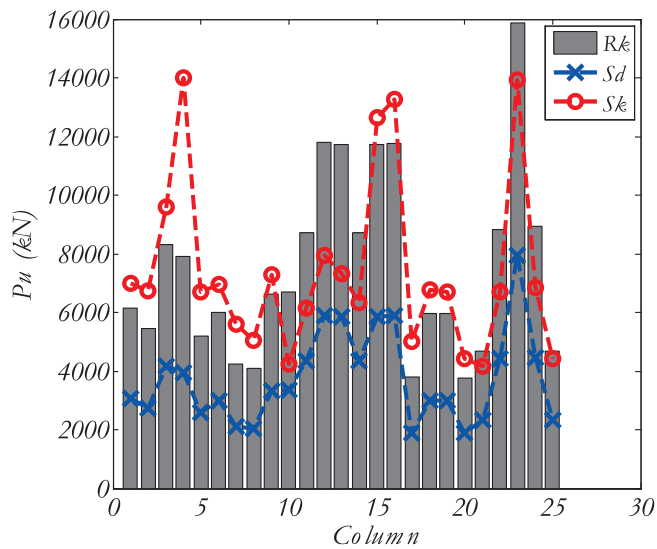
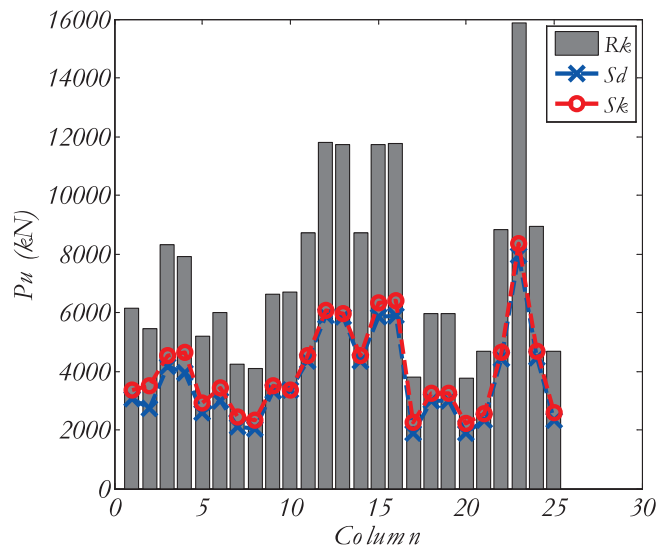
according to item 6.2.1.2 of NBR 6122 [16]. The total loads in the foundations presented in the design presented a difference of 46% when compared with the model. In the evaluation of the collapse scenario, they presented a difference close to 5%, a result that was in agreement with the reports [8] [9] that there was no failure of the foundations at the moment of collapse. Figure 15 (a) shows the differences between founded loads (S_k) according to the require-

ments of NBR 6118 [10] and the designed (S_d) ones. The values of ultimate strength (R_k) are exceeded in 60% of the elements, indicating an under sizing and the hypothesis of possible rupture if they were put into service. For the moment of collapse of the building (b) the loads estimated by the model (S_k) were very close to those of the designed (S_d), not exceeding in any case the ultimate resistance of the assessed elements.

Figure 15
Foundations loads

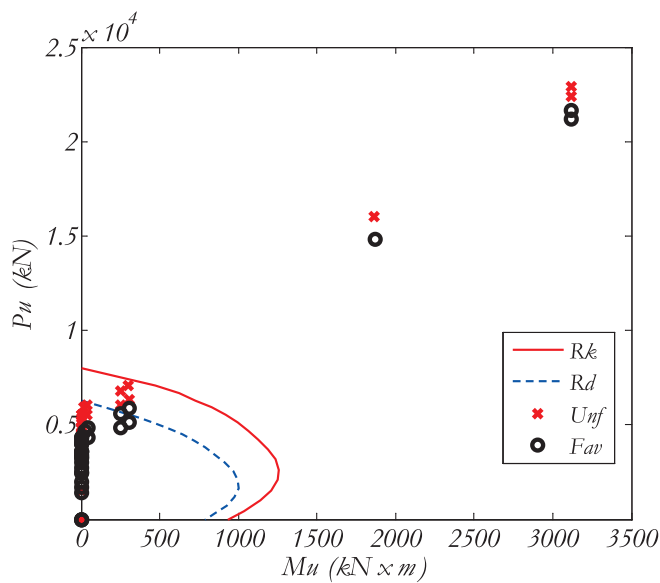
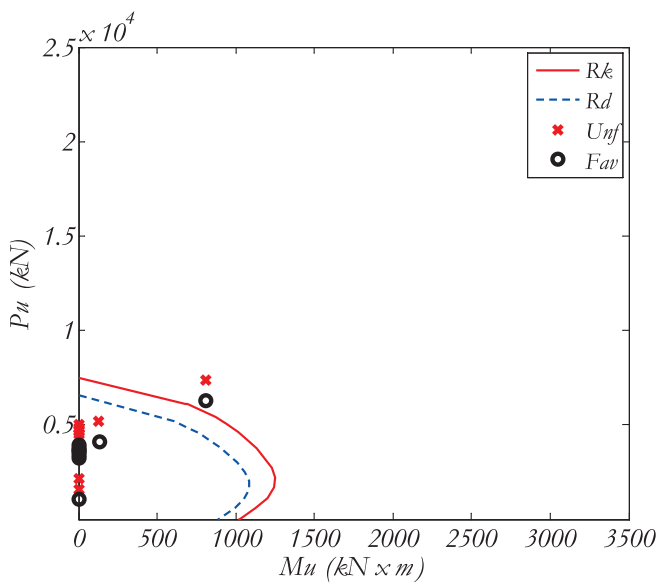
Figure 16
Interaction diagram of column P04

the P02, P04, P07, P19 and P25. As the P04 and P07 columns had the lowest safety margin and the highest probability of failure for the combinations used (9%) and they could be considered as the first to failure. Due to the complexity of the wind forces acting on the buildings the loads for the collapse scenario of the P04 column for the abovementioned wind gusts (Figure 22) are shown as: frequent occurrence in the region (12 and 17 m/s), that used in the technical report (23 m/s) and the probable responsible

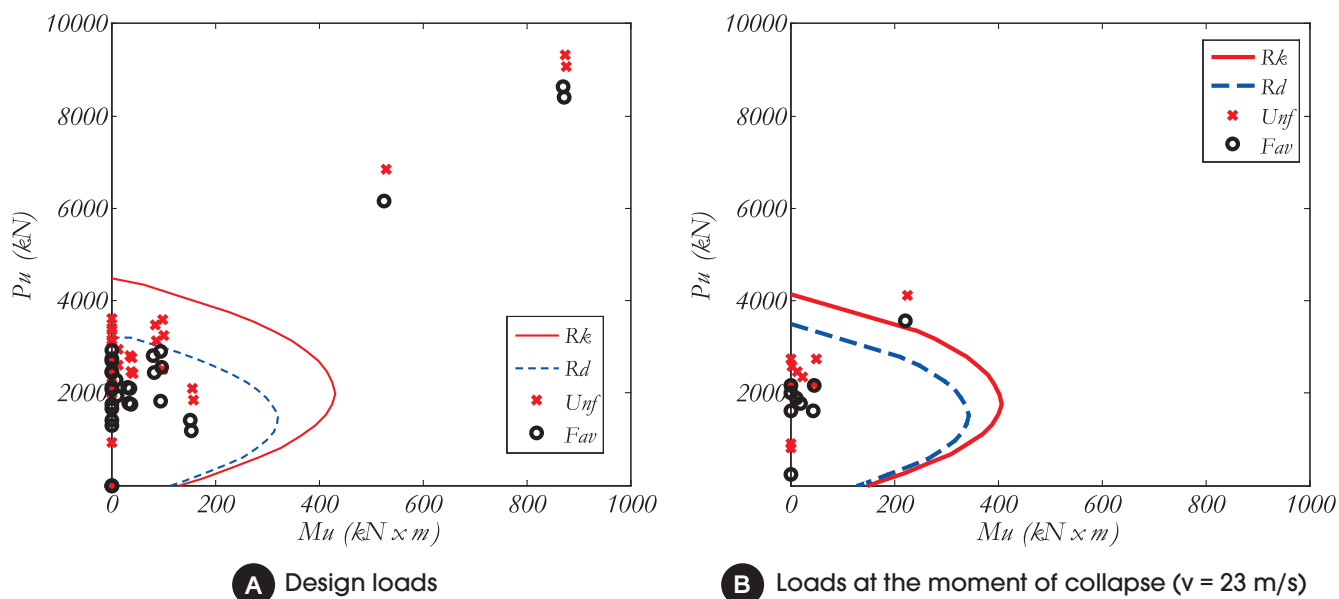
Figure 17
Interaction diagram of column P07

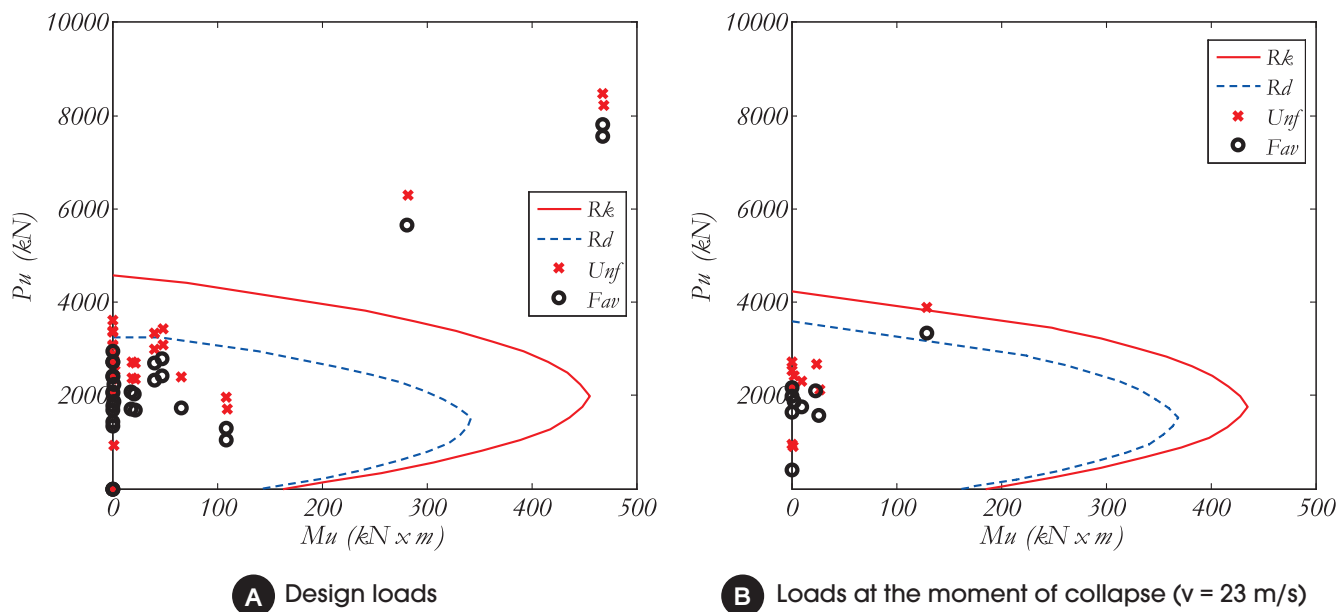
Figure 18
Interaction diagram of column P08

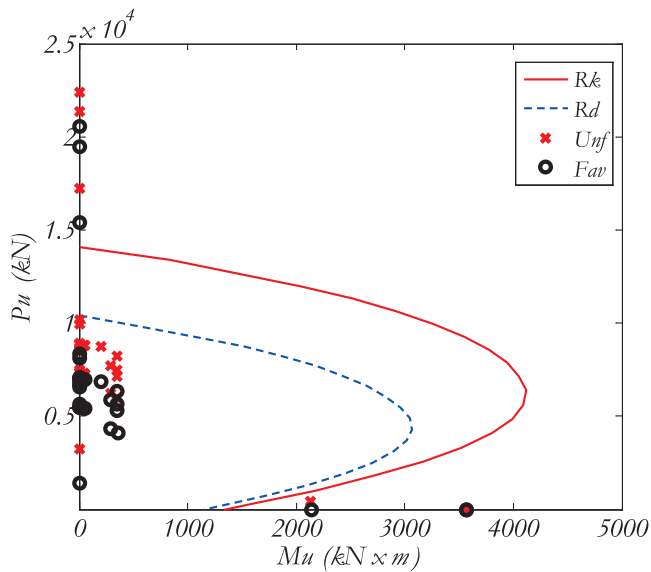
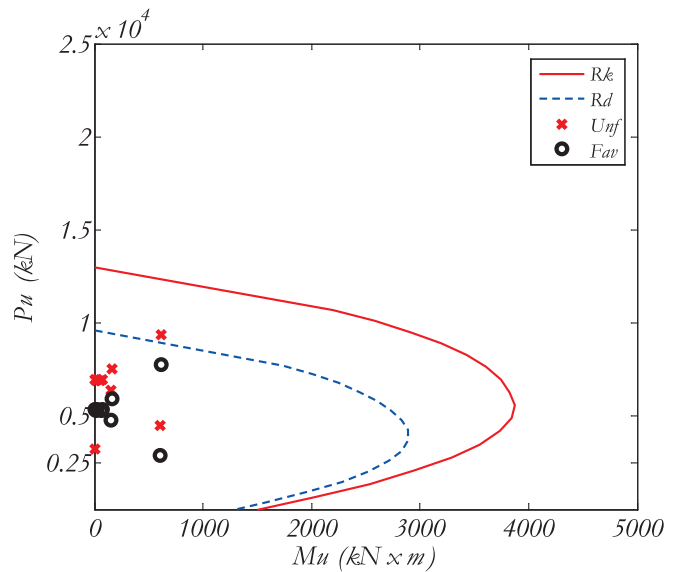
umns as being responsible for the collapse [8], being shown: the conformity of the elements with the NBR 6118 (a) code and the loadings configuration in the collapse scenario (b). The stress distribution in the diagrams shows that a large number of columns had a reasonable number of combinations very close to the design resistance limits (R_d) when evaluating design compliance. In tables 4 and 5 are presented the margin of safety (ω) and the estimated probability of failure (p_f) of the columns in the computational models. As shown in Table 4, the P15, P16 and P17 columns were

Figure 19
Interaction diagram of column P16

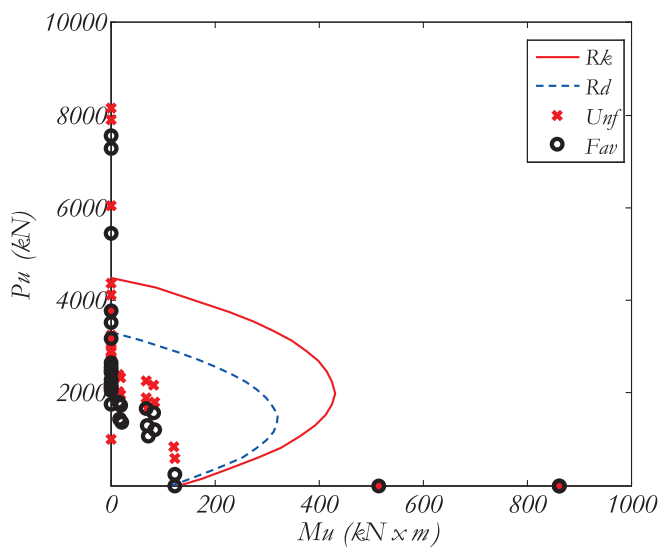
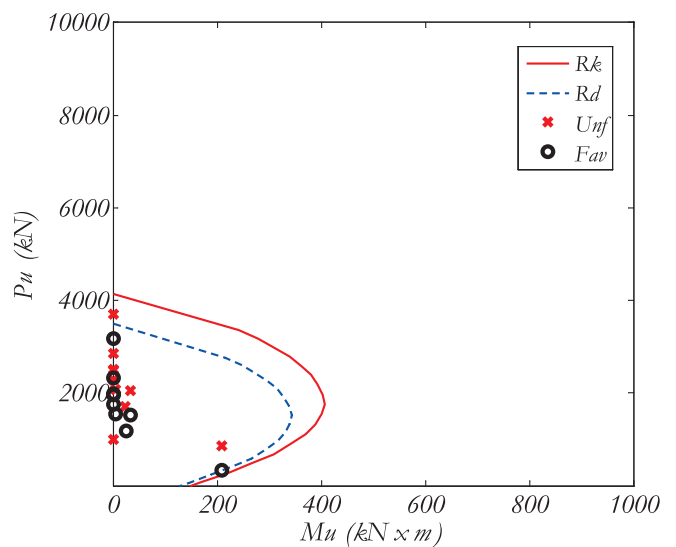
Figure 20
Interaction diagram of column P17

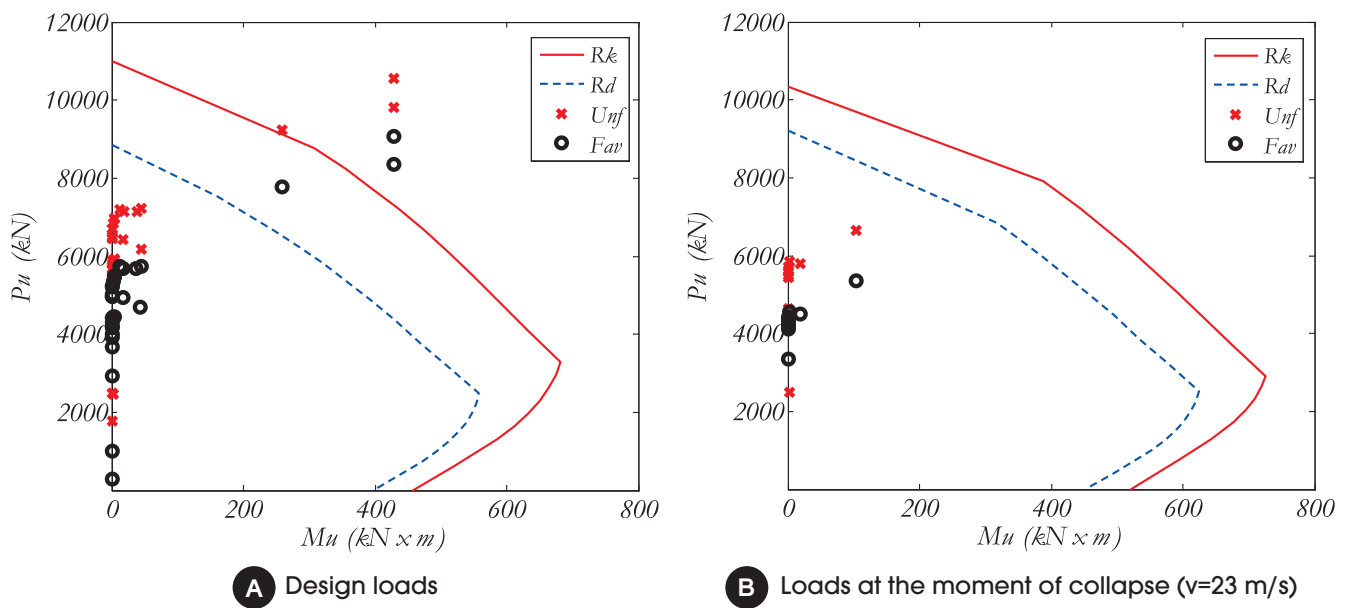
Figure 21
Interaction diagram of column P22

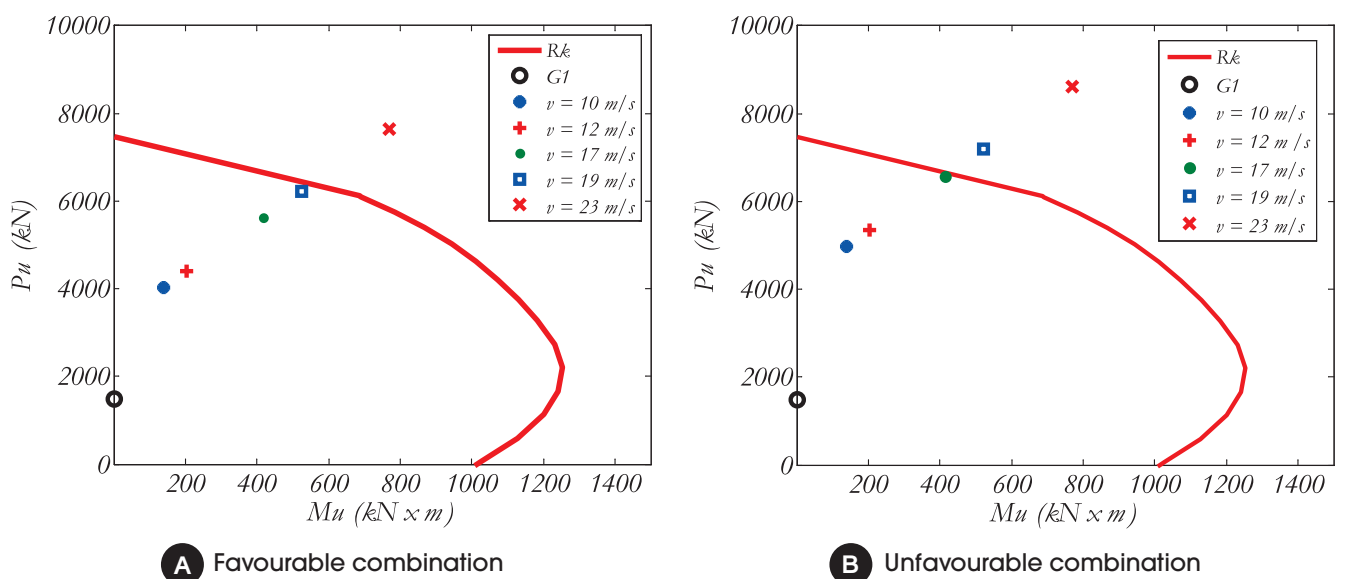
Figure 22
Interaction diagram of column P04 under frequent wind gust velocities

- It was verified through computational model that the wind speed of 19 m/s could lead to failure the P04 and P07 columns. This speed, according to the local meteorological data, presents a high probability of occurrence in a period of 10 years;
