# Welding and Thermal Spray Processes for Maintenance of Hydraulic Turbine Runners: Case Studies

**How to cite:** Váz RF, Tristante R, Pukasiewicz AGM, Capra AR, Chicoski A, Filippin CG, et al. Welding and thermal spray processes for maintenance of hydraulic turbine runners: case studies. *Soldagem & Inspeção*. 2021;26:e2540. <https://doi.org/10.1590/0104-9224/SI25.40>

**Abstract:** Hydraulic runners are susceptible to failures by cracks or wear by erosion, corrosion, or cavitation. The modern runners are fabricated in carbon steel and martensitic stainless steel. Arc welding processes normally do the repair of eroded areas, or cracked parts. Each material or type of repair needs specific criteria, procedures, and precautions to guarantee their success and prevent future issues, like the recurrence of the cracks or reduction of the useful life of the runner by modifications of the original material. Wear-resistant coatings are applied by welding or by thermal spray processes, considering this last one has no metallurgical interaction with the material of the runner, keeping the original properties of the material. For several years the companies Copel GeT, Lactec, UTFPR, and UFPR

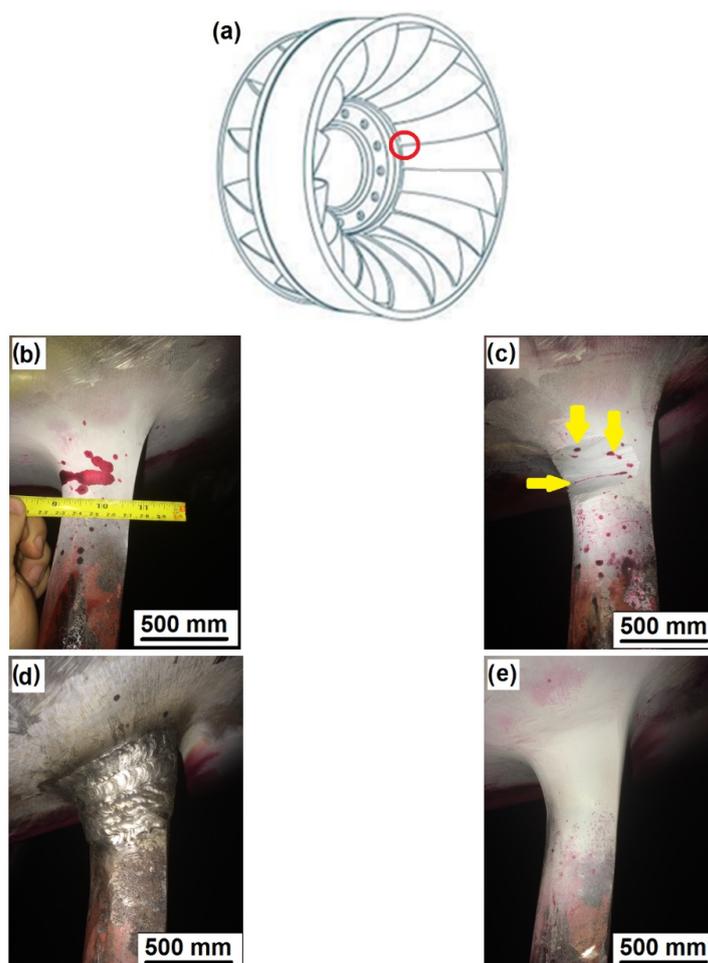
The initial inspection resulted in the crack indicated in Figure 2b, which was located in the transition from the blade to the crown, as indicated in Figure 2a. During the elimination of the crack, some discontinuities from the casting fabrication process were found, Figure 2c, and eliminated before the repairing welding, since they were in a region of high tension and they act as tension amplifiers.

**Figure 2.** Crack repair of UHEGNB runner. (a) crack localization; (b) initial condition with cracked revealed by DPT; (c) crack and casting discontinuities observed during the grinding; (d) as-welded aspect; and (e) final aspect clear of discontinuities revealed by DPT.

- Identification of the crack length by visual inspection and DPT (Metal Chek, Bragança Paulista, SP, Brazil);
- Complete elimination of the affected area by manual grinding and preparing the chamfer for welding;
- Welding manually by GTAW (Miller XMT 304 CC/CV, Appleton, WI, USA), direct current 140 to 180 A, using shielding gas Ar, with austenitic stainless steel filler metal AWS A5.9 309L diameter 3.2 mm (Welding Alloys). The preheating and interpass temperature was 120 °C;
- Grinding and polishing to adequate the profile of the surface;
- Visual inspection and DPT to evaluate the quality of the repair.

After many welding beads, the aspect of as-welded repair is indicated in Figure 2d and after the manual grinding and polishing procedure, the surface with adequate profile is presented in Figure 2e, which indicates also the result of the DPT, that did not revealed any discontinuity and from this interpretation the repair is approved. After about 20,000 h or 4 years operating, the visual inspection and the DPT of this area did not reveal a re-occurrence of the crack, guaranteeing the quality of the repair.

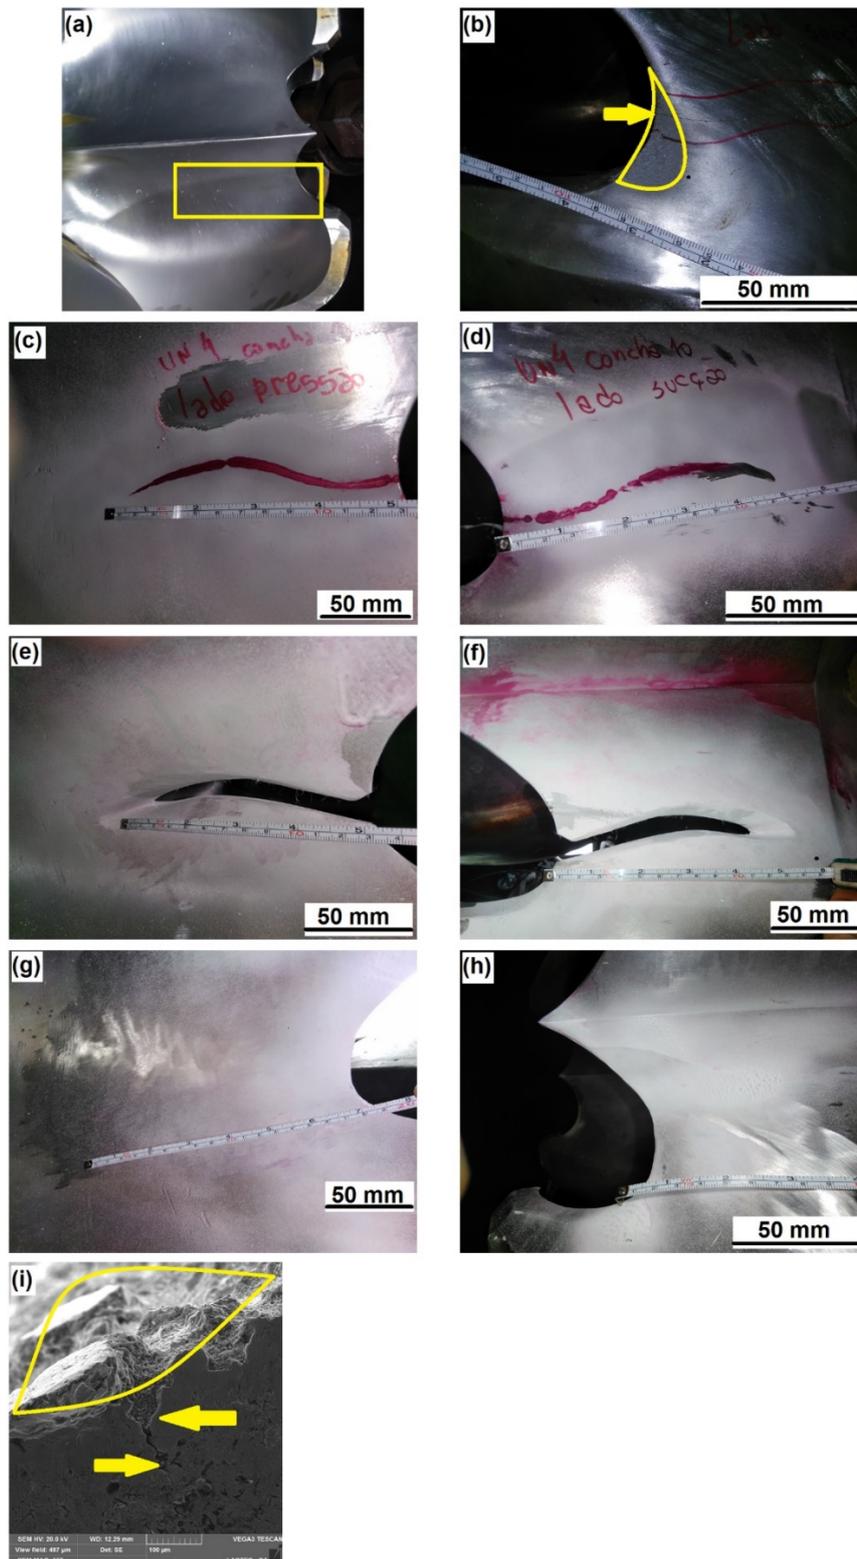
The crack was located in a region of high stress of the bucket, as indicated in Figure 3a, for the intern or pressure side or pressure of the bucket, and Figure 3b, for the back or suction side of the bucket. In Figure 3b is delimited and area eroded by cavitation and indicated by arrow where the crack nucleated, from where was cut a piece for analysis by microscopy at the Lactec facilities (Curitiba, PR, Brazil).

Figure 3i presents an image obtained by SEM. The crack had its nucleation in craters of the erosion by cavitation. This eroded area is seen on the suction face of the bucket in Figure 3b, and is located in a part of the bucket with a high concentration of stress due to the operation principles [45].

**Figure 3.** Crack repair of UHEGPS runner. (a, b) crack localization, pressure and suction bucket sides; (c, d) crack revealed by DPT, pressure and suction bucket sides (e, f) chamfer prepared to welding and total elimination of crack revealed by DPT, pressure and suction bucket sides; (g, h) final aspect of repaired area, after revelation of DPT, pressure and suction bucket sides, and (i) SEM image of crack surface, circled the eroded area and indicated by arrows a crack.

The delimitation or identification of the original crack length was revealed by DPT, as presented in Figure 3c,d, while the elimination of the crack resulted in the chamfer indicated in Figure 3e,f, with the inexistence of discontinuities revealed by DPT. The final result after polishing to the roughness lower than Ra 1.0 µm is presented in Figure 3g,h, with the positive result of DPT. The lowest possible roughness is important to prevent cavitation on hydraulic runners, since clear relation between the surface state and the cavitation phenomena was previously observed, and the lower is the roughness the lower is the cavitation erosion [43].

After finished the process, the hardness of the repaired area was measured, and the results were satisfactory and adequate. The base metal CA6NM before the welding had 247±8 HV, lower than the reference values for this material 290 HV [19], 284 HV [12], or 271 HV [44]. The welding metal had 320±30 HV, lower than references values 380 HV [19], or 364 HV [12]. The heat-affected zone had 350±21 HV, close to the reference values 360 HV [34], 360 HV [19], or 355 HV [44].

Analyzing the hardness of the material and its correlation to the toughness, the repair was considered done with success. However, the problems on the microstructure inherent to this process of repair cannot be easily quantified in-situ, mainly the content of the phase  $\gamma$ -austenite and  $\delta$ -ferrite in the  $\alpha'$ -martensite of the CA6NM. Above determined amount of those phases, a reduction of the toughness of the material is seen [11,20,24,40]. In addition, the residual stress imposed on the component by the welding repair must be considered as an important factor for new crack nucleation. For those reasons, after few months operating, an inspection of the repaired parts was carefully performed and did not reveal any re-incidence of the crack in this bucket, confirming the success of the repair.

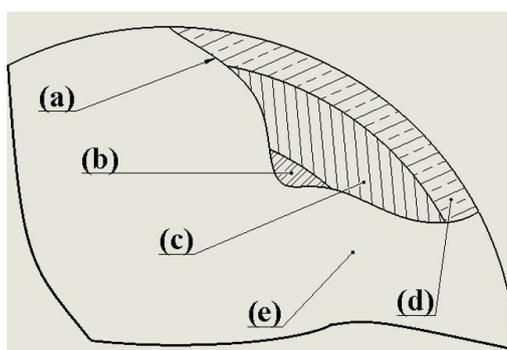
**Figure 4.** Scheme of repair of eroded area, depositing Co alloys. (a) prepared area after elimination of worn material; (b) carbon steel welding; (c) 309L welding, thickness between 9 and 15 mm; (d) Cavitaloy, thickness up to 10 mm; (e) base metal of the runner.

- Delimitation of the eroded areas done visually by an expert inspector, who defined the areas to be repaired;
- Elimination of eroded material by arc gouging and by grinding. Inspection of the area cleaned by visual inspection and DPT (Metal Chek, Bragança Paulista, SP, Brazil);

- Restoration of blade profile by manual grinding and polishing, resulting in smooth surface. To evaluate the roughness, a Mitutoyo SJ-210 (Kawasaki, Japan) was used;

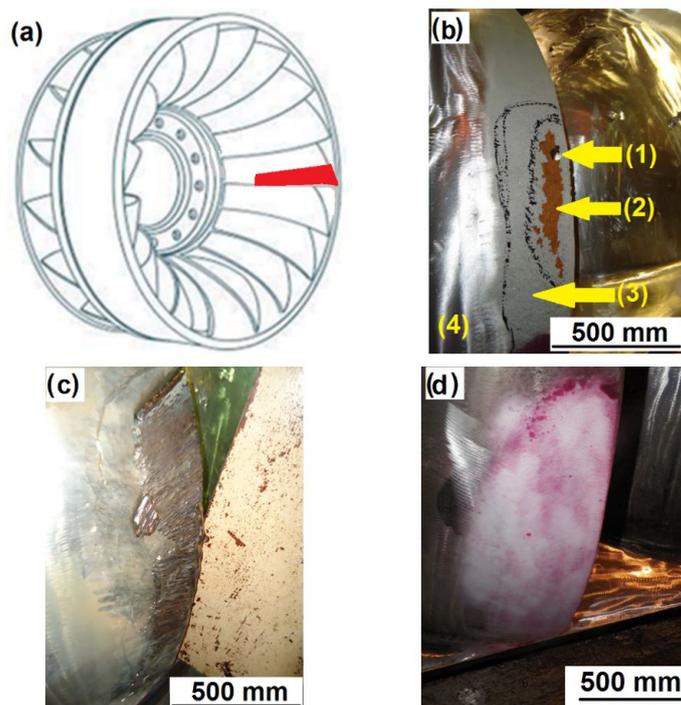
The area indicated in Figure 5a presented the most severe wear in the UHEGBM runner, with the erosion of the stainless steel coating, Figure 5b (3), reaching the carbon steel metal base Figure 5b (2), and even passing through the blade Figure 5b (1). The unharmed area of the runner is indicated by (4) in Figure 5b. Similar condition was seen in all of the 15 blades of the runner.

**Figure 5.** Erosion repair of UHEGBM runner. Stages of repair: (a) region eroded; (b) mapping of damage; (c) welding beads; and (d) revelation of DPT after restoration of blade profile.

After the total elimination of the eroded material and preparation of the surface for the welding, the visual inspection and DPT did not indicate discontinuities and the welding was done, following the steps indicated in Figure 4, with the as-weld aspect presented in Figure 5c. The welding beads are in horizontal direction with the objective to reduce the residual stress in the region of the transition from the blade to the runner external ring.

The result of the manual adjustment of the profile and final inspection by DPT is indicated in Figure 5d, with no discontinuities seen. The manual polishing resulted in a roughness of Ra 1.2±0.4 μm, under the roughness of the unharmed blade areas, which helps to prevent the cavitation phenomena [43].

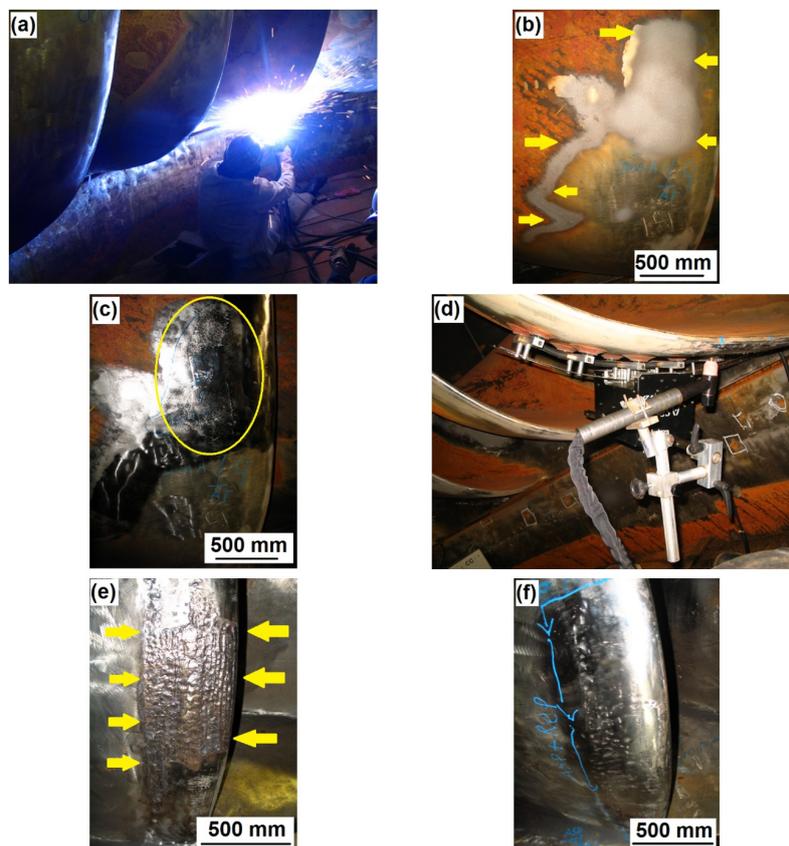
Inspections of this runner, after thousands of hours of operation, indicated the rate of volume loss by cavitation on this remelted area similar to observed on Co-steel welded areas, and lower than 309L welded, proving the efficiency of the application of the FeMnCrSi alloys by ASP and PTA remelted.

**Figure 6.** Coating by ASP of UHEGBM runner. (a) deposition of coating; (b) as-sprayed aspect (coating indicated by arrows); (c) polish aspect (area circled); (d) PTA torch prepared for remelting; (e) remelted aspect (area indicated by arrows); (f) polish aspect.

Figure 6a indicates the activity of manual deposition of the coating on the previously prepared surface by manual sand-blasting, which cleaned the surface to grade Sa3 and rough to a minimum Ra 5.0  $\mu\text{m}$  and Ry 30  $\mu\text{m}$ . The as-sprayed characteristic is indicated by the arrows in Figure 6b, and as-polished by the circle in Figure 6c, with roughness lower than Ra 1.0  $\mu\text{m}$ . The remelting torch and robot are presented in Figure 6d, the as-welded aspect indicated by arrows in Figure 6e, and the polished condition in Figure 6f.

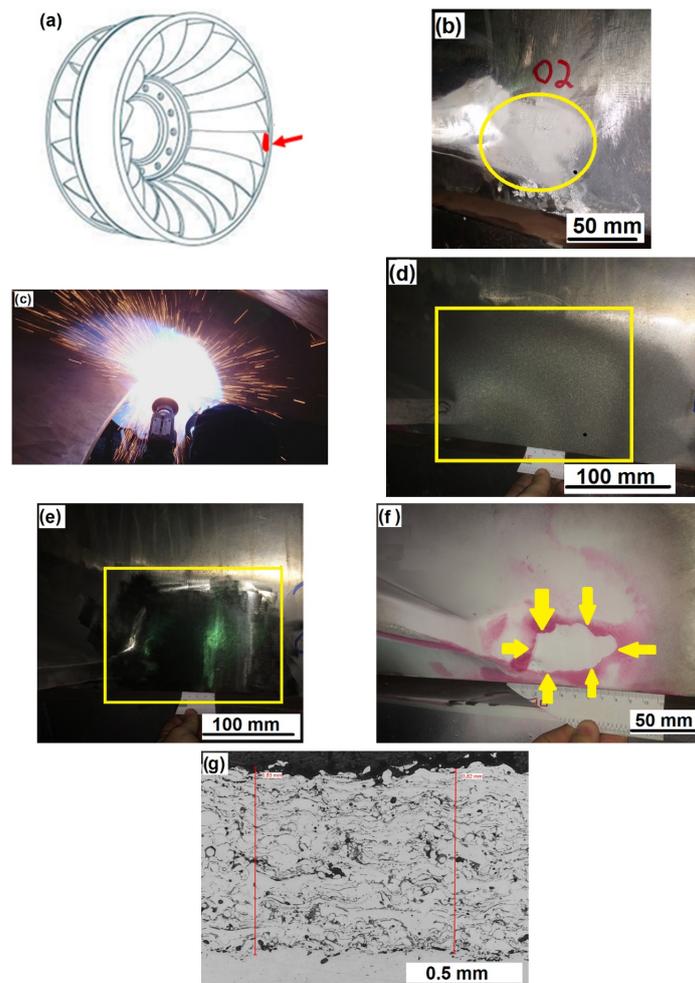
The area delimited to be coated, on the ring and close to the blades, is schematically indicated for one area in Figure 7a. The initial condition is indicated in Figure 7b, considering that this condition is repeated for almost all of the blades. The manual deposition, Figure 7c, resulted in a dark gray coating, Figure 7d, which became very bright after polishing to a roughness lower than Ra 1.0  $\mu\text{m}$ , Figure 7e.

After 20,000 h of operation, the inspection of the runner indicated the effectiveness of the sacrificial FeMnCrSi coating, which was eroded to prevent the wear of the CA6NM, as indicated by arrows in Figure 7f. On this surface was again sprayed the coating, but an inspection with less time of operation is desirable to measure the rate of volume loss of the coating and determine the interval time for re-deposition of the coating more sharply.

From the microscopy of a sample cross-section, the Figure 7g was obtained, from where is possible to see the typical morphology of the ASP coatings, with metallic phase, oxide layers, and vacancies or porous. From the image analysis was interpreted a porosity lower than 2%, which is in accordance with the presented by other researches [34,51,52]. The low amount of porosity is important, because it has a severe influence on the cavitation resistance since the mechanism of mass loss by cavitation is related to the lower adhesion between the metallic lamellae in the coating [36]. The higher porosity the lower cohesion in the coatings [39,53]. The microhardness of the coatings, measured in the transversal section was  $312 \pm 16$  HV0.3, which is consonant to the obtained by Pukasiewicz et al. [34,47], confirming the replication of the laboratory properties on the in-situ application properties.

**Figure 7.** UHEGJR runner eroded by cavitation. (a) Eroded area delimitation; (b) eroded surface; (c) manual deposition of the coating by ASP; (d) as-sprayed coating; (e) polished coatings; (f) revelation of DPT on the same area after 20,000 h of operation of the turbine; and (g) morphology of the coatings by optical microscopy.
