Case Report

Magnetic Resonance Imaging in a Patient with Pacemaker

Jaime Giovany Arnez Maldonado, Maria Euda Pereira, Karina Rabelo de Albuquerque, Jorge Pires
Manaus, AM - Brazil

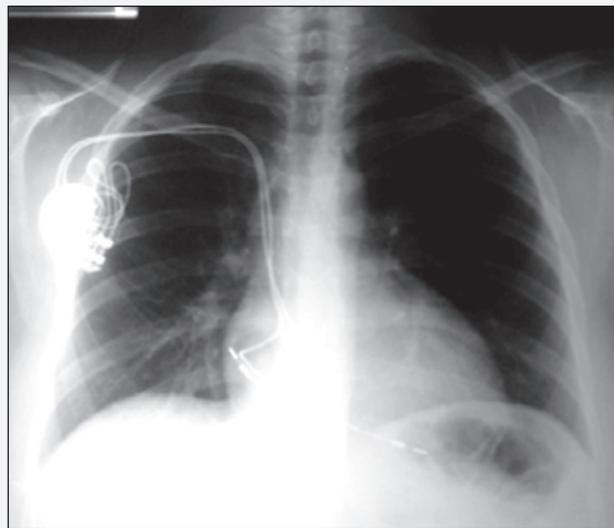
patient's entrance into the MRI tunnel and activation of the radio-frequency field. The control chest X-ray showed no change in regard to the position of the electrodes and generator (fig. 3).

Fig. 3 - Chest X-ray after magnetic resonance imaging.

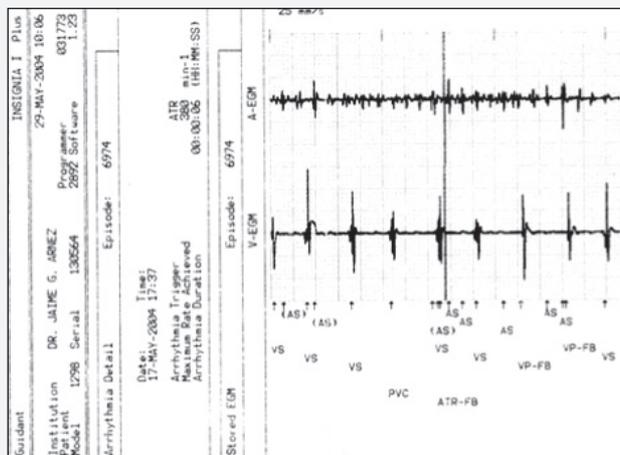
The pacemaker was reassessed by use of telemetry, with no difficulties on interrogation. An increase was observed in the atrial command threshold from 0.4 volts with 0.4 ms to 0.7 volts with 0.4 ms, and the electrodes remained with the same impedance. The atrial and ventricular sensitivities were not altered. The programming showed no alteration, and no damage was detected in the pacemaker circuit or in the generator's battery. The event counter function documented one atrial fibrillation (AF) (fig. 1) and one atrial tachycardia (AT) (fig. 2), which coincided with the

Fig. 1 - Atrial fibrillation (A-EGM: Atrial channel; V-EGM: Ventricular channel).

In our patient, the precordial burning sensation, presence of supraventricular arrhythmia (AF/AT), and change in the PM command threshold may be attributed to warming and vibration of the electrode system caused by the radiofrequency energy emitted during image obtainment. In addition, no other alteration was observed in the pacemaker system.

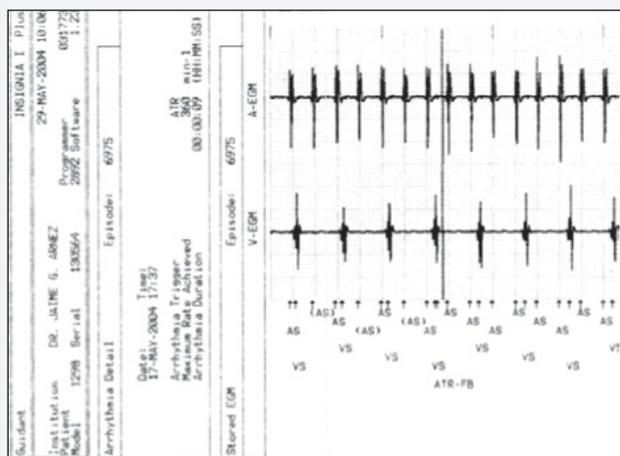
Fig. 2 - Atrial tachycardia (A-EGM: Atrial channel; V-EGM: Ventricular channel).

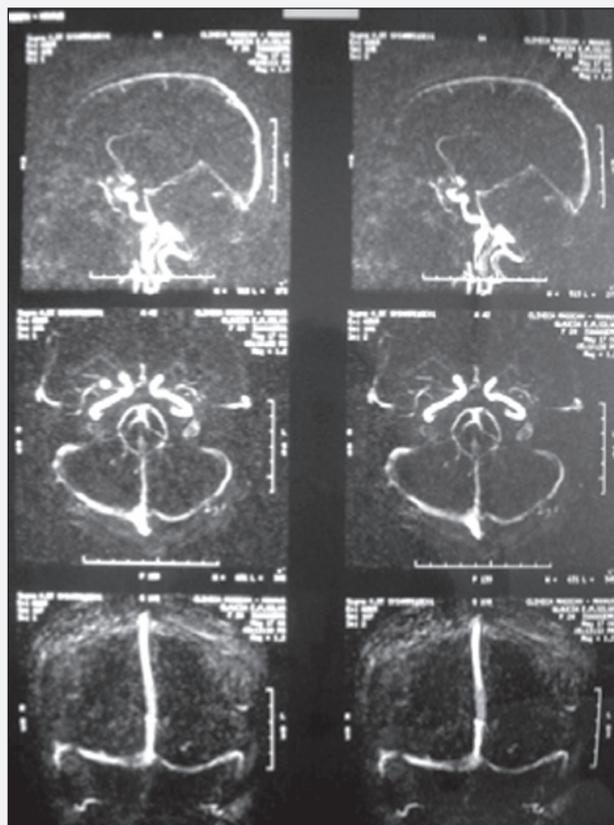
Regarding the result of the cranial images obtained through MRI, no type of artifact was generated by the presence of the pacemaker (fig. 4 and 5).

Fig. 4 - Cranial angioresonance.

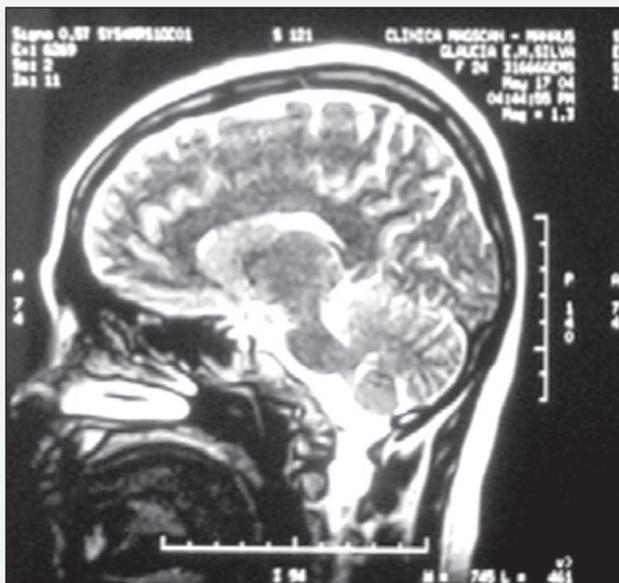
Fig. 5 - Cranial magnetic resonance.
