Culverts in paved roads as suitable passages for Neotropical fish species

Sergio Makrakis^{1,3}, Theodore Castro-Santos², Maristela Cavicchioli Makrakis^{1,3}, Ricardo Luiz Wagner³ and Maurício Spagnolo Adames³

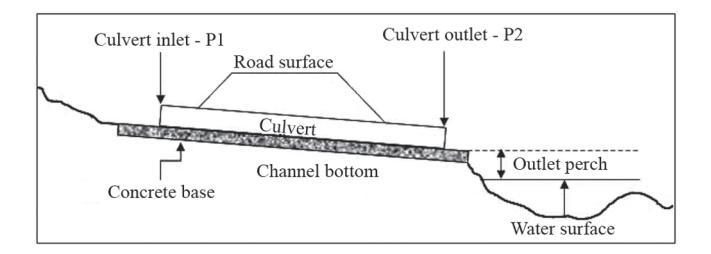
Fig. 2. Selected measurements used to classify culverts. Outlet perch = elevation of culvert outlet (P2) - water surface (modified from Nislow *et al.*, 2011).

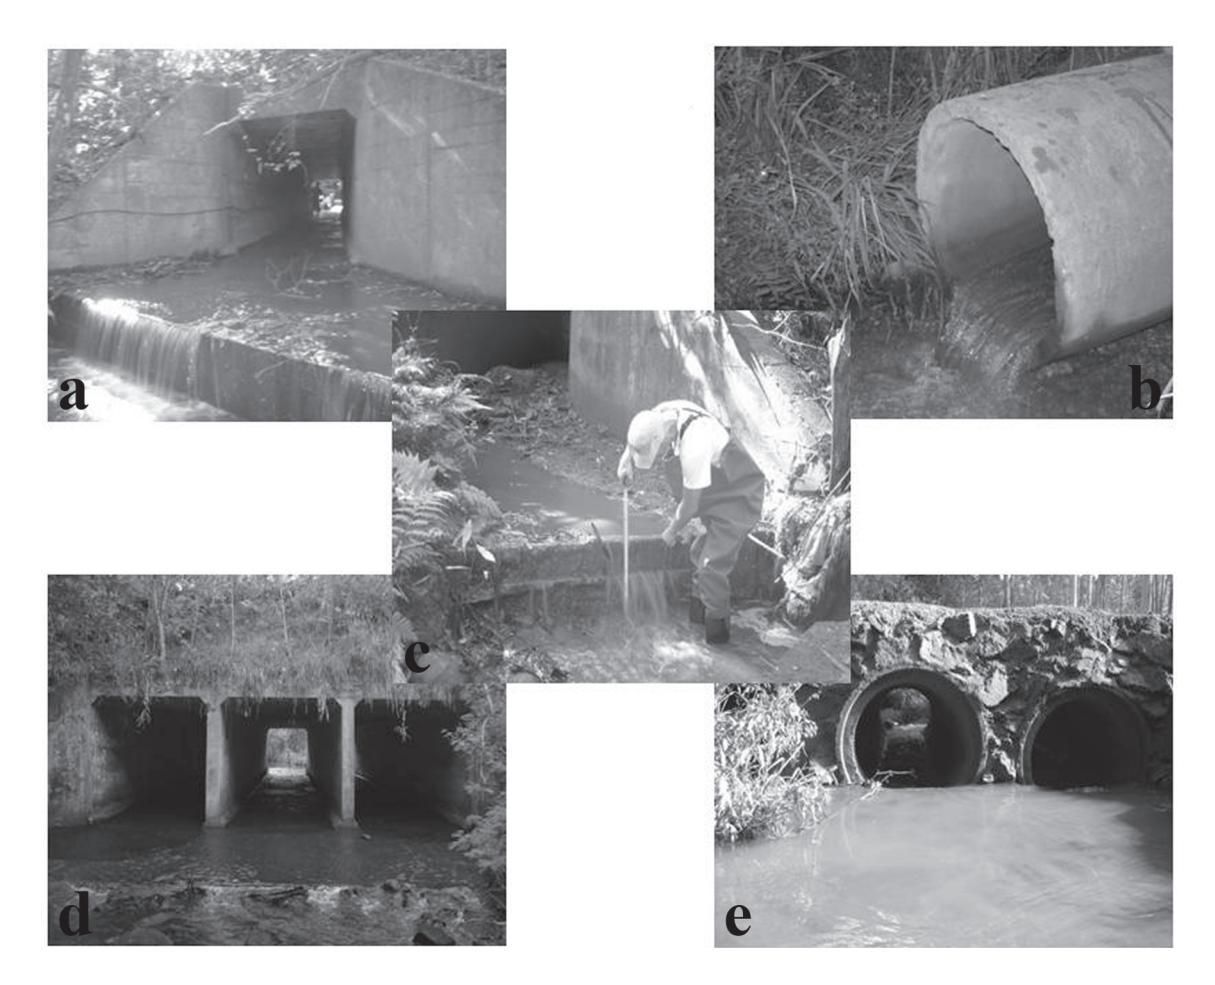
The velocities calculated by the Manning's formula ranged from 0.0 to 4.25 m/s, with an average of 0.83 m/s. Two forms of perch in the culverts were observed, and the consequent formation of a barrier, depending on their heights, may be impassable for some Siluriformes, due to the concrete base that holds the culvert (Fig. 3a-c), and the other due to the circular culvert perch (Fig. 3b). Multiple culverts (Fig. 3d-e) were also found, *i.e.*, more than one culvert at the same place, 9 sites (31%) have more than one.

The results presented in Table 2, with their respective physical and hydraulic data, were compared with recommendations for building new culverts. Out of the studied culverts, 55% were box and the 45% were circular (Fig. 3d-e; Table 2). The observed materials used for construction of the culverts were smooth concrete, corrugated metal and stony soil, resulting in 87.5, 10.0, and 2.50%, respectively.

The major factor possibly blocking the passage of fish to the upward movement in this study was the perch of the culverts, where it was observed values above 100 cm of height, with an average of 36 cm in the 40 culverts studied. Outlet drop was the most important factor affecting passage success: low probability of passage for small trout (< 100 mm fork length) at outlet drops greater than 15 cm and for large trout (> 100 mm) at outlet drops greater than 21 cm (Burford *et al.*, 2009).

Fig. 3. Some culverts in the study area: **a**) box shape, with an exposing the concrete base; **b**) circular shape of concrete and perched; **c**) measurement of the height of fall; **d**) multiple culverts in Pindorama Stream, and **e**) multiple culverts in Lopeí Stream.
