OBSERVATIONS ON AQUATIC MACROPHYTE DYNAMICS IN THE RESERVOIR OF THE BALBINA HYDROELECTRIC POWERPLANT, AMAZONAS STATE, BRAZIL

Ilse WALKER¹, Roberto MIYAI², M. D. Amaral de MELO³

Key-words: Hydroelectric powerplants, Amazonas, Balbina, water plants.

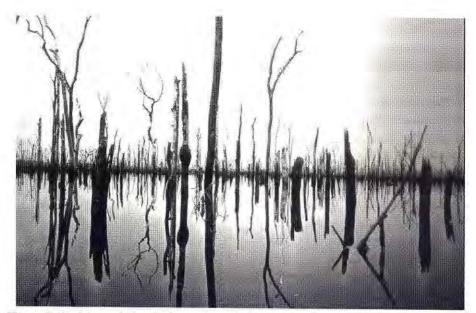
Figure 2. Dead forest during the low water period in September 1995. *Nasutitermes* sp. colony above the dark lower segment that marks the high water level.

broke off near the highwater mark. This zone is also preferred by the termites *Nasutitermes* sp.: of a total of 89 nests counted in September 1995 on standing trunks of 5-25 m height above the highwater mark, 43 were within 1 m above the mark. Also, several trees were noted with dense fungus belts just above this mark (Fig. 2).

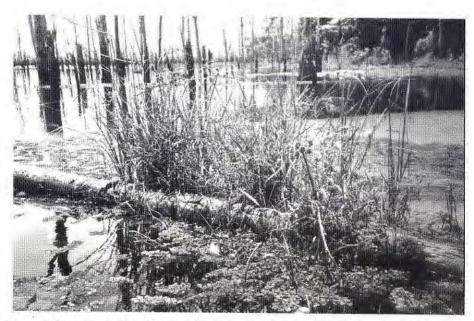
Figure 3. Floating trunk with vegetation and Salvinia in the vegetation belt of the Serra do Chocador island.

The vegetation colonizing drift wood. Decomposing logs drift on the water surface for months, if not for years, and they get colonized by a characteristic vegetation, (Fig. 3) which, when fully developed, may reach 40-80 cm in height. Examination of mostly bare trunks in Sept. 1995 showed that
