Microstructural and Topographic Characterization of Concrete Protected by Acrylic Paint

Concrete structures must be designed and constructed so as to resist the conditions established in the project design and suffer no deterioration for many years. In highly aggressive environments, in addition to the minimum layer covering the framework, the concrete must receive a protective coating. In this work, the efficiency of acrylic paint as a protective coating, while the concrete was placed in an aggressive environment, was assessed utilizing a profilometric and microstructural characterization. The concrete was dosed using the ACI – American Concrete Institute method. The specimens were prepared with 370 kg.m⁻³ of cement and the water-binder ratio of 0.50 corresponds to the value established in NBR6118¹ types for concrete subjected to highly aggressive environments. With the use of profilometry, 3D topographical images and surface roughness parameters were generated, which allowed for the identification of the degradation process and the minimization of the effect of this attack on concrete that had received surface protection. The topographic roughness parameters, as well as the imag

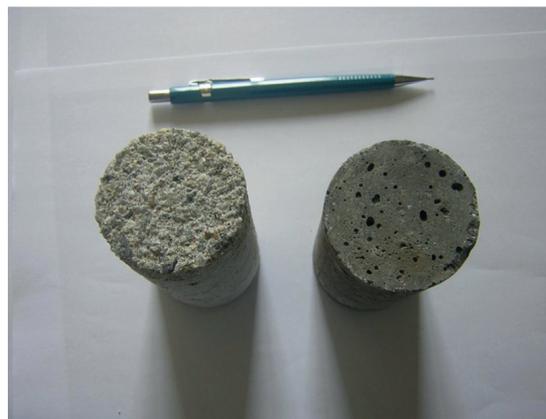
Figure 1. Specimens without protective coating, before and after H_2SO_4 attack.

Scans were performed on a 15 × 15 mm area of the sample top surface, which was subdivided into 30 two-dimensional profiles generated by approximately 8,000 points each, which allowed for the topographic characterization of the concrete surface from a statistical point of view. Also worth noting is the fact that replicates were made in all the studied situations, which reaffirmed the same trend found for the analyzed deltas. Figures 1 and 2.

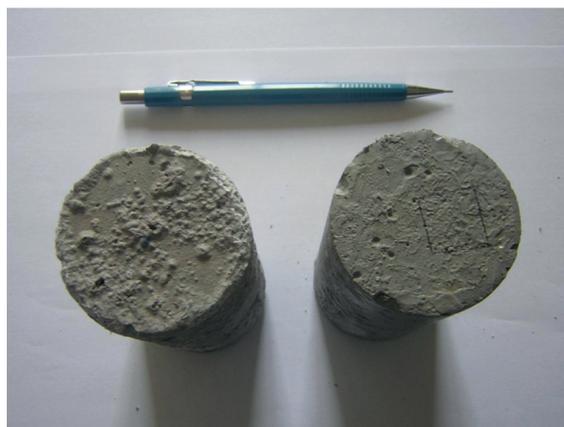
Figure 2. Specimens with acrylic paint protective coating, before and after H_2SO_4 attack.

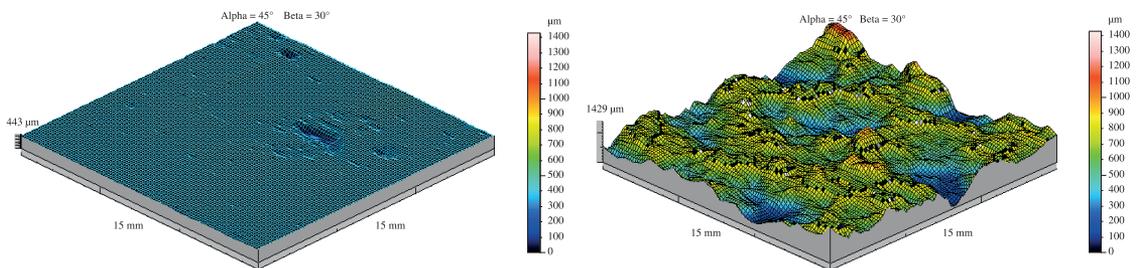
Figure 3. 3D Image of unprotected concrete, before and following chemical attack with H_2SO_4 .

A clear degradation of the concrete with no protection was noted following the chemical attack in relation to its conditions prior to the attack (Figure 3), which may be confirmed through the parameter S_t , the distance between the highest peak and the deepest valley, which varied from 443 μm to 1,429 μm , which corresponds to a variation of 223%.

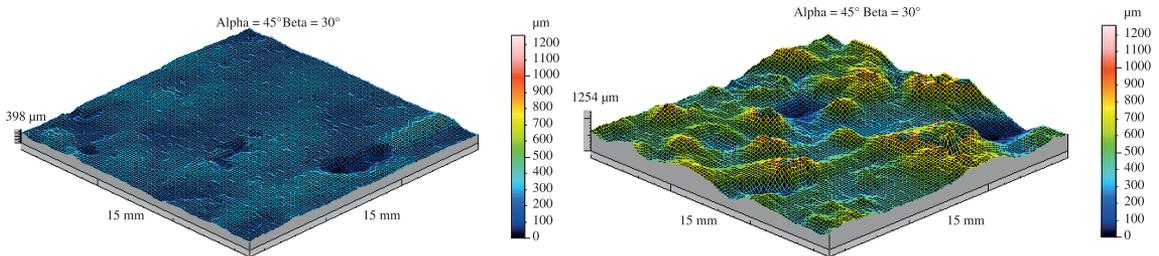
Figure 4. 3D image of concrete with acrylic protective coating, before and following the attack.

The performance of the acrylic paint, before and after the chemical attack, can be observed in the images (Figures 4), as can the variation of 215% in the S_t parameter, from 398 μm to 1,254 μm , which allows for the evaluation of the resulting effects of the chemical attack on the concrete with an acrylic paint protective coating.

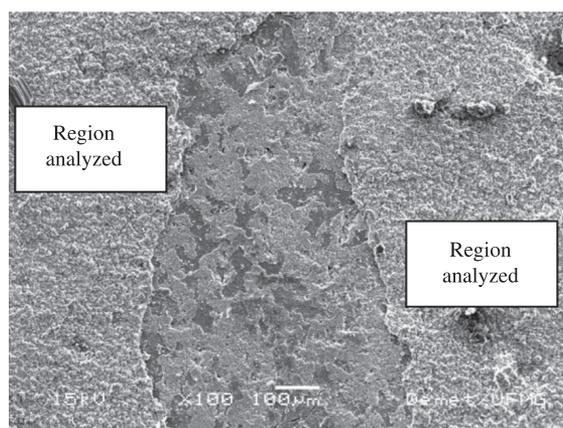
**Figure 5.** Secondary electron image, obtained using an electronic microscope (EM), of the concrete surface with no protection and not subjected to a chemical attack, amplified 100 \times .

chemical composition of concrete without protective coating before chemical attack, note the predominance of Ca and O (41.0% and 23.5%, respectively), indicating the presence of portlandite crystals $[Ca(OH)_2]$ resulting from the hydration of the cement. Also worth noting is the fact that the cement paste contains Al and Si. In Figure 6 large crystals in the form of hexagonal prisms can be seen, formed by the portlandite $[Ca(OH)_2]$ present in the cement paste.

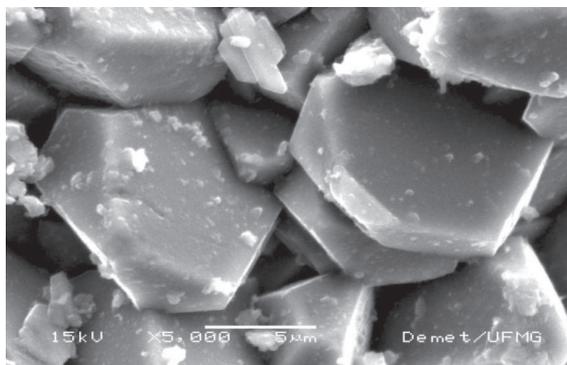
Figure 6. Image amplified 5,000× (Figure 5) of the concrete surface without protective coating and not under chemical attack, showing a detail of the portlandite crystals $[Ca(OH)_2]$.

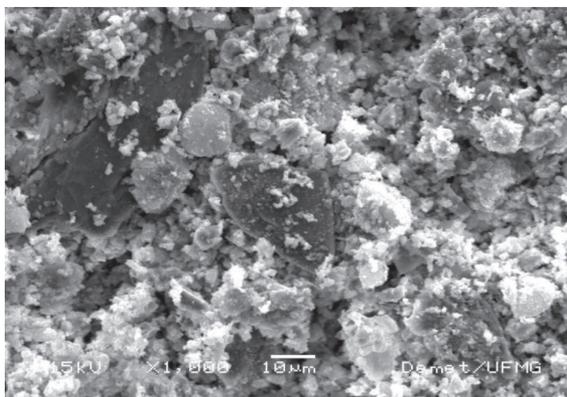
Figure 7. Image, amplified 1,000 times, of the concrete surface without protective coating and following chemical attack.

Portlandite crystals can be seen in Figure 7 covered by a whitish material. Through Table 4, which shows the chemical composition of the concrete without protective coating after chemical attack, it is possible to conclude that this material is composed of Si, which varied from 3.1% to 13.4%, Ca varying from 41.0% to 9.6% and O varying from 23.5% to 27.8%, which originate from the aggregate matter and from the sulfuric acid (H_2SO_4) used in the attack on the concrete.

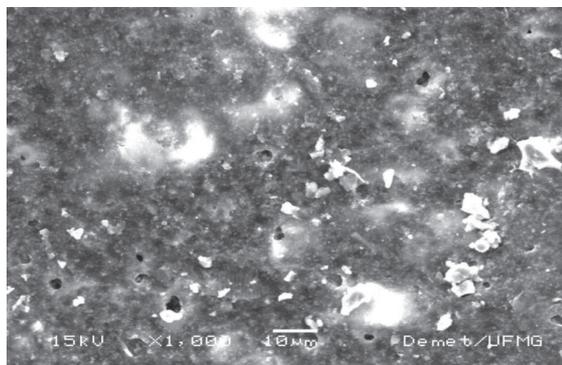
Figure 8. Image, amplified 1,000 times, of the concrete surface with the acrylic protective coating and without chemical attack.

The image (Figure 8) obtained with the SEM depict more homogeneous surfaces, with no flaws in the coating, indicating a good adherence of the paint to the substrate. The EDS analysis shows a predominance of C, O and Ti originating from the protective acrylic coating (Table 4),

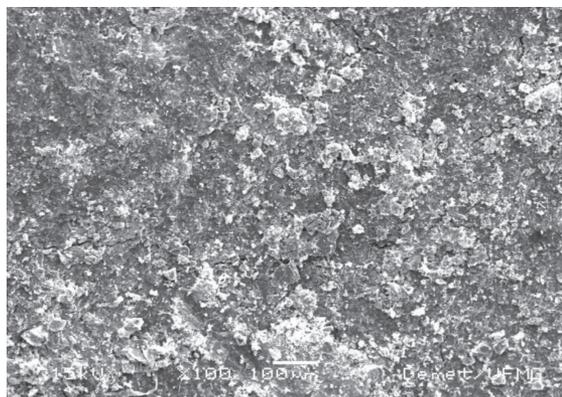
Figure 9. Image of the concrete surface with acrylic coating obtained following chemical attack, amplified 100×.

Figure 9 shows a whitish surface on the concrete protected with acrylic paint following attack with H_2SO_4 , resulting from the sulfuric acid used during the attack. In the EDS a decrease in C may be observed, due to the degradation of the acrylic paint and an increase of Si and O, as a consequence of the appearance of the concrete components.
