REVISTA BRASILEIRA DE ANESTESIOLOGIA

CLINICAL INFORMATION

Lost guide wire – lessons learned

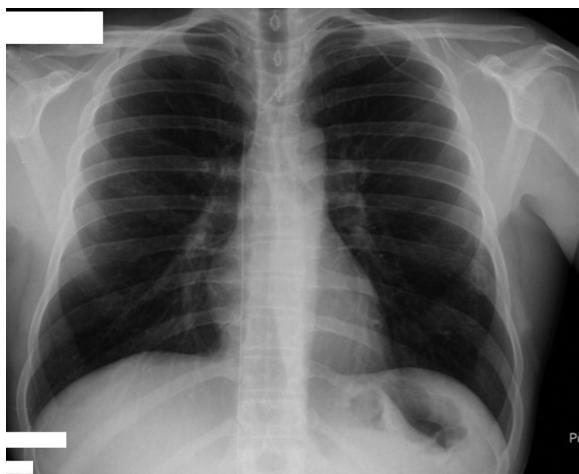
Figure 1 Posteroanterior chest radiograph depicting a radiopaque line to the right of the sternum.

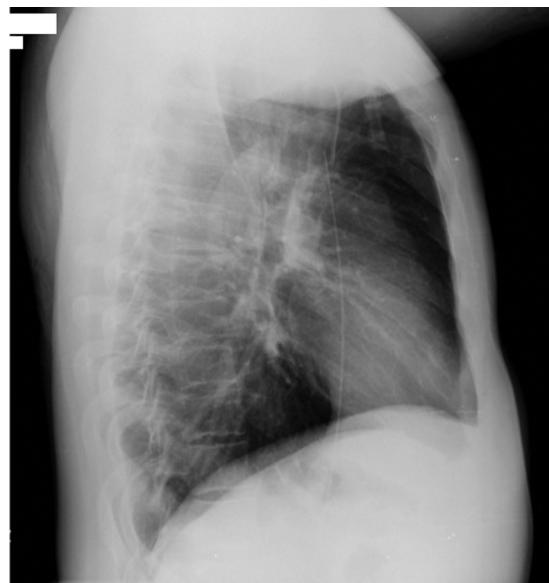
Figure 2 Left lateral chest radiograph, depicting the same radiopaque line, clearly distal to the catheter tip and consistent with an intravascular position.

- 6 It is important not to hastily discard compatible images as representing wires at the surface of the patient³; if there is doubt, a lateral view may be particularly helpful. In our case, considering the presence of the catheter partly in the IVC, echography was also helpful.

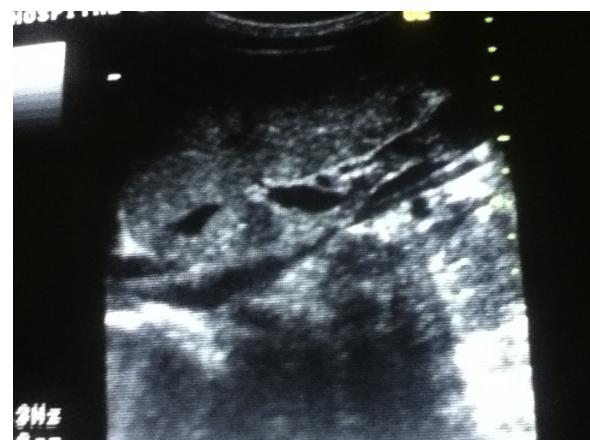
Figure 3 Still of the abdominal echography, where we can see a partially collapsed inferior vena cava with an echoreflective structure inside (corresponding to the guidewire).

inferior vena cava (IVC) view, which once again confirmed the presence of an echoreflective linear image inside the IVC (Fig. 3, Film 1). The case was then presented by the surgical fellow to interventional cardiology, and the guide wire was removed percutaneously via a right femoral vein approach, uneventfully.
