Article - Engineering, Technology and Techniques

Development of a Low-Energy Mobile Current Waveform Impulse Generator for Application in Low Voltage Surge Arresters

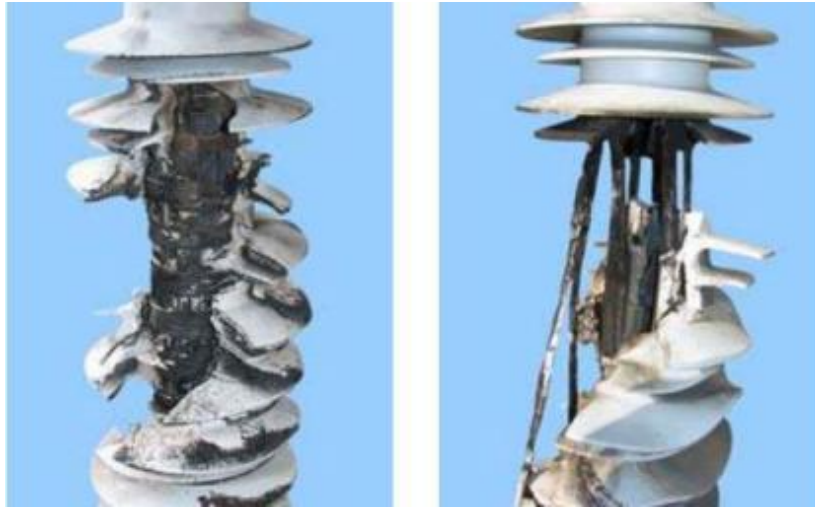
Figure 3. Surge arrester damaged after failure in operation [19].

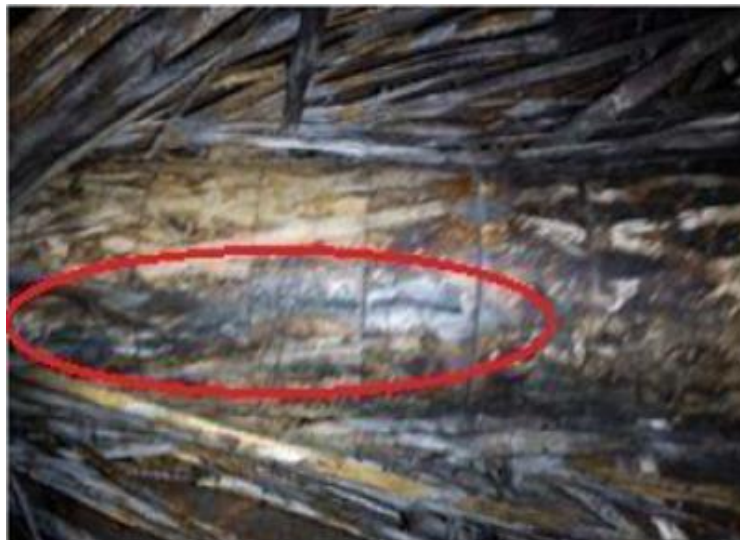
Figure 4. Damage caused by lightning [21].

According to [20], there are two types of damage: fault or degradation of the elements. Fault-type damages result in instant damage to the varistor elements, manifesting as destruction (Figure 3) or punctures and perforations (Figure 4). On the other hand, degradation damages affect the $V-I$ characteristic of the varistor blocks, which can eventually lead to a fault.

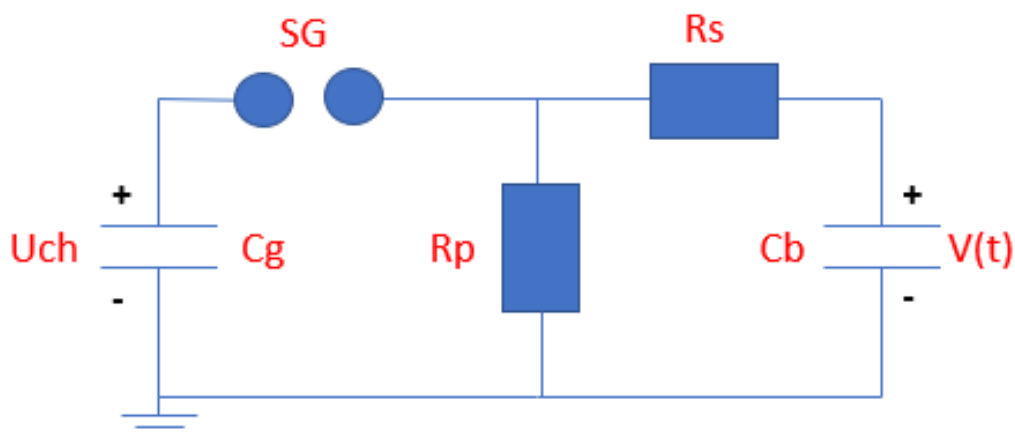
Figure 7. Current waveform impulse generator electric circuit – based on [35].

To generate the current waveform impulse, the base circuit (Figure 7) was used, where the value of resistor R_p determines the tail time of the waveform, and R_s and C_b determine the front time of the waveform. The front time T_1 is obtained using the relationship given in equation (2), and T_2 can be determined using the connection shown in equation (3).

Where U_{ch} is the charging voltage; C_g is the capacitance of the generator; SG is the spark gap that defines the firing voltage; R_p is the parallel resistance, responsible for the tail time; R_s is the series resistance, responsible for the front; and C_b is the capacitance presented by the load.

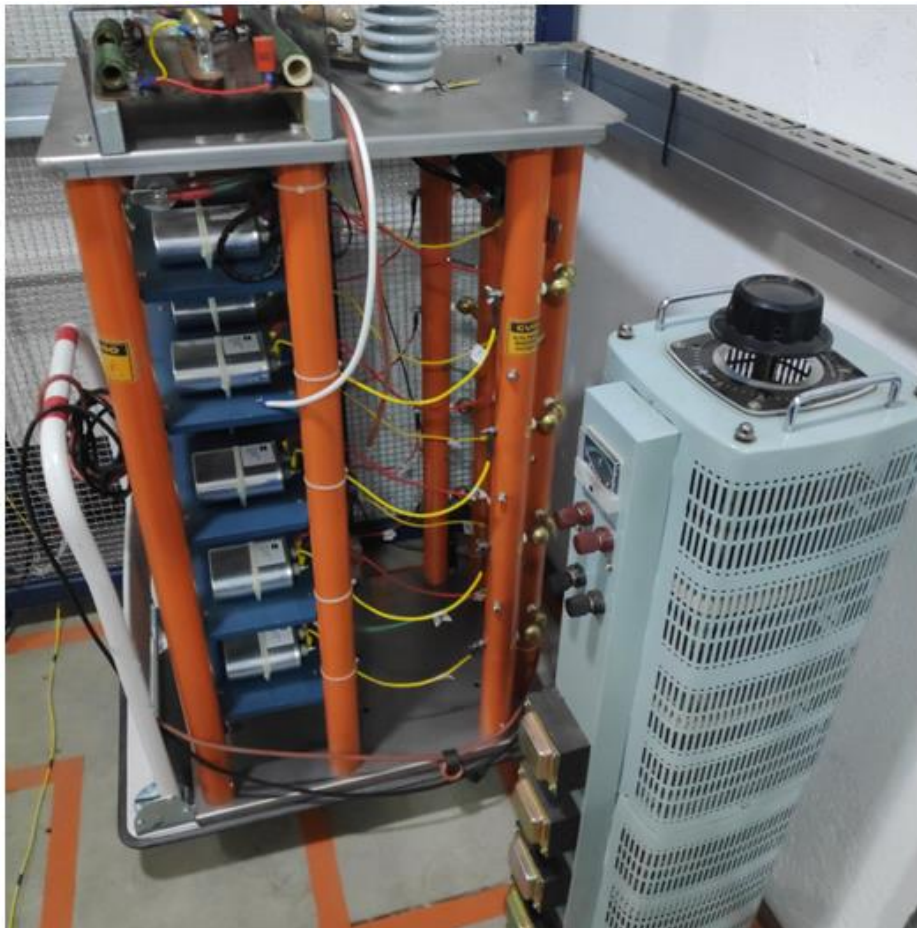
Figure 8. Laboratory portable impulse current waveform low energy.

This section presents a mobile laboratory developed for the partial aging process. Detailed construction and technical information will be provided to enable the replication of the experiment. The laboratory, shown in Figure 8, is designed to apply up to 30 kV peak voltage with an energy of 0.1 kJ. It generates an 8/20 μ s waveform, and modifying components in the waveform conditioning circuit can make adjustments.

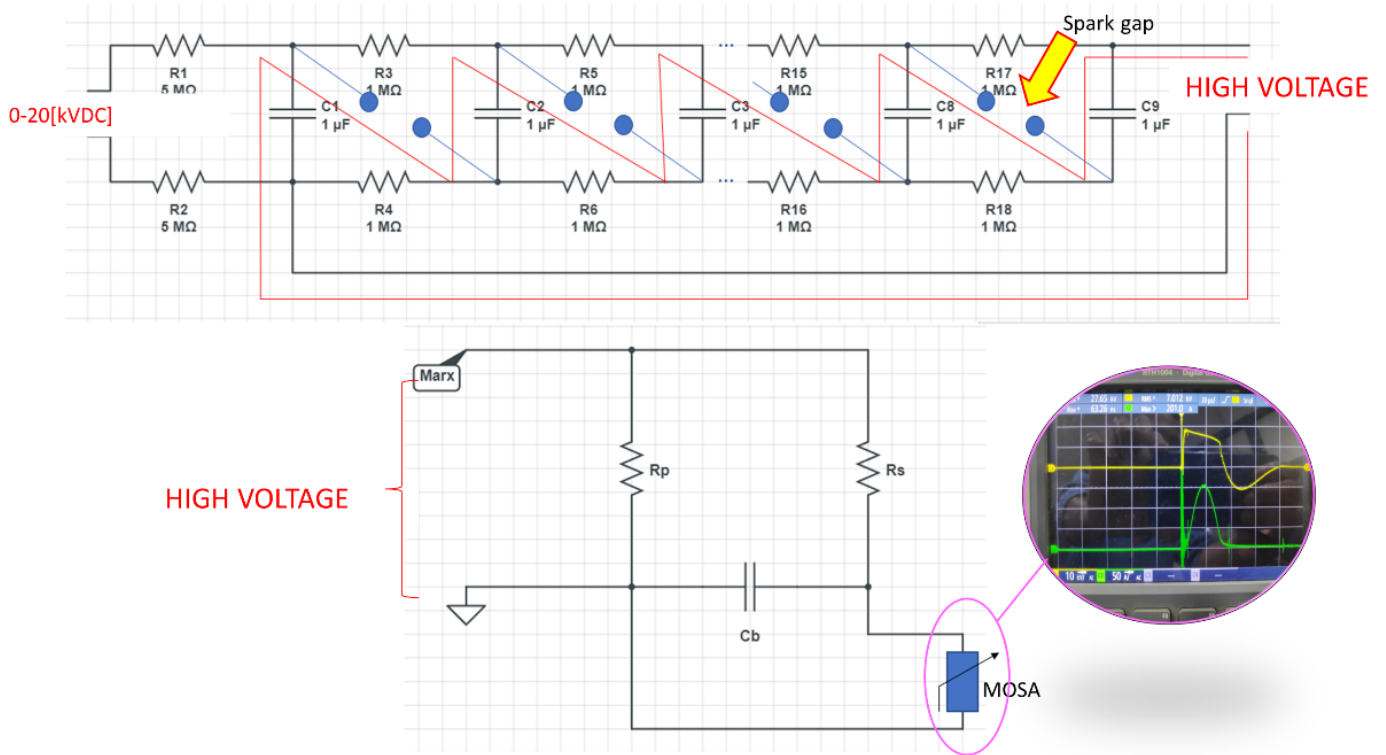
Figure 9. Impulse generator electrical diagram: a – Marx generator, b – Conditioning circuit.

The electrical diagram is presented in Figure 9, composed of a Marx generator [36]. The circuit is fed with direct voltage and provides a parallel association of capacitors, and series resistors allow different charging times for each capacitor. At the end of the charge, the last capacitor in the array reaches sufficient electrical potential to break the dielectric strength of the air and conduct it through the spark gaps. Conduction creates the path highlighted in red (Figure 9a) through which the capacitors are connected in series and discharged in the conditioning circuit (Figure 9b).

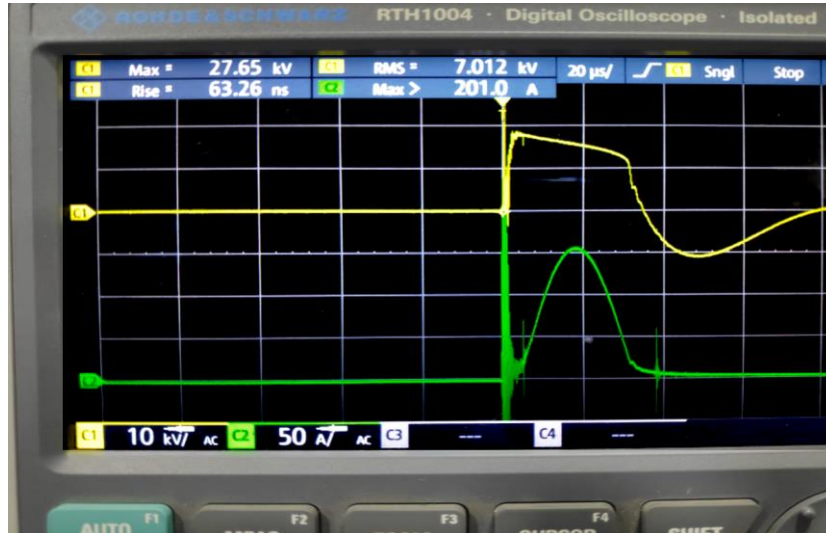
Figure 12. Impulse voltage and current waveforms.

The impulse waveform generator was tested in the laboratory along with new surge arresters. Three units of distribution-type surge arresters with a nominal voltage of 6[kV] and a nominal current of 10[kA] were tested. The yellow curve represents the voltage waveform, with flattening due to the capacitance of the surge arrester, while the green curve represents the discharge current. The residual values in the tested surge arresters were 19[kV] and 152[A] peak, as shown in Figure 12.
