## Case report

# Spontaneous dislocation of the polyethylene component following knee revision arthroplasty: case report<sup>☆</sup>

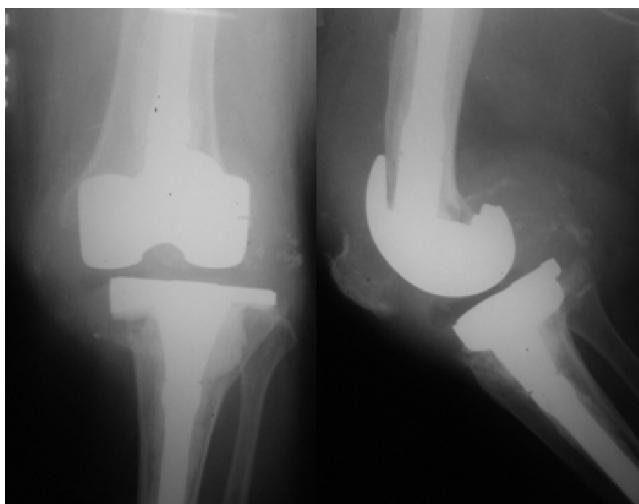
**Fig. 1 – Radiographs in anteroposterior and lateral views of the left knee, demonstrating the revision prosthesis without signs of loosening or dislocation of the tibial polyethylene.**

On examination, coarse instability of the knee was observed, with joint effusion and diffuse pain. Although the initial diagnostic hypothesis suggested the possibility of periprosthetic fracturing, radiographs demonstrated displacement of the tibial polyethylene (Fig. 1).

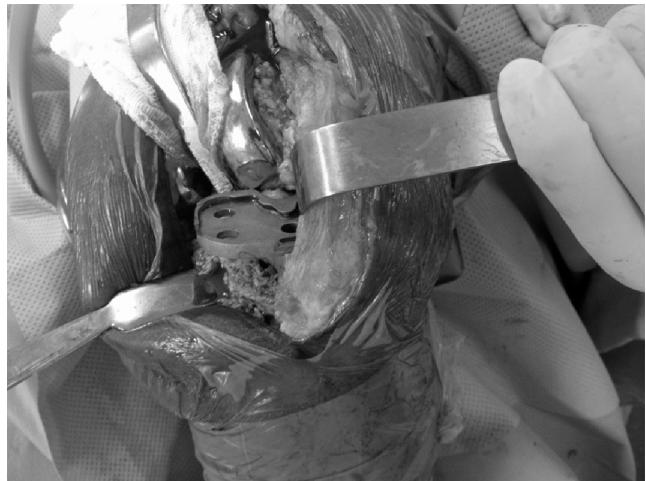
**Fig. 2 – Transoperative clinical image of revision of the arthroplasty of the left knee, demonstrating osteolysis in the medial tibial metaphysis.**

The patient therefore underwent a new revision procedure. During the operation, an area of osteolysis in the proximal medial tibial metaphysis was shown, in addition to dislocation of the polyethylene (Fig. 2). Nevertheless, the tibial nail presented adequate stability. Thus, the polyethylene piece was exchanged and a larger medial metal wedge was inserted (Figs. 3 and 4).

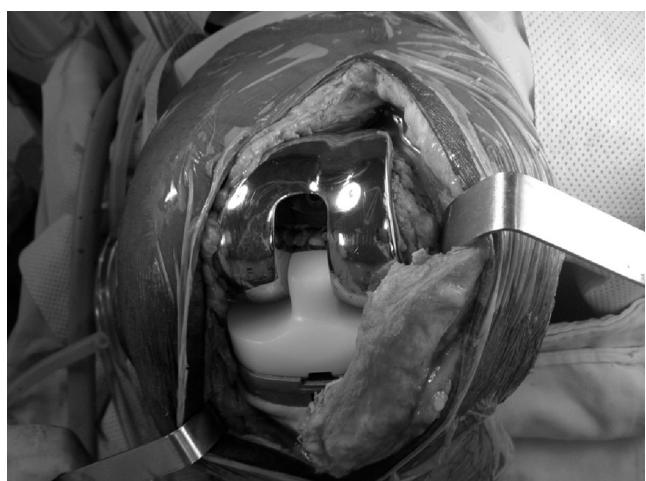
**Fig. 3 – Transoperative clinical image (final result) of revision of the arthroplasty of the left knee.**

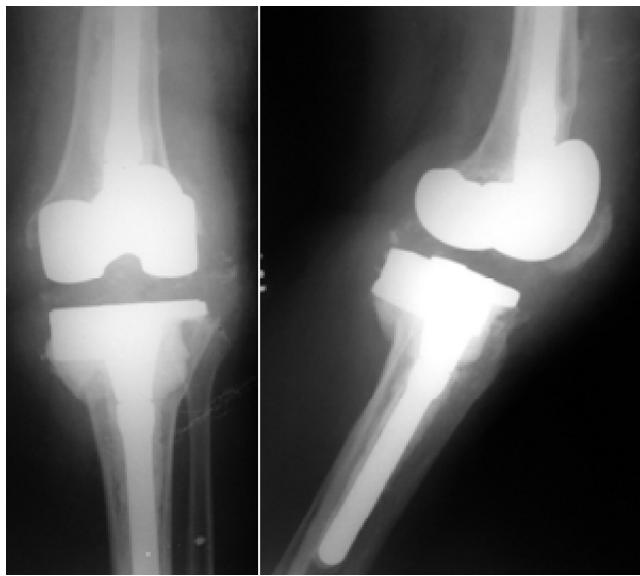
**Fig. 4 – Radiographs in anteroposterior and lateral views of the left knee, demonstrating postoperative control of revision of the arthroplasty, with exchange of the polyethylene and the medial tibial metal wedge.**
