# Degradation of the EBR-CFRP strengthening system applied to reinforced concrete beams exposed to weathering

Gláucia Maria Dalfré<sup>a</sup> Guilherme Aris Parsekian<sup>a</sup> Douglas da Costa Ferreira<sup>a</sup> <sup>a</sup>Universidade Federal de São Carlos – UFSCar, Programa de Pós-graduação em Engenharia Civil, São Carlos, SP, Brasil

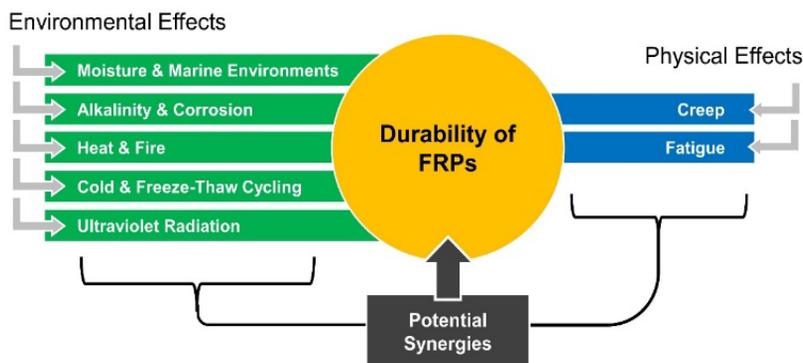
Figure 1. Degradation mechanisms of FRP systems [12]

All materials used in the construction industry are subject to degradation, originated by chemical, physical, or mechanical sources. Applying an FRP strengthening system to a determined concrete element, these degradation mechanisms should be considered to achieve better long-term behavior and durability [12]. Degradation mechanisms can occur either individually or together in the degradation of the composite FRP material (Figure 1).

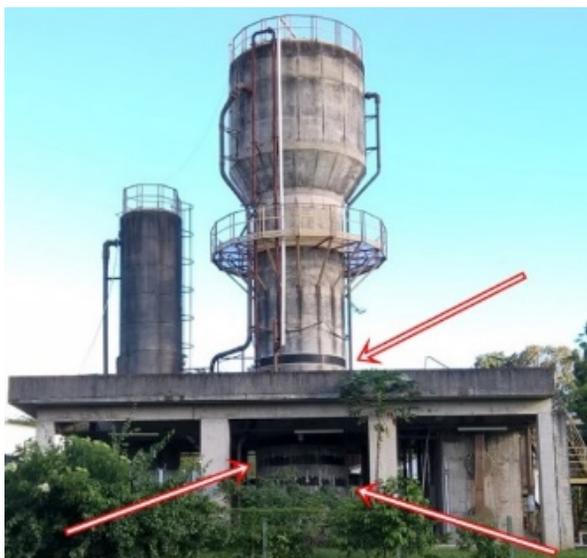
Figure 2. Sewage station with CFRP sheets externally applied according to the EBR technique [14]

It is generally known that degradation mechanisms directly affect the most sensitive part of the strengthened structure, i.e., the bond between the concrete substrate and the FRP composite. Bonding usually relies on epoxy-based resins, which are susceptible to degradation in harsh environments. These resins are susceptible to ultraviolet (UV) radiation, temperature, humidity, and acid rain [13]. Unless a protective layer is used, the FRP gets directly exposed to the external environment and, consequently, to the possible aggressive agents or eventualities, as shown in Figure 2.

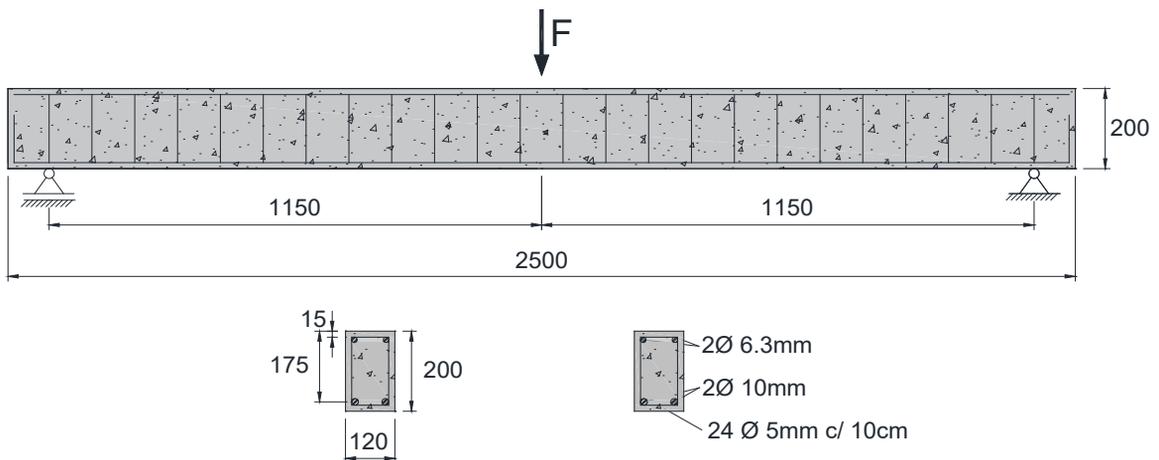
Figure 5. Characteristic of reinforced concrete beams (units in mm).

The experimental program consisted on twelve simply supported beams of  $120 \times 200 \times 2500 \text{ mm}^3$ , 20-MPa, and positive longitudinal reinforcement composed by two CA-50 steel bars (10-mm diameter; reinforcement ratio of 0.75%). To avoid shear rupture, CA-60 steel stirrups (5-mm diameter and 10-cm spacing) with two top longitudinal reinforcement bars of CA-50 and 6.3 mm diameter (Figure 5). The beams were designed in the deformation domain 2, based on NBR 6118 [21].

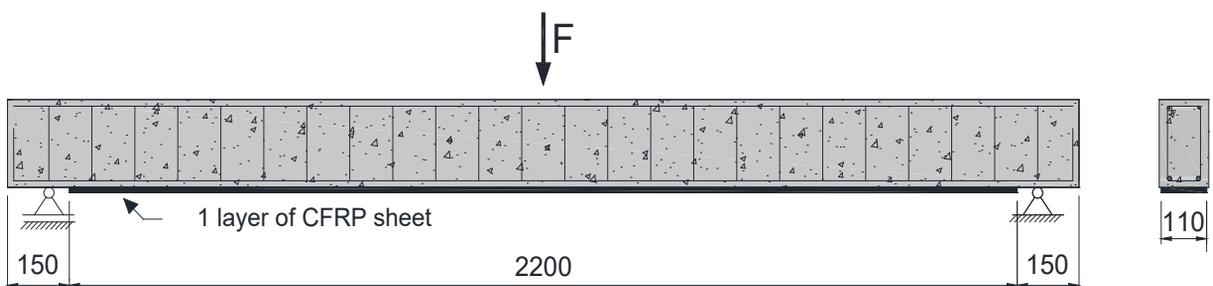
Figure 6. Details of the strengthening system (units in mm)

Eight beams were reinforced with unidirectional  $300\text{-g/m}^2$  weight carbon fiber sheets of 0.13 mm thickness. The sheet was cut into  $110 \times 2200 \text{ mm}$  strips to fit the tension surface of the reinforced concrete beam (Figure 6).

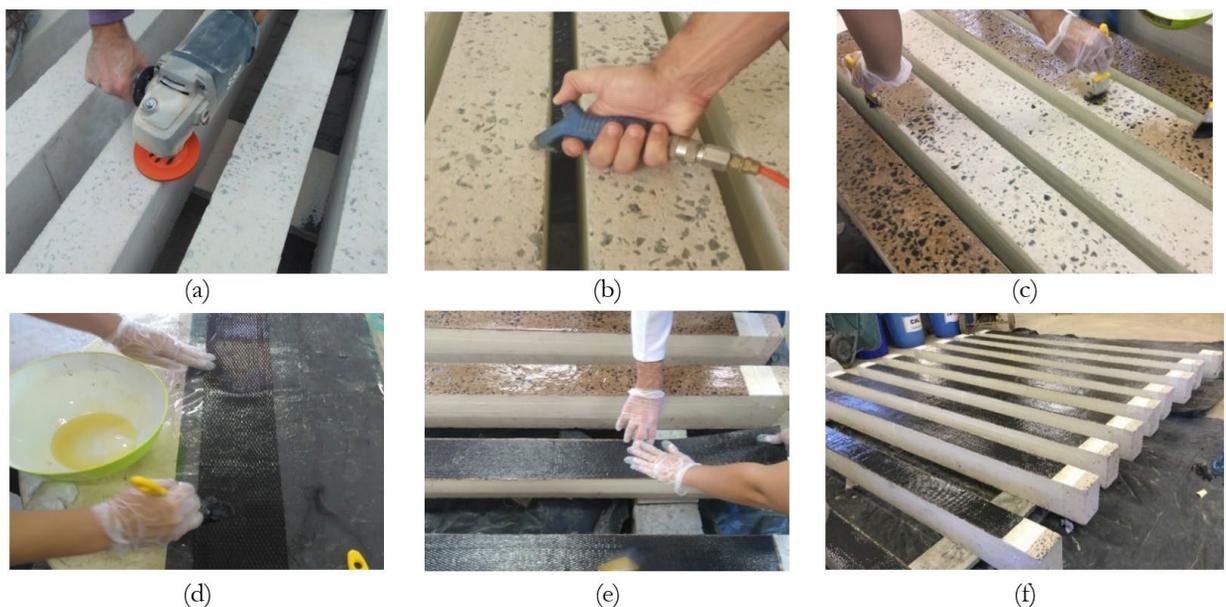
**Figure 7.** (a) Preparation of the concrete surface, (b) surface cleaning with compressed air, (c) application of the primer, (d) impregnation of the CFRP composites, (e) application of CFRP to the concrete substrate and (f) final aspect of the strengthened members

The CFRP sheets were applied externally to the beams when they were 186 days old. The substrate was cut with a diamond thinning disc grinder until the entire layer of cement paste was removed and the aggregates were exposed. After, compressed air was applied to the surface for disposing of any solid particles. A layer of the primer resin (Resin A) was applied to improve the adhesion conditions between the CFRP and concrete substrate. The CFRP was bonded using the epoxy lamination resin (Resin B), which was applied 45 minutes after the primer. The primer and saturation resins were

prepared into three steps: agitation of each component, mixture of component A to B in the proportion indicated by the manufacturer, and mechanical mixture until a uniform color was obtained. The primer resin was spread on the concrete surface using a brush. The CFRP sheet was covered with lamination resin and applied to the concrete substrate before the application of the strengthening system. While strengthening, we tried to ensure the alignment of the fibers in the longitudinal direction of the beam, to check the non-formation of air bubbles in the back of the CFRP composite, and to avoid the accumulation of excess resin. The steps and procedures used to strengthen the reinforced concrete beams are depicted in Figure 7.

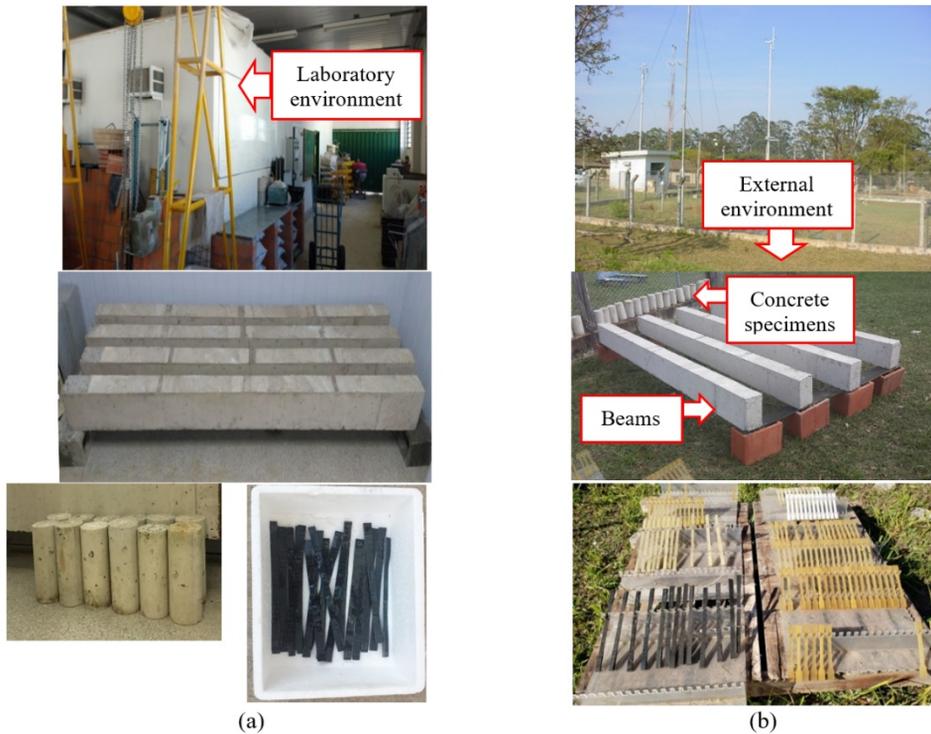
**Figure 8.** Exposure environments: (a) isolated and protected chamber and (b) exposure to weather (outdoor environment)

Of the twelve beams made, four had no strengthening, and the others were strengthened in flexure with one layer of CFRP sheet applied according to the EBR technique. Two exposure environments were adopted in this research (Figure 8), as given below.

- Laboratory environment (LAB): internal to a chamber, protected, and with monitoring of ambient temperature and humidity, which served as a reference for the other tests (Figure 8a)
- Exposure to weathering (WEA): external environment, free of obstacles that promoted shading in beams and specimens, and with monitoring of humidity, temperature, and radiation (Figure 8b).

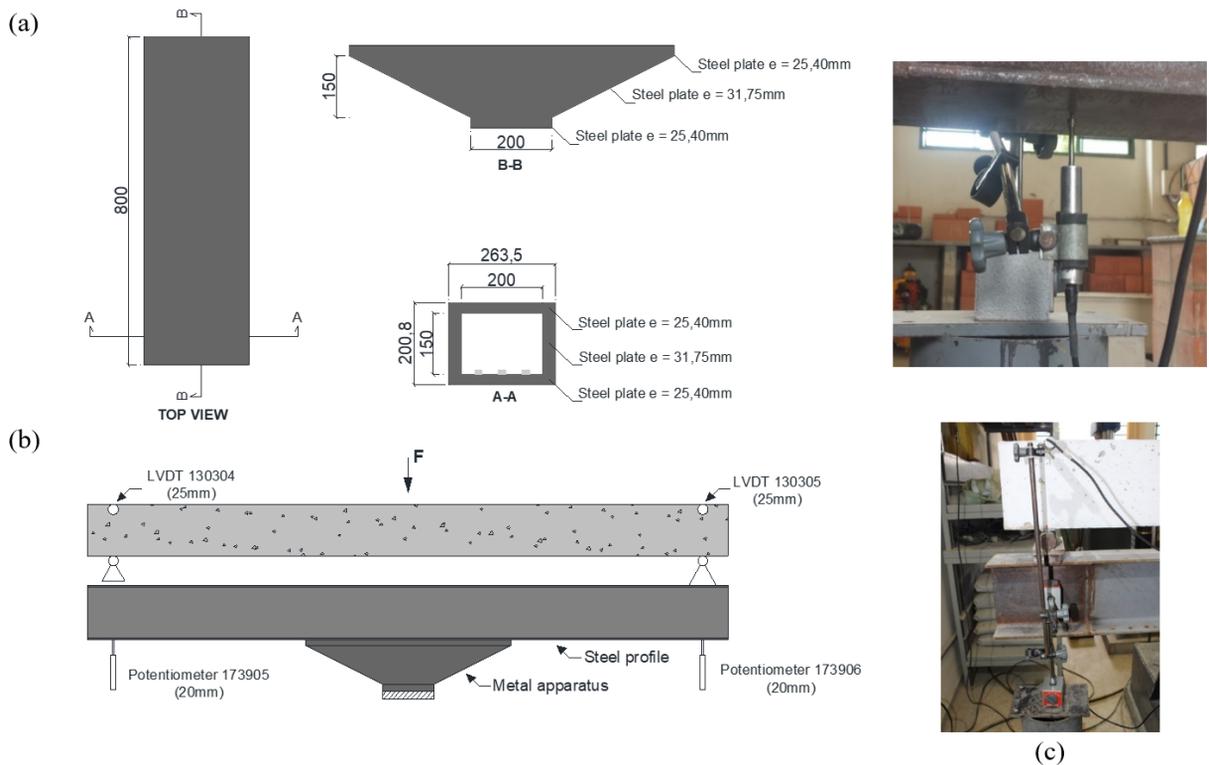
**Figure 9.** (a-b) Steel apparatus and (c) details of the positioning of the LVDTs and potentiometers used to measure the displacement of the metal beam and rotation of the supports (units in **Figure 9a**: mm)

A self-reaction system was designed to allow testing the beam inside the universal testing machine. A double corbel element (Figure 9a) was designed using 31.75-mm and 25.40-mm thick. The corbel was fixed to the testing machine base and supported a 250-cm long steel section (W200 x 26.6). The corbel was screwed to the base of the test machine using six steel hexagon screws type M12, and the metal profile was mounted on it with eight steel hexagon screws type M10. The concrete beams were supported on the metal profile at a roller and at a fixed support, as shown in Figure 9b.

To measure the rotation of the supports and displacement of the steel beam ends, two Linear Variable Differential Transformers (LVDTs) with 25-mm stroke and two potentiometers with 20-mm stroke were used, positioned as shown in Figure 9b, 9c.

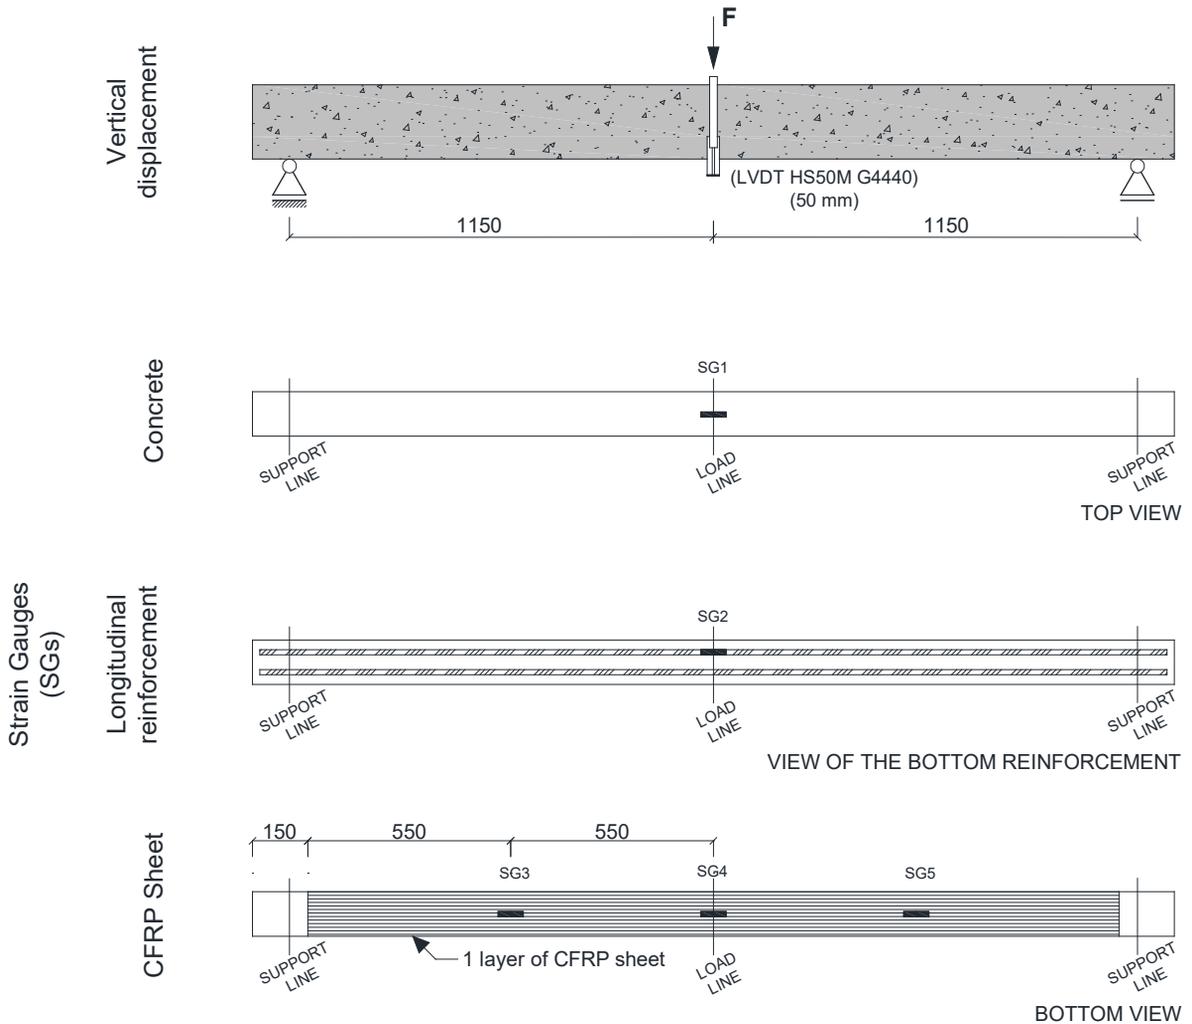
Figure 10. Instrumentation used in beam testing (units in mm)

The deformations in the concrete were measured on an electric strain gauge of type PA-06-1500BA-120 (resistance of 120  $\Omega$  and length of the reading grid of 40 mm; produced by Excel Sensors), which was positioned in the middle of the beams (SG1). The deformations in the longitudinal strengthening were measured on electrical strainers of type KFG-20-120-C1-11 (resistance of 120  $\Omega$  and length of the reading grid of 20 mm; produced by KYOWA), which was positioned in the section of the central section of one of the longitudinal strengthening (SG2). In relation to CFRP composite deformations, electrical strain gages of type KFG-20-120-C1-11 (the same used in longitudinal strengthening) and type PA-06-250BA-120 (resistance of 120  $\Omega$  and reading grid length of 6 mm; produced by Excel Sensors), positioned along the strengthening material (SG3 to SG5). Figure 10 shows the instrumentation used.

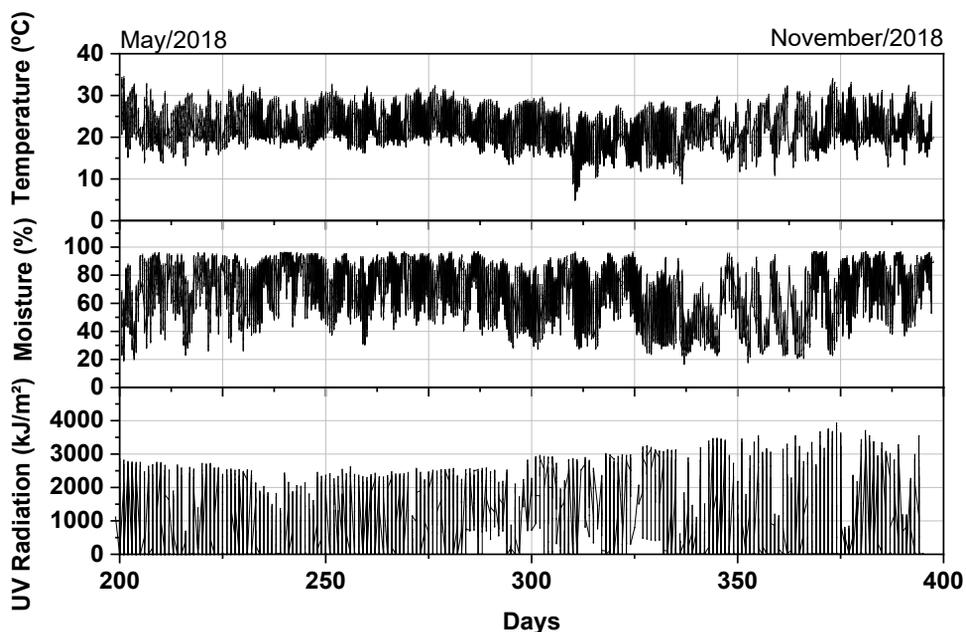
Figure 11. Weather data for the weather exposure. Source: INMET

The temperature and average humidity readings in the laboratory environment were 23.3°C ( $\pm 0.03\%$ ) and 36.5% ( $\pm 0.24\%$ ), respectively. The values in parentheses represent the Coefficient of Variation (COV). For exposure to weathering (external environment), Figure 11 presents the data of temperature, humidity, and UV radiation throughout the exposure period of the beams and concrete specimens, i.e., from May to November 2018. During this period the maximum and minimum temperatures were 34.2°C and 4.7°C, and the maximum and minimum humidity were 95% and 16%, respectively. Regarding UV radiation, the surface weather station recorded a peak of 4112 kJ/m<sup>2</sup> and an average of 788 kJ/m<sup>2</sup> over the exposure period.

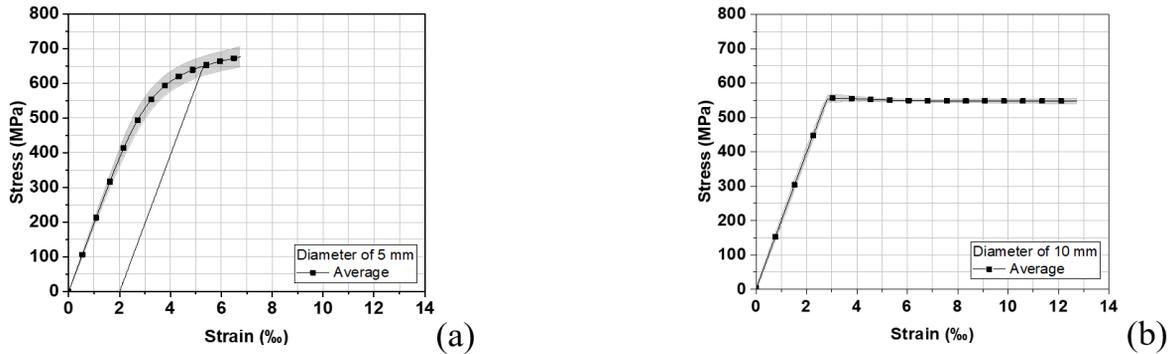
Figure 12. Stress versus deformation of materials: (a) stirrups and (b) steel of longitudinal reinforcement

Regarding the characterization of steel, for bars with a diameter of 5 mm, type CA-60, an average yielding stress was observed at 2.0‰ of 646.9 ( $\pm 4.04\%$ ) MPa and a maximum tensile stress of 670.6 ( $\pm 3.62\%$ ) MPa (Figure 12a). For steel with a diameter of 10 mm, a typical behavior of CA-50 steel was verified with a plastic plateau (Figure 12b),

with an average yielding stress of 547.4 MPa ( $\pm 2.13\%$ ), mean yielding strain of 2.8‰ ( $\pm 1.59\%$ ), and a maximum tensile stress of 591.5 MPa ( $\pm 6.25$ ). The elasticity modules verified for the 10 mm and 5 mm bars were 196.9 GPa ( $\pm 1.58\%$ ) and 191.3 GPa ( $\pm 7.19\%$ ), respectively.

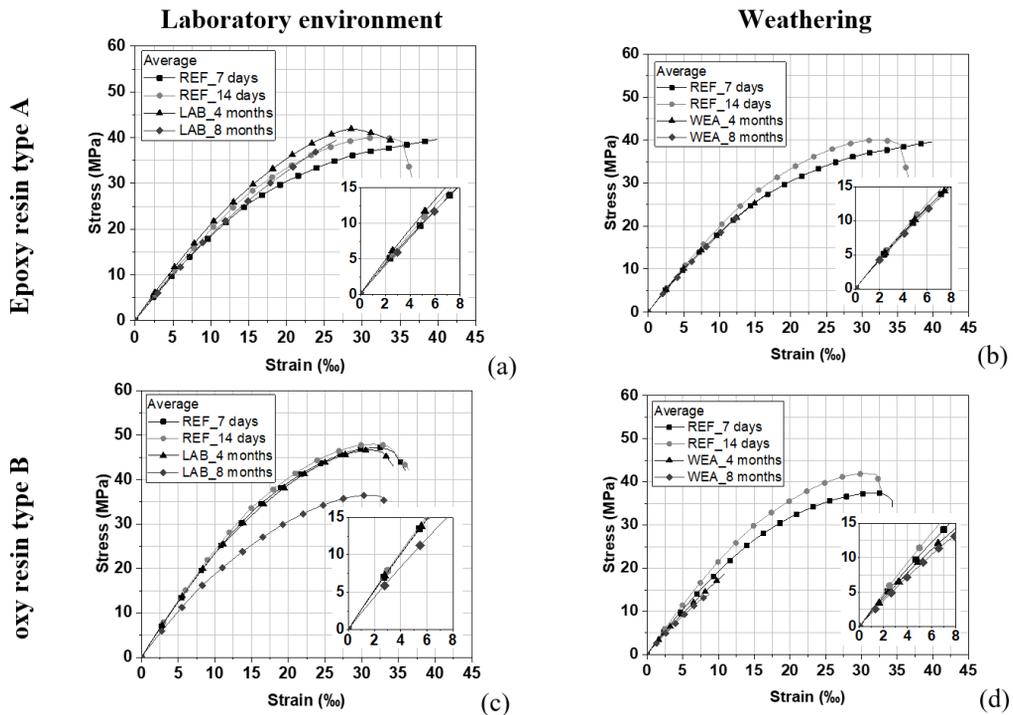
**Figure 13.** Stress versus strain relationship of primer (a-b) and saturation (c-d) resins maintained in a laboratory environment or exposed to weathering

The characterization tests for the resins were experimentally performed at the ages of 7 and 14 days and 4 and 8 months after the application of the strengthening system, as presented in Figure 13. Considering 14 days of cure for Resin A (Figure 13a), which was maintained in a laboratory environment, the material presented a small increase in maximum tension and modulus of elasticity (5.7% and 4.5%, respectively) at 4 months. After 8 months of exposure and with the results of the tests performed at 14 days as a reference, there was no major change in the maximum tensile stress of the primer, which presented a small reduction of 2.9%. However, a 9.1% reduction in the modulus of elasticity was verified in the assays. There was also a small reduction in the ductility of the specimens after 8 months of exposure in a laboratory setting. Therefore, there were no significant changes in the mode of rupture and stress-strain behavior throughout the exposure period in the laboratory environment.

Considering the exposure to weather of Resin A (Figure 13b) and with the tests performed at 14 days as a reference, a reduction of 39.1% in tensile strength and 4.5% in the modulus of elasticity was noted at 4 months. At 8 months of exposure, a sharper reduction in tensile strength (about 51.0%), while the modulus of elasticity showed a reduction of 9.1%. It was also verified, for both ages, that the reduction of ductility of the specimens with alteration in the mode of rupture from ductile to fragile without a defined plasticization interval. Further, Resin B, which was maintained in a laboratory environment (Figure 13c) did not present major changes in its mechanical properties (reduction of only about 3.1% of tensile strength) up to 4 months of exposure. However, after 8 months, there was a considerable reduction of 23.8% and 19.2% in tensile strength and modulus of elasticity, respectively. This reduction in tensile strength and modulus of elasticity did not alter the behavior of the stress-strain diagram, and the maximum stress level continued to be reached with close deformations. At 7 days of cure, the tensile strength was already close to that obtained in the complete cure indicated by the manufacturer (14 days). For Resin B's exposure to weather (Figure 13d), the stress-strain diagrams did not present major changes at 7 and 14 days, only a small increase in the maximum tension. After 4 months, there were remarkable losses in its mechanical properties, with a reduction in its tensile strength and modulus of elasticity of 63.3% and 9.1%, respectively. At 8 months, the maximum tensile strength decreased sharply (about 69.2%), while the modulus of elasticity showed a reduction of 18.2%. Observed, also, the reduction of ductility for both ages of exposure with alteration in the mode of rupture, which occurs abruptly and without any stretch of plasticization. Unlike Resin A, Resin B yielded a considerable loss in its mechanical properties after 8 months of exposure to the laboratory environment. Another divergence found in the epoxy resins is related to their mechanical properties at 14 days of curing. It was noted that both the tensile strength and modulus of elasticity of Resin B were higher (about 16%) than those of Resin A despite the equivalent curing time.

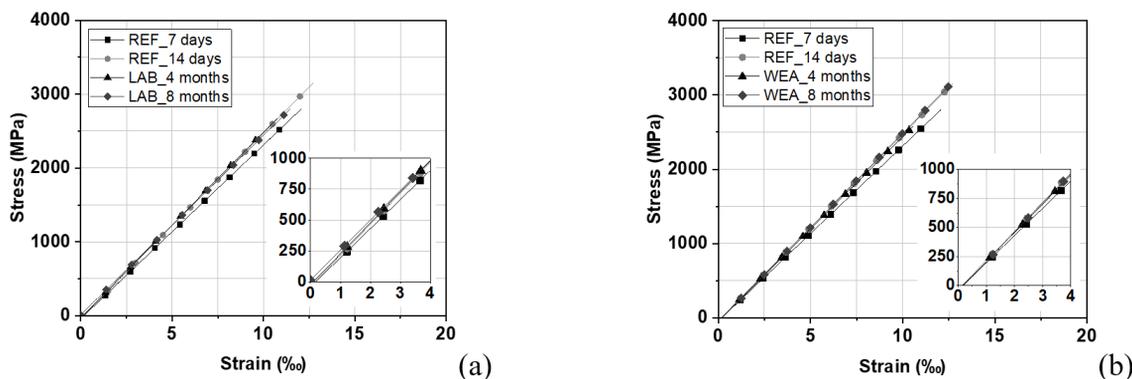
Figure 14. Stress versus strain relationship of CFRP composites maintained in laboratory environment (a) or exposed to weathering (b)

For CFRP composites (Figures 14a, 14b), the specimens presented a linear elastic behavior until their rupture, typical of fragile materials. Regarding their exposure to the laboratory environment (Figure 14a), a more significant variation was seen in the behavior of the specimens after the ages of 4 and 8 months. Further, a greater reduction in the tensile strength of the specimens occurred after 4 months of exposure (reduction of about 15% of tensile strength). During this same period, there was a small reduction of 1.73% in the modulus of elasticity. After 8 months of exposure, the CFRP composite specimens gained resistance and showed a lower loss in tensile strength, at about 11%, while the modulus of elasticity reduced by only 3.3%. The last deformation also showed reductions of 14% and 7% over 4 and 8 months' exposure to the laboratory environment, respectively. It was verified that a greater loss occurred in the test performed at 4 months.

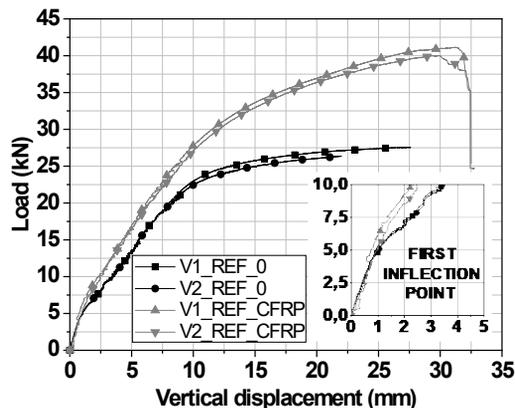
Figure 15. Load versus displacement of reference beams without strengthening and strengthened

In order to evaluate the effectiveness of the strengthening system with CFRP sheets applied according to the EBR technique, Figure 15 presents a comparison between the Load and vertical displacement of the reference beams without strengthening (V1\_REF\_0 and V2\_REF\_0) and strengthened (V1\_REF\_CFRP and V2\_REF\_CFRP). Upon analysis of Table 4 and Figure 15, it is possible to verify the effectiveness of the CFRP EBR strengthening system for the reinforced beams without strengthening and the increase in the load capacity of the strengthened beams.

In relation to the beginning of the steel yield, it was verified that the strengthening provided an increase in the load capacity corresponding to the beginning of the longitudinal steel yielding and the maximum force of 19.7% and 50%, respectively. In addition, a reduction in the average vertical displacement of 9.7% for the strengthened reference beams, compared to the reference beams without strengthening due to the reduction of cracking that the strengthening system promotes, restricting the reduction of element inertia was observed.

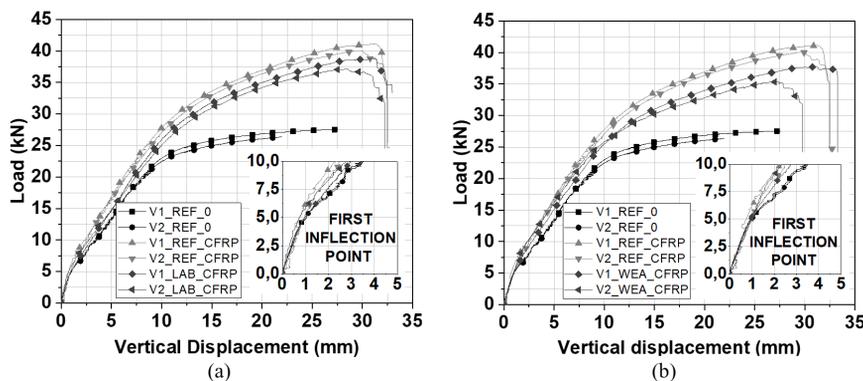
Figure 16. Relationship between Load versus vertical displacement of reference beams exposed to the environments: (a) laboratory and (b) weathering

As failure modes, the reference beams without strengthening, V1\_REF\_0 and V2\_REF\_0, designed in Domain 2, presented a ductile rupture characterized by the yielding of the longitudinal tensile reinforcement and later crushing of the compressed concrete. All the strengthened beams (V1\_y\_CFRP and V2\_y\_CFRP), after great deformation and high curvature of the elements, showed appearances of cracks parallel to the strengthening material in the moments before the failure of the element. Therefore, it appears that the use of the CFRP EBR strengthening system alters the failure mode of the strengthened elements. The failure, which was previously ductile and ruled by the deformation of the longitudinal strengthening, became almost fragile with the detachment of the CFRP sheet adhered to the concrete substrate. Figure 16 presents a comparison between Load and vertical displacement relationship of the reference beams without strengthening (V1\_REF\_0 and V2\_REF\_0) and strengthened (V1\_REF\_CFRP and V2\_REF\_CFRP), with those exposed in laboratory environment (V1\_LAB\_CFRP and V2\_LAB\_CFRP) and to weathering (V1\_WEA\_CFRP and V2\_WEA\_CFRP), respectively.

For the yielding of the steel reinforcement of the strengthened beams maintained in laboratory environment or exposed to weathering, an average increase in load capacity of 4.6 and 9.6%, respectively, was observed in relation to the yielding of the steel in the beams without strengthening. For the maximum strength, an average increase in load capacity of 40.7 and 35.1% in the reference beams without strengthening (REF\_0), respectively, was observed. Analyzing the yielding of the steel reinforcement of the exposed beams and considering the results obtained in the tests of the strengthened reference beams (REF\_CFRP), it was noted that the elements maintained in laboratory environment and exposed to weathering presented a reduction of the average load of 12.6 and 8.4%, respectively. It was also observed that the maximum force recorded in the strengthened beams exposed to weathering suffered a reduction of 6.4 and 10.0%, respectively, when exposed to the environments previously presented. Finally, taking into account the maximum force recorded in the tests with the strengthened beams (Table 4), exposure to weather was more aggressive for the strengthening system, since its ultimate load was lower than that of the elements maintained in laboratory environment.

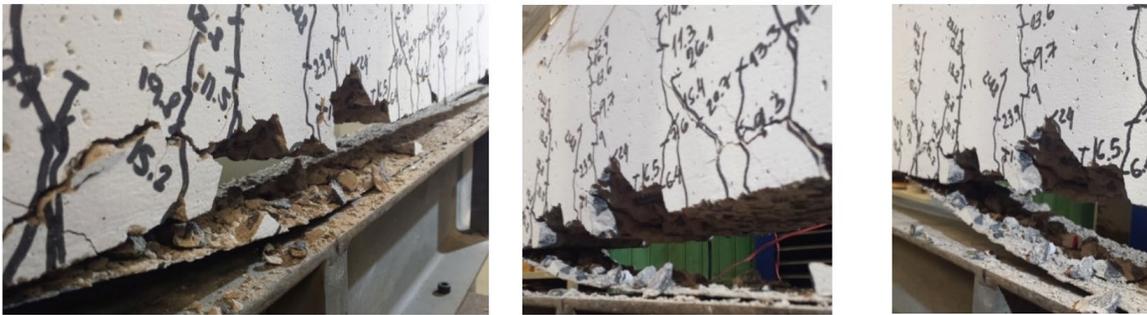
Figure 17. Verified failure mode on the strengthened beams

Concerning the failure load of the strengthened elements exposed to the environments, it was verified that there were no changes comparing it to the strengthened reference beams, presenting an almost fragile failure, preceded by pops and a lower load than verified for the strengthened reference beams, with the detachment of the CFRP sheet adhering to the concrete substrate (Figure 17).
