Tempered Bainite and Martensite Embrittlement in Microalloyed Steel for Forged Railroad Wheel to Heavy Haul Application

This research shows two new microalloyed steels with niobium (Nb) for railroad wheels (Nb1 and Nb2) applied on heavy haul transportation (load over 30 tons/axle). The steels have mixed microstructure composed of pearlite and bainite (finished wheel rim section), and another one composed of martensite with bainite (black wheel section removed on machining) obtained by continuous cooling quenching heat treatment followed by tempering. The bainitic and martensitic microstructure are sensitive to the temper embrittlement phenomenon; therefore, knowing the embrittlement temperature range of these steels is mandatory in order to avoid such an event in the tempering process. Charpy specimens were extracted from the rim of railroad wheels, austenitized (860 °C), quenched in water for four minutes, and tempered at different temperatures to obtain the embrittlement curve. Three materials were compared: AAR (Association of American Railroads) Class C steel with pearlitic microstructure (not sensitive to embrittlement), Nb1, and Nb2 microalloyed steels with martensitic, bain

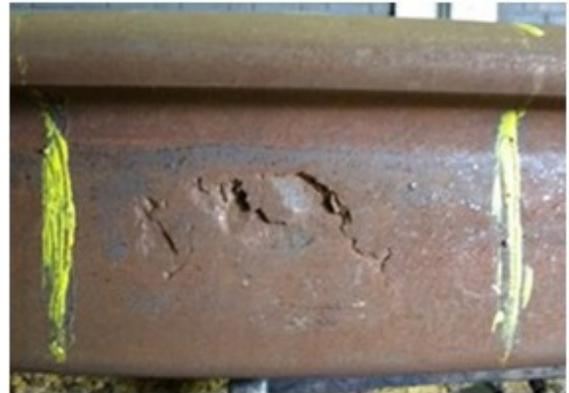
Figure 1. Wheel with shelling on the tread.

The major problem in railroad wheels applied on heavy haul transportation is shelling. It is characterized by plastic deformation on wheel tread regarding high wheel-rail contact load, which overtakes the wheel steel yield strength with tread material detachment, as observed in Figure 1⁴.

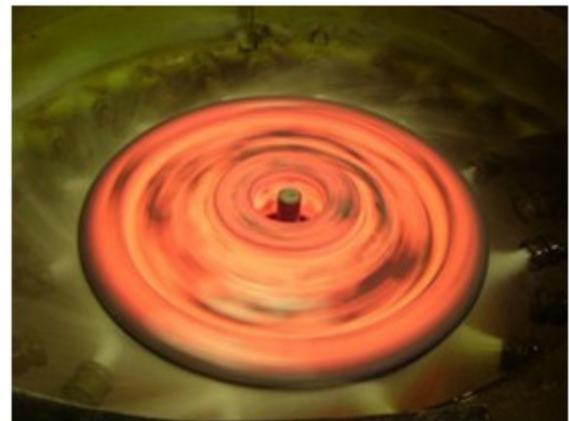
Figure 2. Railroad wheel heat treatment: water quenching on flange and tread on black condition.

The wheel heat treatment process involves austenitization, water quenching on the rim and flange, followed by tempering for stress relief, as shown in Figure 2. *The AAR specification does not stipulate the temperature range for wheel tempering*, because, so far, the wheel microstructure is fully pearlitic.

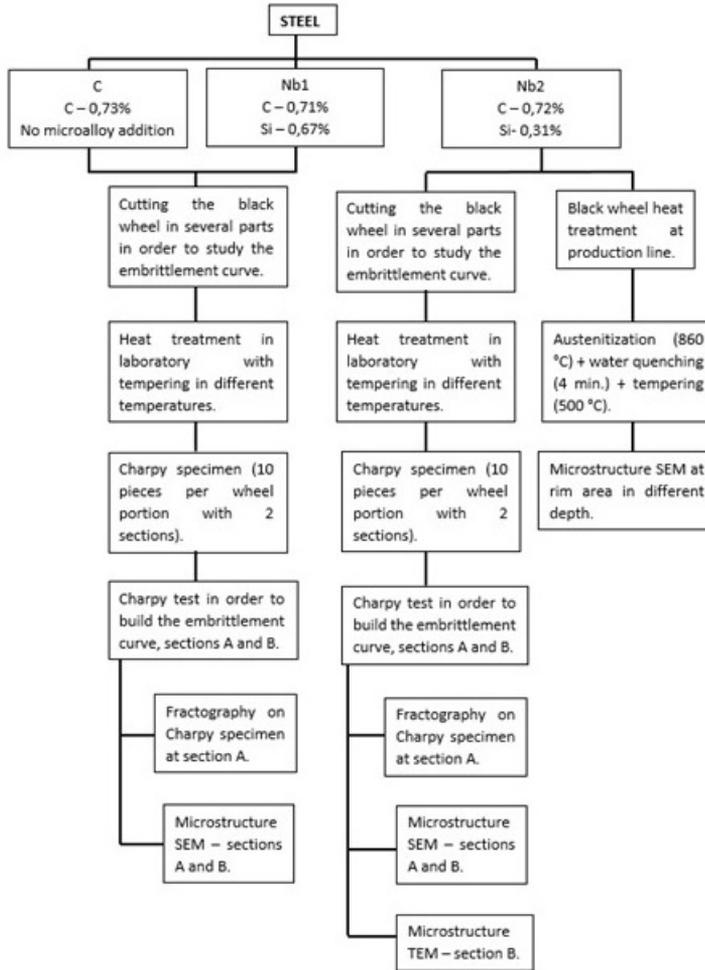
**Figure 3.** Research steps flowchart.

tempering in most cases with 500 °C, sometimes less. The flowchart in Figure 3 shows the research steps.

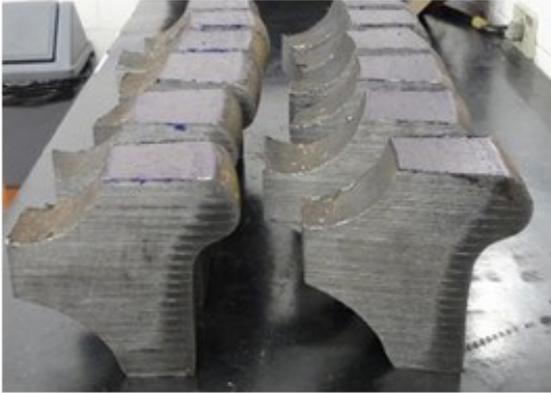
Figure 4. Wheel portions for heat treatment simulation.

The black wheel portions (Figure 4) were austenitized in a laboratory furnace at 860 °C with thermocouple control on wheel rim, followed by water quenching for 4 minutes in a water tank where 20 millimeters of the wheel rim were immersed into the water, as shown in Figures 5, 6A, and 6B.

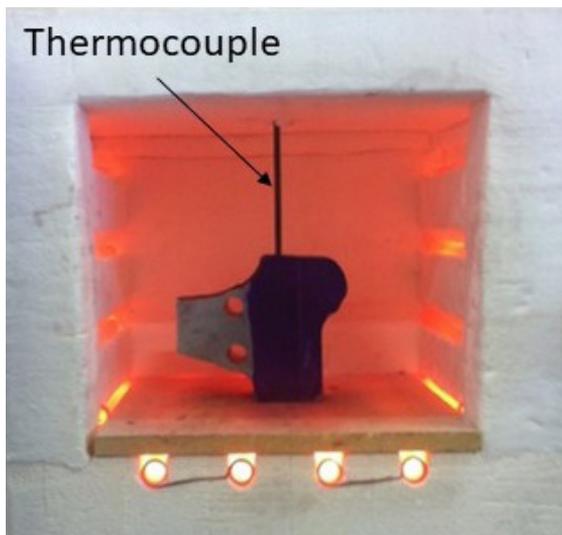
Figure 5. Laboratory furnace for austenitization with thermocouple on wheel rim.

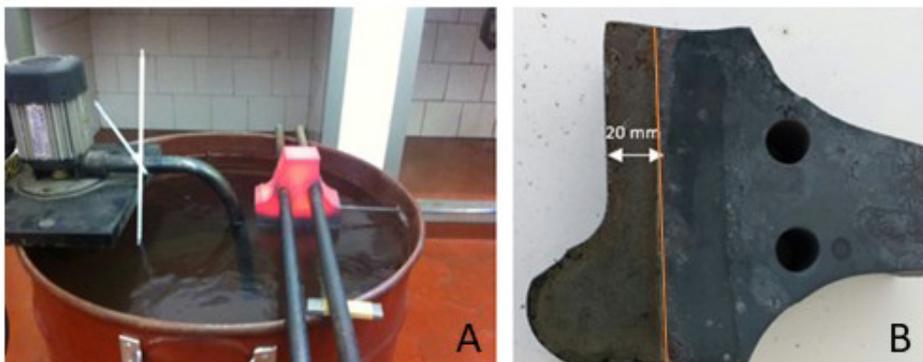
Figure 6. (A) Water tank to reproduce the quenching operation in wheel production line; (B) Quenched part of the rim (20 mm).

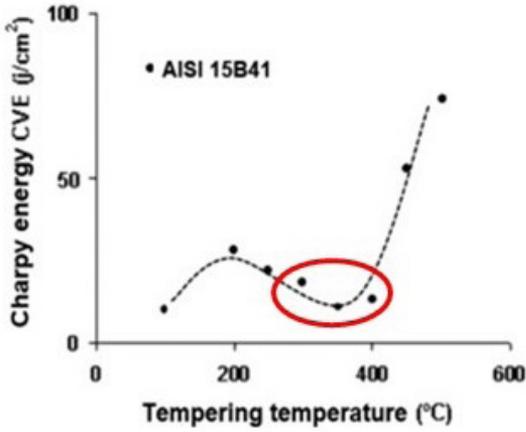
Figure 7. Temper embrittlement curve with impact energy reduction of TME range⁸.

The TBE and TME curves were determined by the Charpy tests taking different tempering temperatures into consideration. The impact energy on TBE/TME temperature ranges is reduced, according to the example for AISI 15B41 with boron, in this case for TME. The TBE and TME curves have the same shape, which represents the same phenomenon, as shown in Figure 7¹⁵.

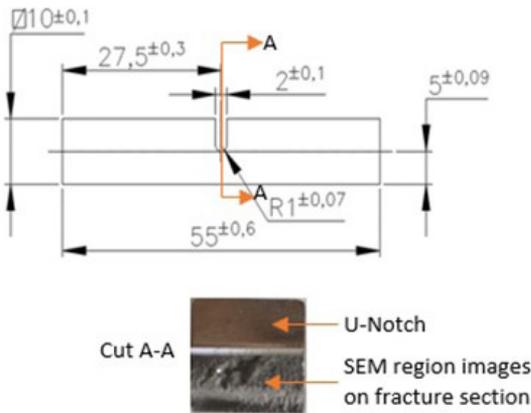
Figure 8. Charpy specimen dimensions in millimeters and SEM region images.

The Charpy impact tests were performed with a U-Notch specimen, according to ASTM A 370-12. Figure 8 presents the specimen dimension and SEM region images on fracture section, and Figure 9 its position on the wheel rim. Forged railway wheels have a 5 mm radius over metal on the tread (average). In service, wheel wear reaches, on average, 20 – 25 mm in tread radius, until they achieve the end of their useful life (Figure 10). This is the reason why Charpy's specimens were extracted in two sections - to cover the entire useful area of the wheel track. After heat treatment, the black wheel portions were identified with 10 Charpy specimens per portion (Figure 11), separated into two sections and five positions, as follows:

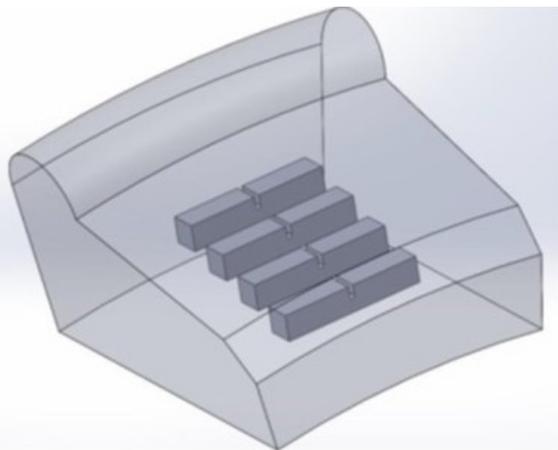
Figure 9. Charpy specimen position on the wheel rim.

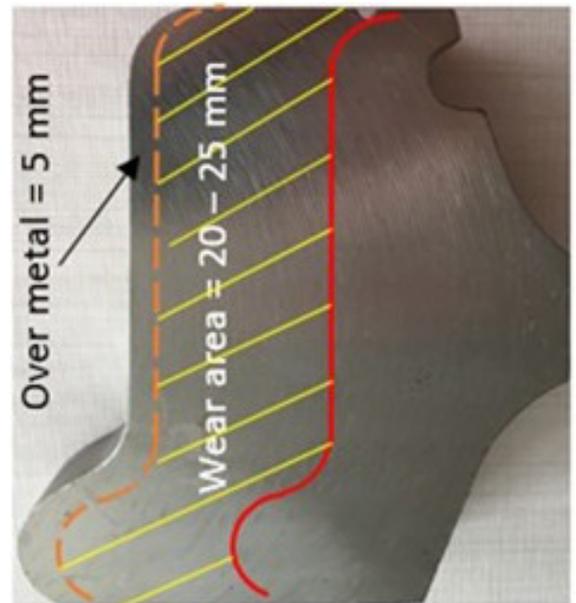
Figure 10. Forged wheel over metal and wear area dimension.

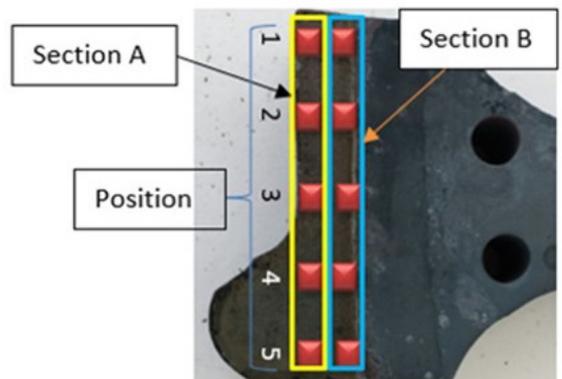
Figure 11. Location of the Charpy specimens on the wheel rim.

Section A: close to tread surface with predominant martensitic and bainitic microstructure, which are partially removed during final wheel machining operation. In this section it is not possible to isolate the effect of martensite and bainite on the temper embrittlement phenomenon on the embrittlement curve; therefore, the graphics on this section were identified as TME/TBE.

Section B: this section is more valuable for this research, as it remains on the finished wheel rim, with a pearlitic and bainitic microstructure that corresponds to useful wheel tread area.

The Charpy position and section indicated on following items are shown in Figure 11.

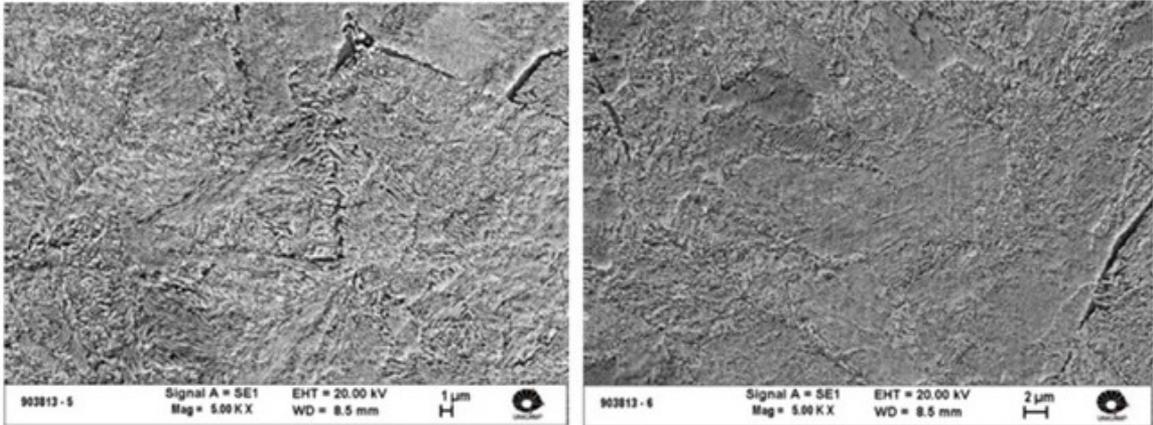
Figure 12. *Class C steel*: Pearlitic microstructures on Charpy specimens section A, 2% Nital per 10 s (left). Section B (right). No evidence of martensite or bainite in section A and B (SEM image).

Steel class C has a predominant pearlitic microstructure, which is not sensitive to TBE/ TME, as seen in Figure 12. The embrittlement curve is in Figure 13A (section A) and 13B (section B). The average Charpy impact test result increases continuously with tempering temperature (section A), which indicates the presence of martensite and/or bainite (not detected on microstructure analyses). Section B remains stable, without any embrittlement indication, which indicates only pearlite on the microstructure. The fractography of the

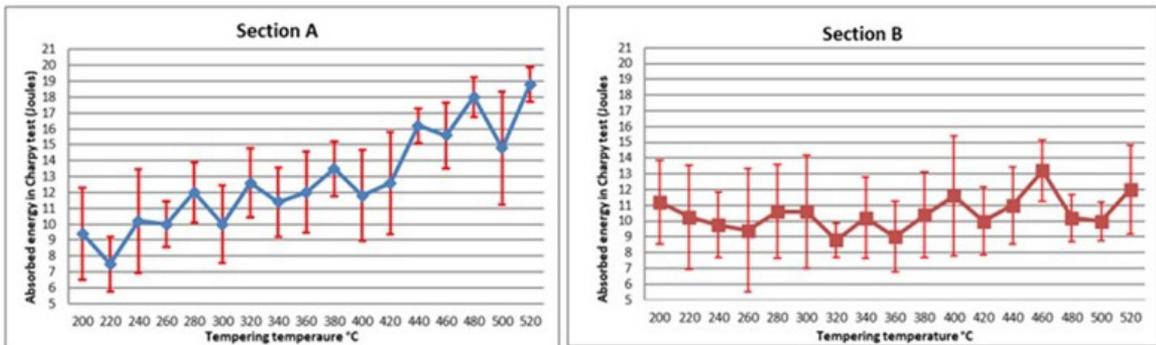
Figure 13. Section A: curve for *class C steel*; Section B: curve for *class C steel*.

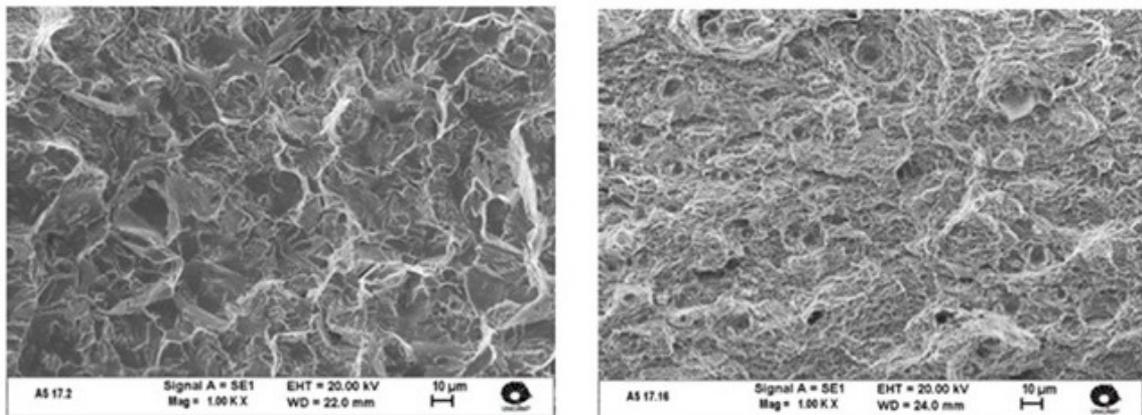
Figure 14. *Class C steel*: Fractography section A and position 5, tempered at 220 °C (6 Joules) with cleavage and areas with few dimples (left). Fractography section A and position 5, tempered at 500 °C (18 Joules) with dimples (right).

specimens show dimples and cleavage as fracture mechanism, as observed in Figure 14.

The fracture mechanisms are compatible with the pearlitic microstructure not sensitive to TBE/TME. The dimples

mechanism is characteristic of ductile fracture, having high plastic deformation during crack propagation with high energy absorption. Hence, the specimens with such feature have high Charpy results (18 J). On the other hand, as the cleavage is characteristic of fragile fracture, with low deformation and energy absorption with fast crack propagation, the Charpy results have low value (6 J)¹⁶.

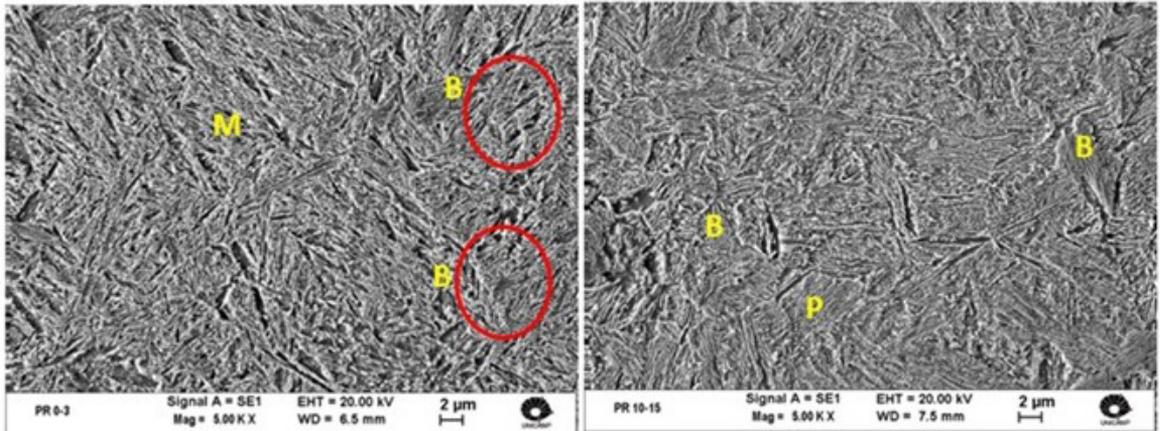
Figure 15. *Nb1 steel*: Martensitic and bainitic microstructure on section A, with 2% Nital per 10 s (left). Pearlitic and bainitic microstructure on section B with 2% Nital per 10 s (right). M = Martensite, B = Bainite, and P = Pearlite. The red circles show the bainite microstructure islands (SEM images).

Nb1 steel has a mixed microstructure with martensite and bainite on section A and pearlite with bainite in section B, both sensitive to TBE/TME, as shown in Figure 15. The embrittlement curves are in Figures 16A and 16B. The Charpy average test results reveal an embrittlement indication on sections A and B. The fractography has dimples and cleavage as fracture mechanism, as observed in Figure 17.

same tempering temperature for section B at position 4 (wheel flange area). This result is compatible with the microstructures in Figure 15, which shows martensite with bainite on section A, and bainite with pearlite on section B. There are different fracture mechanisms inside and outside the embrittlement area. Section A, inside the embrittlement area, presents cleavage as its main fracture mechanism on the specimen, at position

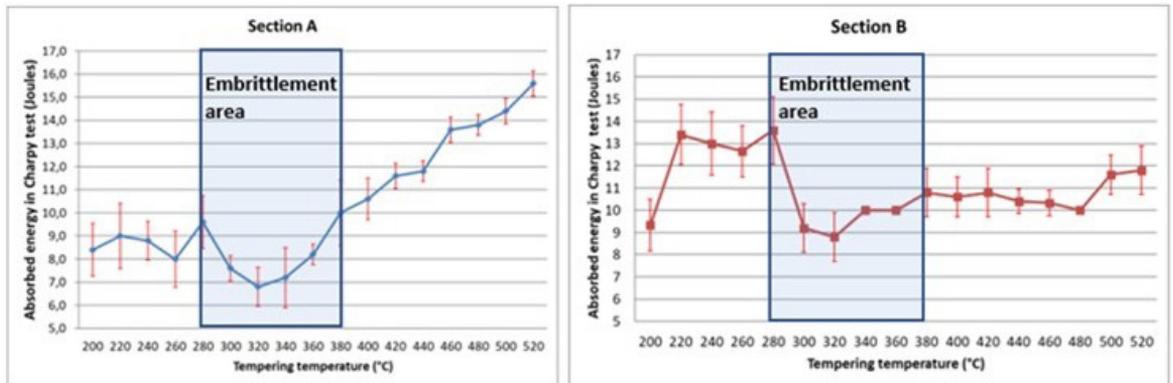
Figure 16. Section A: TBE/TME curve *Nb1 material*; Section B: TBE/TME curve *Nb1 material*.

Figures 16A and 16B show that the embrittlement temperature range for both sections is 280 – 380 °C. The minimum Charpy test result is 6 J on the specimen tempered at 320 °C on section A at position 1 (trad area), and 8 J at the

results. Dimples are characteristic of ductile fracture with high energy absorption, which is compatible with the graphics in Figures 16A and 16B. According to Horn¹⁷, TME is embrittlement from cementite precipitation during tempering. In high strength steels, this occurs at grain lath boundaries, aided by the thermal decomposition of interlath films of

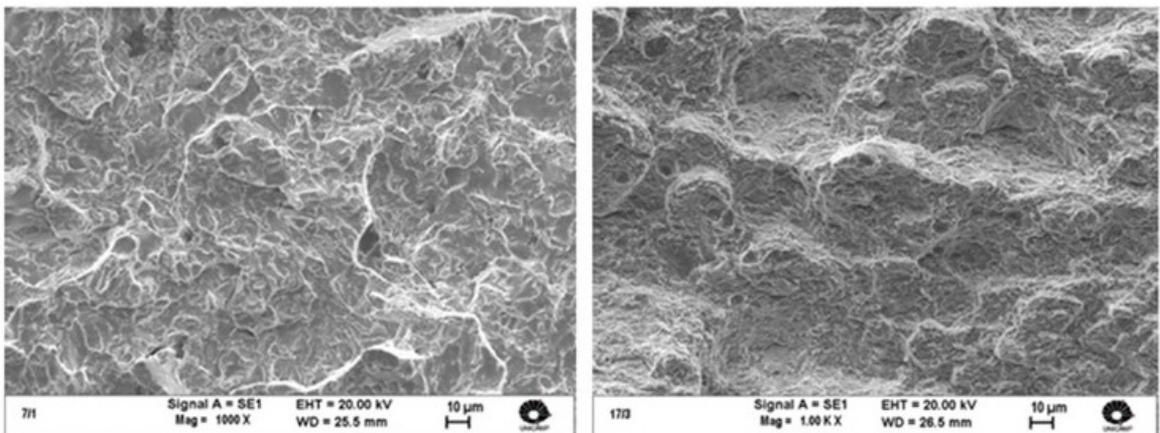
Figure 17. *Nb1 steel*: Fractography section A and position 1, tempered at 320 °C (6 Joules) with cleavage (left). Fractography section A position 3, tempered at 520 °C (16 Joules) with dimples (right) (SEM image).

1 (tread area), tempered at 320 °C (6 J), with the lowest and more critical Charpy results in terms of embrittlement. Cleavage is characteristic of fragile and transgranular fracture, compatible with the specimen inside the embrittlement area. Section A, outside the embrittlement area, fractography presents only dimples as fracture mechanism on the specimen, at position 3 (tread area), tempered at 520 °C (16 J), with higher Charpy

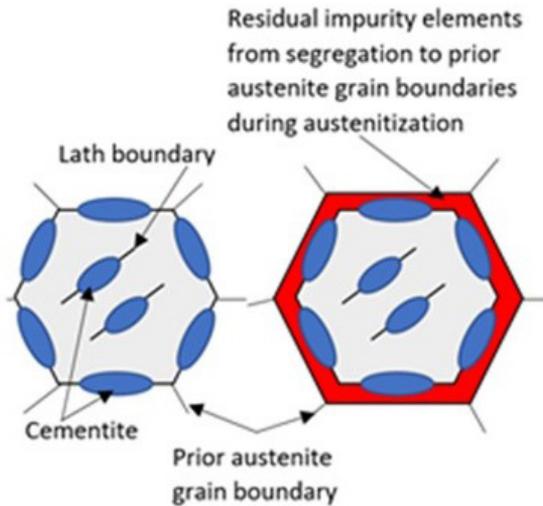
Figure 18. Transgranular cleavage fracture (left). Intergranular fracture (right)¹⁷.

boundary embrittlement, these impurities, such as P or S, are prone to segregate to prior grain boundaries during austenitization. In the embrittlement range, the combination of cementite precipitates and impurities in prior-austenite grain boundaries will lead to the lowest cohesion at grain boundary carbide/matrix interface, resulting in intergranular fracture, as observed in Figure 18¹⁷.

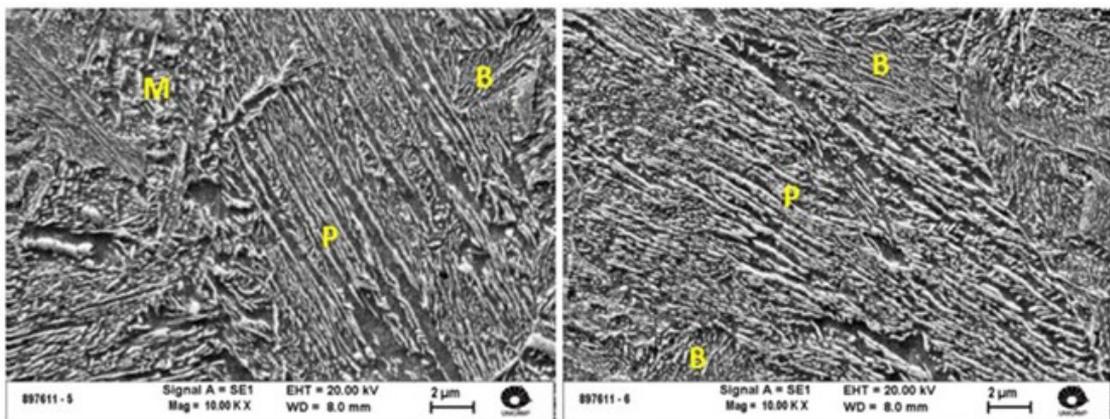
Figure 19. Nb2 steel: Martensitic, bainitic and pearlitic microstructure on section A with 2% Nital per 10 s (left). Pearlitic and bainitic microstructure on section B with 2% Nital per 10 s (right). M = Martensite, B = Bainite, and P = Pearlite (SEM image).

Nb2 steel also has a mixed microstructure with martensite, pearlite and bainite in section A, and another one with pearlite and bainite in section B, both sensitive to TBE/TME, as observed in Figure 19. The embrittlement curves are in Figures 20A and 20B. The average Charpy test results reveal an embrittlement area on sections A and B. The fractography has dimples and cleavage as fracture mechanism, as shown in Figure 21 for section A. For Nb2 steel, section B microstructure was also characterized in TEM for checking it in detail, Figures 22 and 23. The behavior of Nb2 steel was similar to that of Nb1, and the embrittlement range was between 280 - 360 °C. The lowest impact test result on section A was 7 J at 300 °C, position 3 (tread area), less than 320 °C observed for Nb1 steel. The

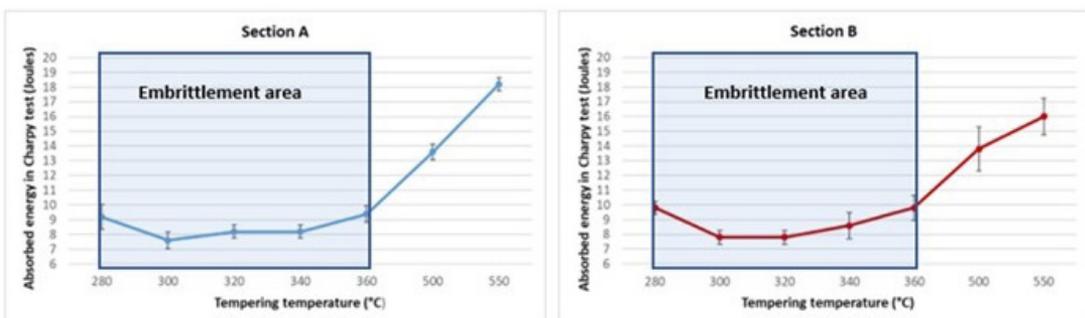
Figure 20. Section A: TBE/TME curve Nb2 steel; Section B: TBE/TME curve Nb2 steel.

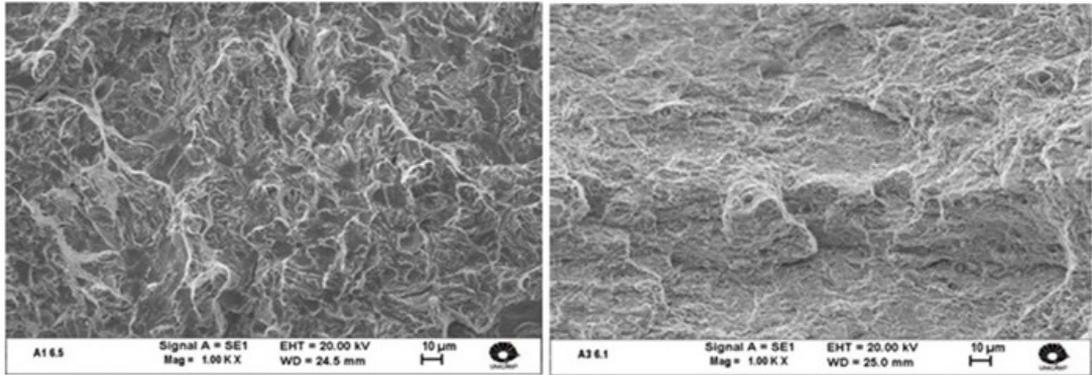
Figure 21. *Nb2 steel*: Fractography section A and position 3, tempered at 300 °C (7 Joules) with cleavage (left). Fractography section A and position 1, tempered at 500 °C (14 Joules) with dimples (right) (SEM image).

The fractography analyses shows the same behavior of Nb1 steel, that is, cleavage inside the embrittlement area and dimples out of it.

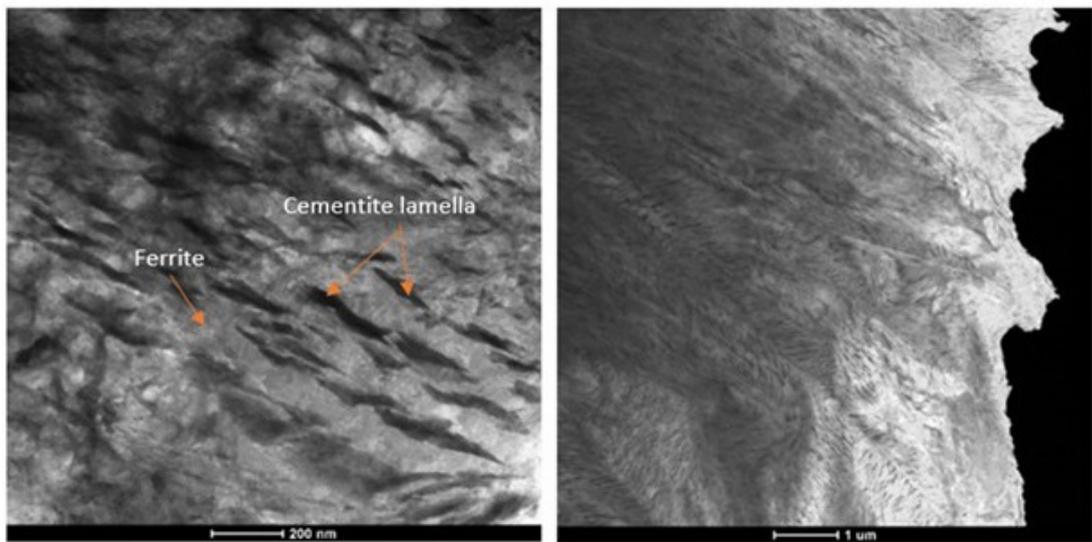
Figure 22. *Nb2 steel*: TEM images of Charpy specimens in section B and position 4 (wheel flange area), tempered at 300 °C (7J). Minimum Charpy result inside the embrittlement area. Microstructure is fully bainite (B).

The TEM analyses showed only bainitic microstructure on the specimen tempered at 300 °C inside the embrittlement area. For the specimen tempered at 500 °C – the typical tempering temperature in railroad wheel manufacturing process – the microstructure was pearlitic and bainitic. Pearlite has more toughness than bainite, which could help increase the toughness and Charpy test results, as well as avoid embrittlement.

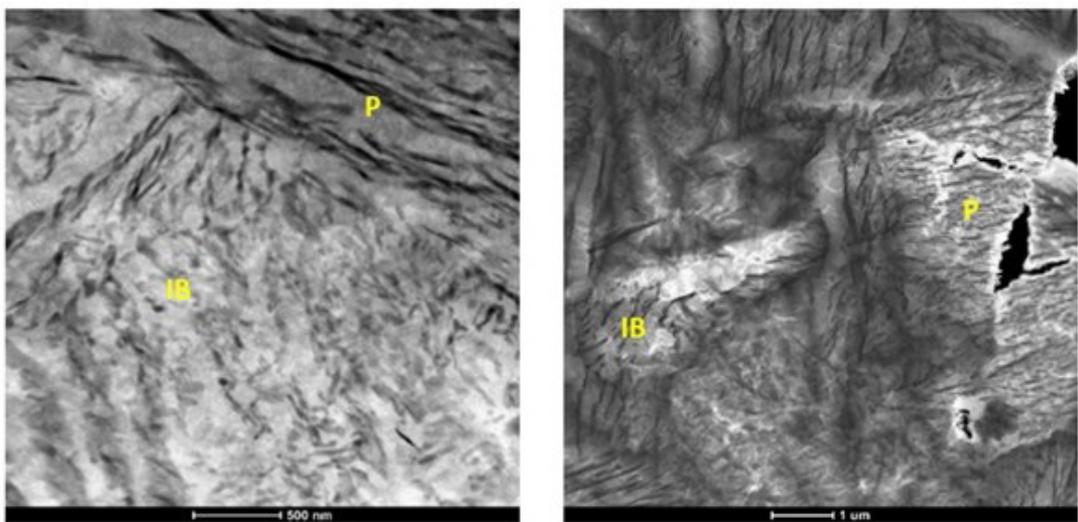
Figure 23. *Nb2 steel*: TEM images of Charpy specimens in section B and position 1 (out of flange area), tempered at 500 °C (14J). Maximum Charpy result out of embrittlement area. Microstructure is inferior bainite (IB) and pearlite (P).

- The microstructure detected on black wheel, heat treated at manufacturing line, is similar to the one on the Charpy test specimen, both tempered with 500 °C (Figure 23). This validates the heat treatment process carried out in the laboratory, which reproduced the same conditions found in the wheel manufacturing line.

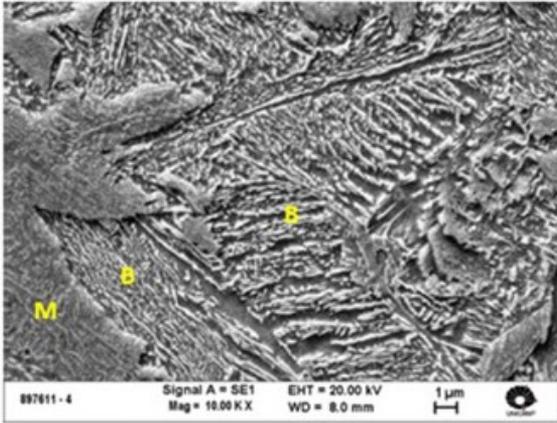
Figure 24. Nb2 steel: Black wheel 5 mm deep with martensite and bainite. B = bainite and M = martensite (SEM image).

The black wheel heat treated on manufacturing line, with the same process used on laboratory simulation, presented a similar microstructure in comparison with the Charpy specimen heat treated in laboratory. The following microstructures 5 mm deep from wheel tread (middle of section A) and 15 mm deep (middle of section B), are on Figures 24 and 25.

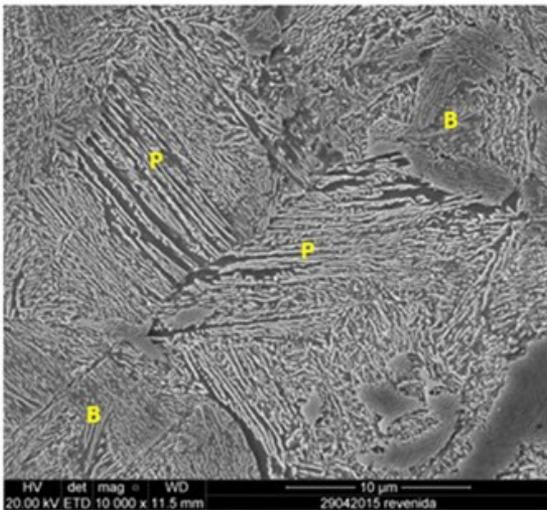
Figure 25. Nb2 steel: Black wheel 15 mm deep with pearlite and bainite. B = bainite and P = pearlite (SEM image).
