Non-destructive ultrasonic tomography for concrete pavement evaluation: signal processing and image analysis of crucial parameters

L. S. SALLES^a
lucio.salles@usp.br

J. T. BALBO^a
jotbalbo@usp.br

L. KHAZANOVICH^b
khaza001@umn.edu

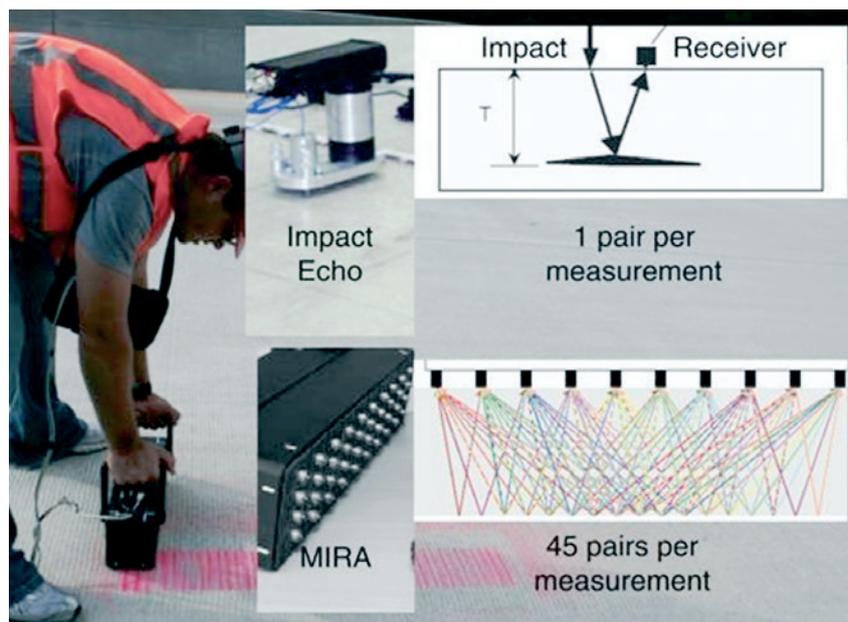
Figure 1
Impact echo versus MIRA (Hoegh et al., 2012[2])

To overcome these problems, dry contact point transducers with the ability to send shear waves of low frequency (55 kHz) allowing the effective penetration at greater depths were created. MIRA, one example of such device, has 45 pairs of transducers and receivers. A survey takes less than 2 seconds and results in a 2D image area. The great amount of data is interesting so that there is a perfect image compilation, especially for very heterogeneous materials. Low frequency waves (typically 50 kHz) allow the signal to navigate through the concrete despite the material heterogeneous characteristics. The signals are always reflected when an acoustic discontinuity takes place, which is defined as the interface between a medium wherein the impedance of the following medium is different. The acoustic impedance is a material property and is the product of sound velocity and material density (Vancura et al. [21]). Figure 1 shows the device and compares its operating principle to the impact echo.

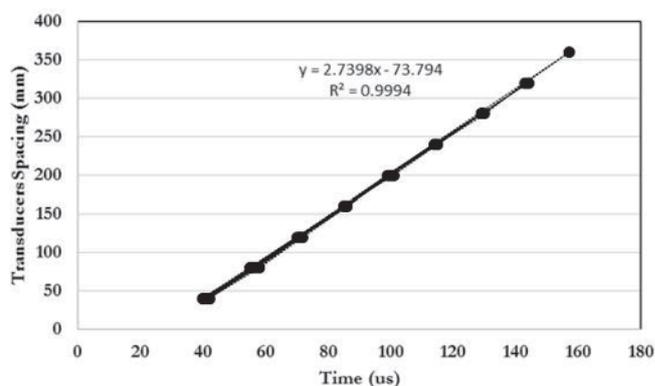
Figure 2 Shear wave velocity determination for the ultra-thin whitetopping

When plotting all $x_{i,j}$ values and $t_{i,j}$ the linear trend line shows the actual shear wave velocity. The delay time can be removed from all points because it is a constant for all transducers. Figure 2 shows an example of this calculation. In this case the shear wave velocity is 2.739 m/ms.

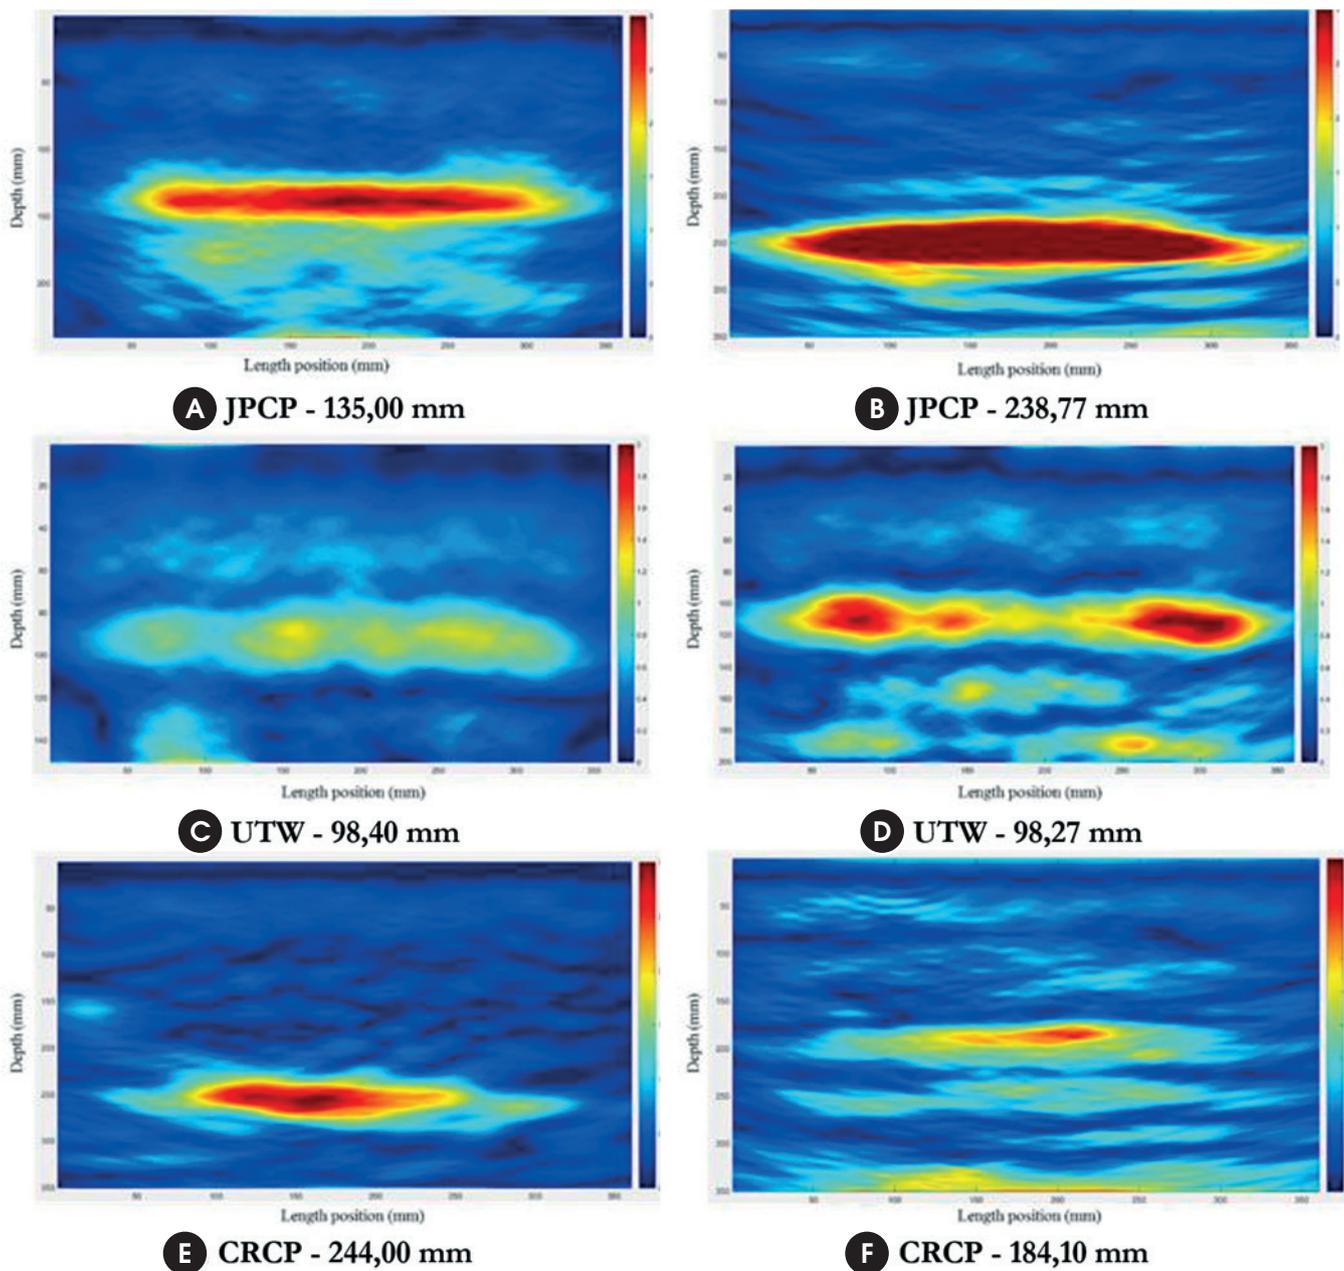
Thickness surveys reconstructions in concrete slabs with designed thickness of (a) 150 mm; (b) 250 mm; (c) and (d) 100 mm; and (e) and (f) 240 mm

have different properties, it is expected that the shear wave velocity in these mediums will be different. The simplicity of pavement structure geometry also helps in the identification of such reflections. Figure 3 shows some cases of B-Scans for thickness determination. In Figure 3, the delineation between slab and base is represented by a reflection line differing from the B-scan remain. The most perfect representation of the interface between slab and base would be a continuous line as shown by Figure 3b. However, several factors such as calibration, concrete heterogeneity, micro cracks and slab-base adhesion can modify the signal shape and strength. The signal attenuation is clear in Figures 3c and 3d for the WTU. Note that the reflection intensity (bar located on the right side of the B-Scans) has a maximum peak of 2 for the WTU, while for the JPCP the peak value is the standard 3. Reflections on a smaller scale show more details of the B-SCAN. This scale increase is necessary to better visualize the interface line. It is assumed that due to the WTU slab being completely adhered to the base layer (asphalt), the ultrasound signal suffers less attenuation than in other cases where the concrete slab is not bounded to the base. Most WTU B-scans show cases similar to Figure 3c, with only three cases having a greater interface reflection as in Figure 3d. This may be an indication of adhesion loss in the latter case. MIRA was applied to identify adhesion loss between two asphalt layers with (Hoegh et al. [29]). In the case of Figure 3f (also with enlarged reflectivity scale of 2), it is possible to visualize a higher level of noise above the interface. These attenuations can result from minor distresses, segregation of coarse aggregates or problems in measurement calibration. However, for all cases it was possible to measure the highest value of the reflection signal disclosing its depth. This value (located below each B-Scan) is considered the thickness of the each slab. Reflections below the slab/base interface should not be considered because the device calibration only takes into account the first layer (concrete) being of little use for the analysis of layers below it.

The WTU thickness is substantially equal to the designed thickness. However, for the JPCP and especially for the CRCP, major variations were found. The first had a slab thickness about 15 mm thinner than the project. The CRCP presents a case (Figure 3e) slightly thicker than the project thickness and other well below it (Figure 3f). Specimens were removed in both positions (Figure 4) with a thickness of 240.6 for the first case and 190.1 for the second

signal. Table 1 shows the HTI value for reconstructions presented in Figures 3, 5 and 6. Note that the cases presented in Figure 6 (distresses) present HTI greater than 90 as expected. Values around 90 may be indicative of incipient distresses demonstrating the HTI ability to predict distresses not yet developed to the surface.

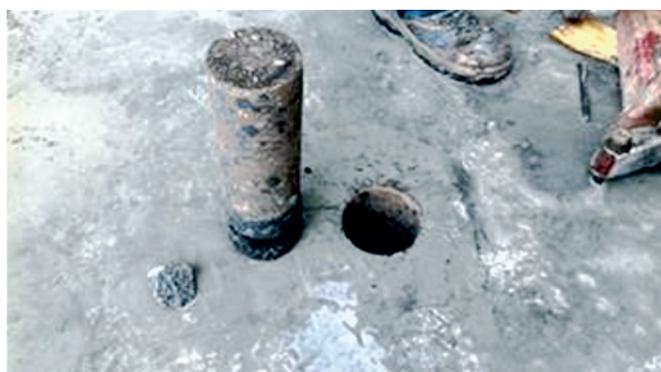
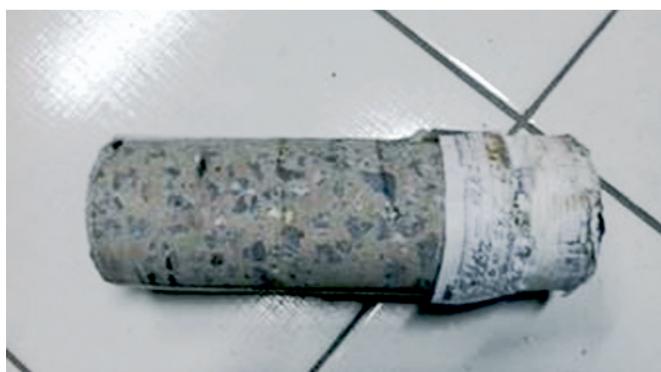
Figure 4
Forensic extraction of CRCP slab specimen

case. The forensic extractions confirm the method accuracy showing error variation around 5 mm, consistent with that found in the technical literature (Edwards [30]).

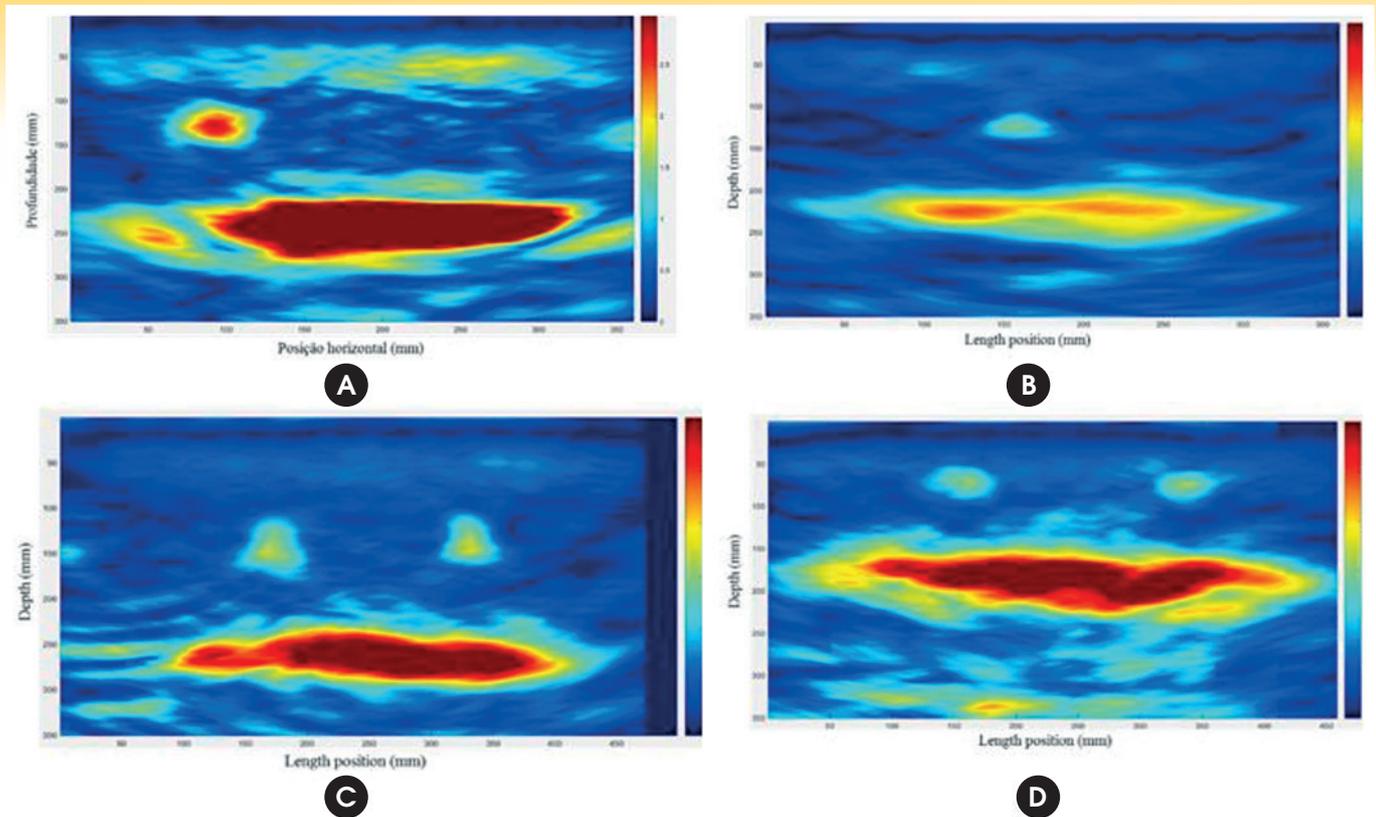
Figure 5
CRCP reinforcement reconstructions

Alterations in the acoustic impedance within the material are automatically recorded by the analytical process described above. As the bar's geometry is commonly known, the reinforcement identification is quite simple. Figure 5 shows B-Scans reconstructions of CRCP reinforcement. Typically, the signal amplitude on the interface between slab and base is greater than the reinforcement amplitude explaining the former greater level of reflection. Interface reflection breaks (Figure b) or weakening (Figures 5b and 5c) are also expected right below the reinforcement due to loss or attenuation of the ultrasonic signal in that region. This evaluation is important to verify important aspects of the structure as reinforcement existence, depth and spacing. For the CRCP, the investigation found that in several cases the reinforcement was positioned below the steel depth indicated by the project, showing another constructive problem in this experimental section. The steel depth/thickness ratio was designed at 0.42, however, thickness deficiencies coupled with steel bars misplacement made the as built ratio to be 0.55.

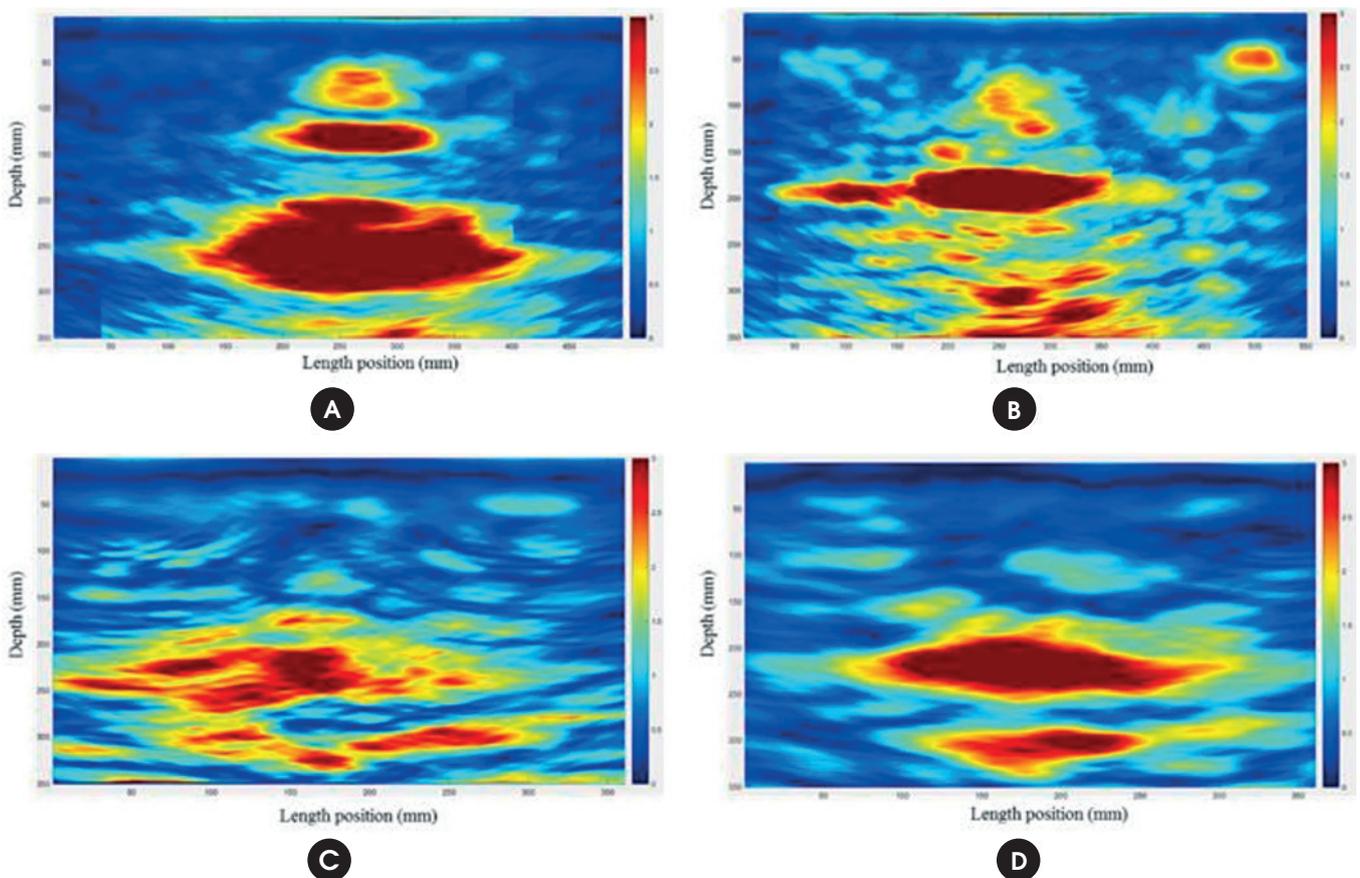
Figure 6
Reconstruction of distress locations presenting (a) and (b) cracks; and (c) and (d) ASR

distresses reconstructions showed unexpected reflections through the concrete. Again, reflections below the interface are the result of the calibration material referent only to the first layer. However, the distress presence in the concrete makes these reflections more obvious in these cases.

Due to the unpredictable shape and depth of concrete pavement distresses, some reconstructions are not as clear as the ones presented in Figure 6. In order to address this issue, an ultrasonic signal quality index, the Hilbert Transform Indicator (HTI), was created. Figure 7 presents two cases on the same slab with their respective ultrasonic signals. The first case (Figure 7a) corresponds to a concrete without degradation where the ultrasonic signal has little amplitude variation. In the other hand, in Figure 7b (location with surface indication of ASR), it is possible to observe several amplitude peaks indicating changes of material property (distress). The HTI values were 82 for the first case and 112 for the latter. It is also interesting to note that the mere B-Scan reconstruction would not necessarily inform about the distress presence as few mid-slab reflections show up in the second case, stressing the importance of a direct analysis of the ultrasonic

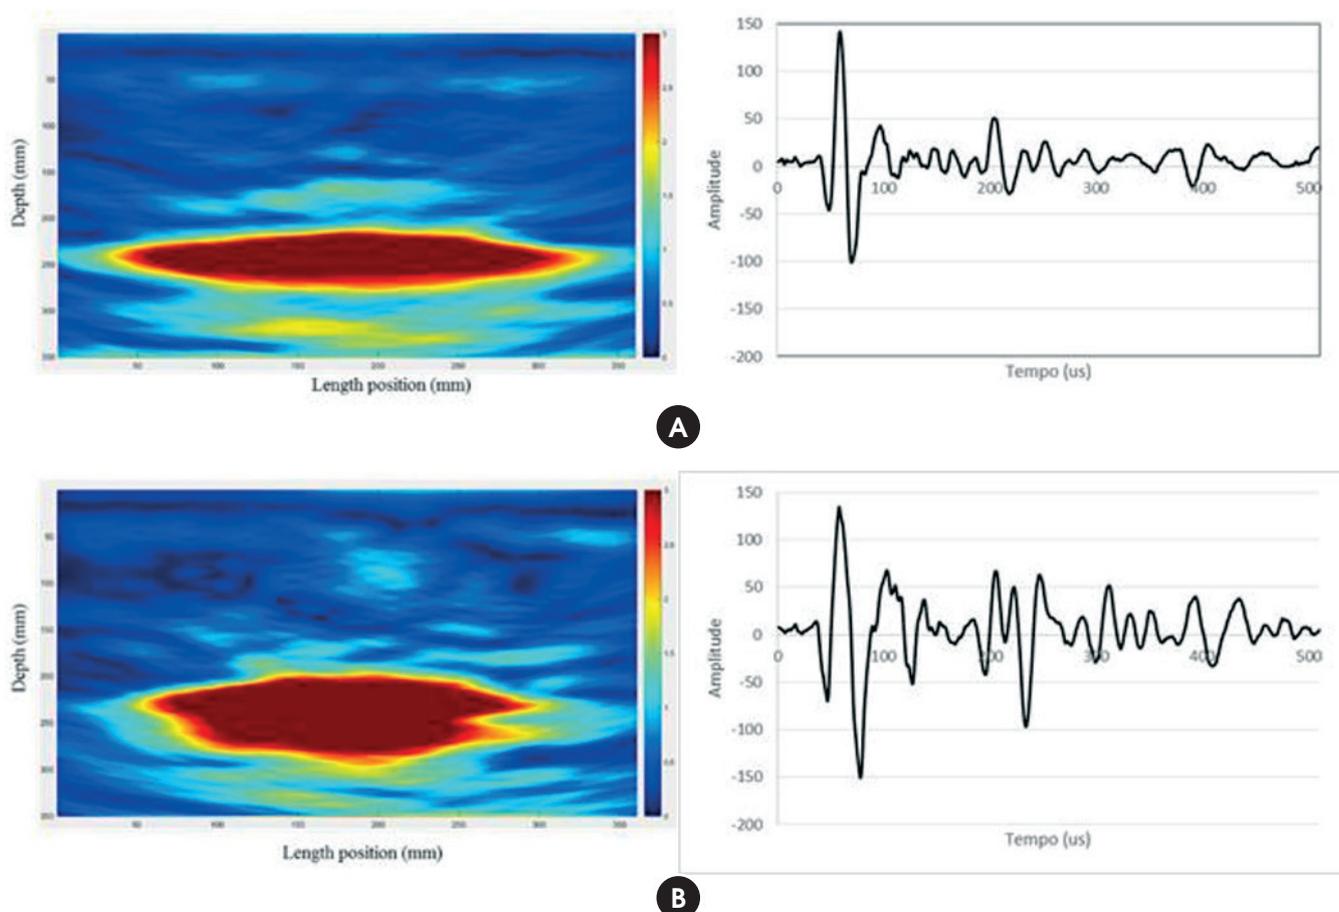
Figure 7
Differences in signal amplitude for sound (a) and damaged (b) concrete
