Experimental study of RC beams strengthened for bending by reinforced grout layer and connectors

Estudo experimental em vigas de CA reforçadas à flexão por encamisamento e conectores

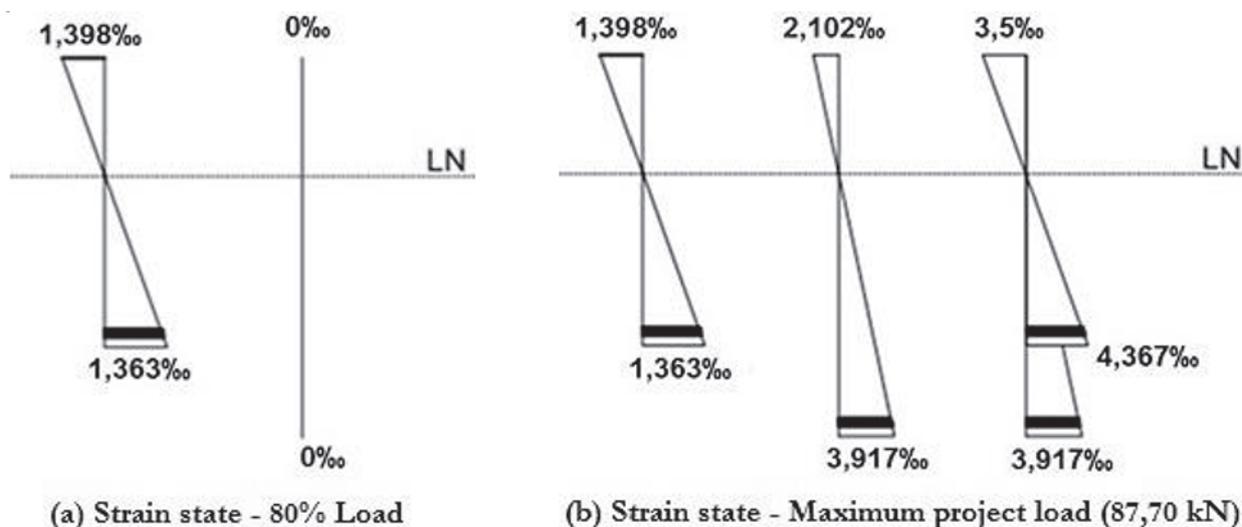
Figure 2
Reinforced section strain state

The original beam section, after having reduced the weight, has not behavior at Ultimate Limit State (ULS), and the new position of the "x" was obtained through the equations of static equilibrium and deformations. In Figure 2, deformation conditions of the section of the original beam with load $F_d = 49.45 \text{ kN}$ (ULS) or $F_k = 35.32 \text{ kN}$ and for the maximum design load after the reinforcement (87.70 kN) are shown, indicating that the failure is likely to occur by shearing. The tension in the concrete for the section submitted to 80% of the design load (34 kN) was obtained according to item 8.2.10.1 of NBR 6118 [7]. The tension in the grout was obtained according to item 8.2.10.1 of NBR 6118 [7], adopting behavior like concrete, as it is cementitious material. A reduction factor of 0.85 (Rüsch effect) was adopted to obtain the grout tension due to the lack of knowledge about this effect in the material.

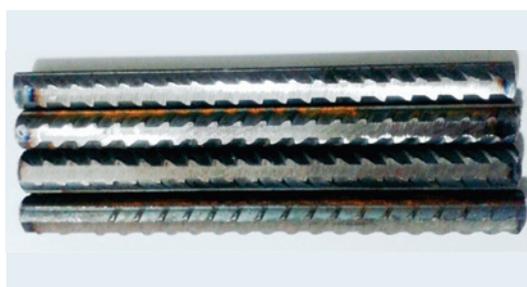
a) Connectors (front)

b) Connectors positioned in a 10 cm spacing

Figure 4
Details of the connectors

The steel connectors were placed in view of a possible partial failure in the bond between concrete and grout. Simple connectors were designed and can be made with common construction steel bars. Thus, they were produced using steel bars of $\phi 10$ mm, having 15 cm of length, being in part of the surface were removed area of the doughs for bonding in the substrate. They were positioned to the partially loaded beams and, later, the reinforcing, the formworks and the grout were placed (Figure 4).
