Bending reinforced concrete beams with glass fiber reinforced polymer bars: an experimental analysis

Tales Viebrantz Fernandes^a Aline Ribeiro Paliga^a Charlei Marcelo Paliga^b ^aUnivesidade Federal de Pelotas – UFPel, Centro de Engenharias, Pelotas, RS, Brasil^bUnivesidade Federal de Pelotas – UFPel, Faculdade de Arquitetura e Urbanismo, Pelotas, RS, Brasil

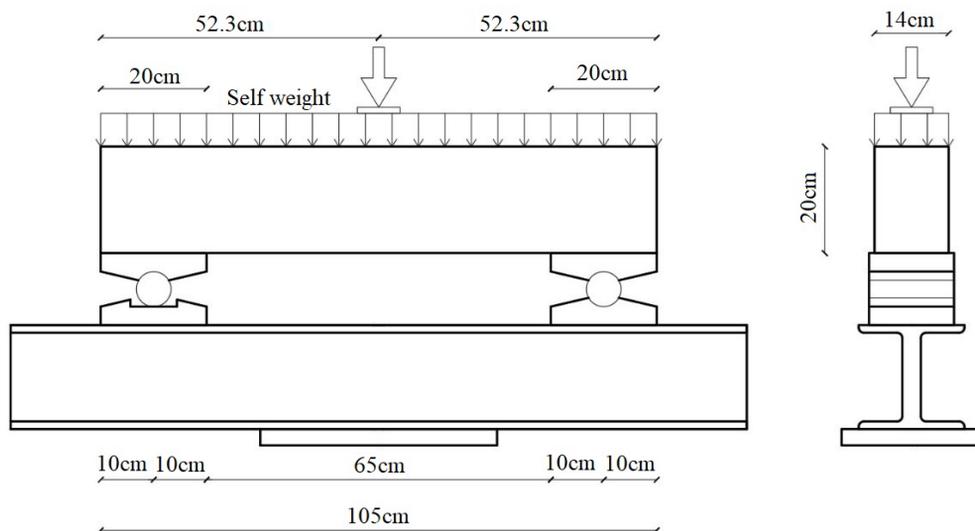
Figure 1. Diagram of the loads of the beams.

Six reinforced concrete beams were designed and tested for different load magnitudes. The point loads applied to the center chosen to perform the flexural design were 23.5 kN, 37.5 kN, and 57 kN, in addition to the beam's self-weight. Thus, two beams were designed for each of these loads, one reinforced with steel bars, designed according to NBR 6118 [11], and the other with GFRP bars, designed according to American standard ACI 440.1R-15 [12]. The dimensions of the beams for all situations were set at 14 x 20 x 105 cm (width x height x length), and their details followed the recommendations of each standard. Figure 1 presents the schematic drawing of how the experimental tests and the application of the loads were carried out.

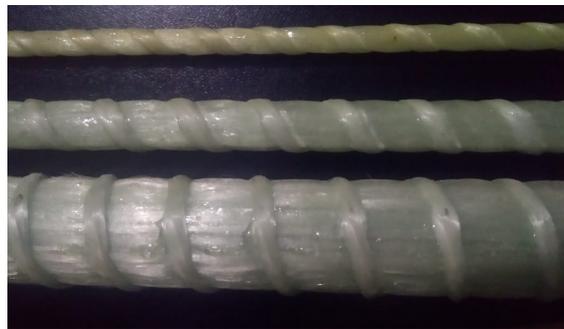
Figure 2. Ribbed GFRP bars.

The flexural design and detailing of the beams reinforced with GFRP bars, VV23, VV37, and VV57, was carried out according to the American standard ACI 440.1R-15 [12] – Guide for the Design and Construction of Concrete Reinforced with FRP Bars. The properties of the GFRP bars were provided by the manufacturer and can be seen in Table 3. Figure 2 shows the GFRP bars, with diameters of 6 mm, 12 mm and 25 mm.

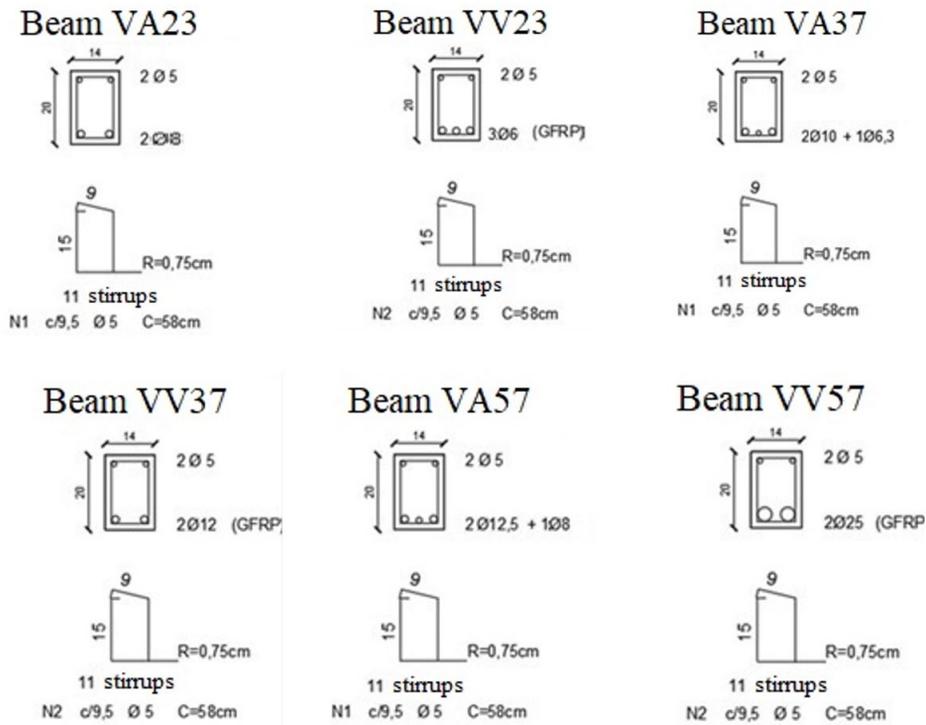
Figure 3. Transversal detailing of the tested beams.

Table 4 presents the areas of steel and GFRP calculated to absorb the tensile stress caused by the bending of the beams, and Figure 3 brings the details of the beams. Figure 4 shows the completed reinforcement of beams VV37 and VA37. After concreting the beams, they were left in an appropriate place in the laboratory, with wet curing by sprinkling water during the first days, and then they were ruptured after 28 days.

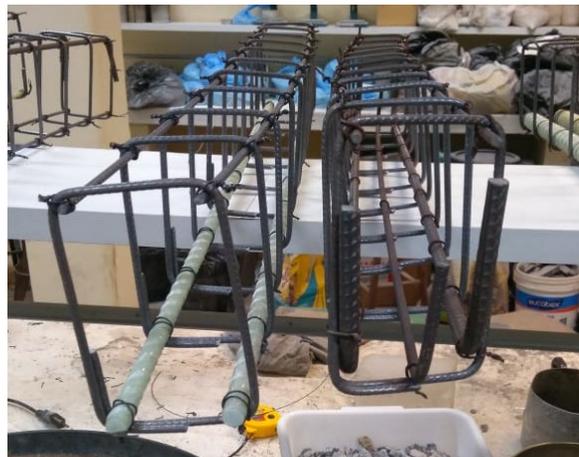
Figure 4. Reinforcement of beams VV37 and VA37.

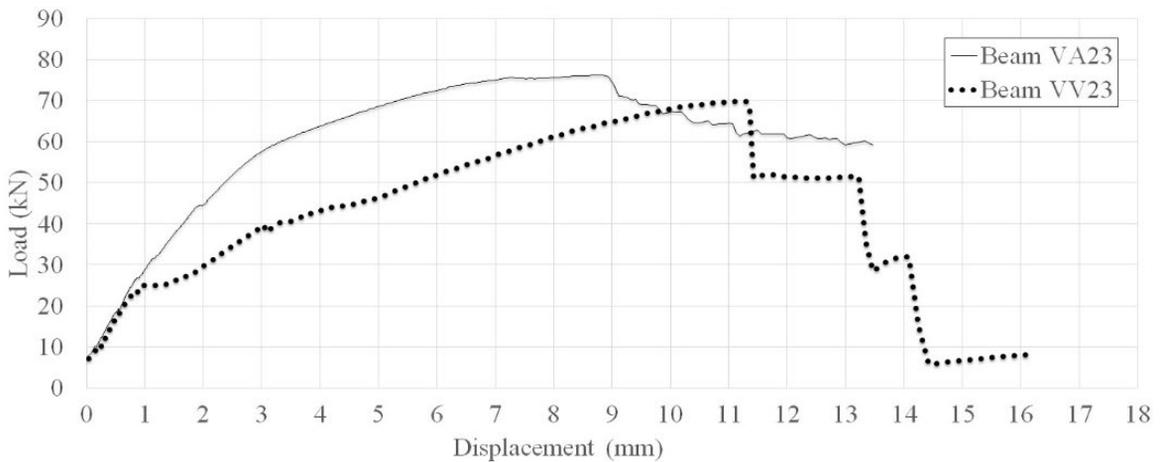
Figure 5. Load vs displacement curves of the 23.5 kN beams.

The load x displacement curves obtained in the tests of beams VA23 and VV23 are shown in Figure 5. With a load of approximately 20 kN, beam VA23 began to crack, after that, appeared the next two cracks with loads of 30 kN and 45 kN, caused by bending. After that, the cracking increased until the reinforcement began to yield, with a load of approximately 60 kN. The maximum load supported by this beam was 76.32 kN, and the corresponding displacement was 8.62 mm. This rupture happened smoothly, since steel was in plastic regime.

For beam VV23, cracks began to appear with a load of 24.5 kN, as can be clearly seen in Figure 5. The cracks were limited to the lower part of the beam, in the direction of the neutral line, presenting a more visible opening close to the bottom endpoint. Flexural cracks can be seen in Figure 6. As the load increased, the beam ruptured abruptly, which is consistent with the brittle linear behavior of the GFRP bars. The mode of failure of the concrete beam occurred due to the tensile rupture of the GFRP bars, as expected, and according to the calculation for this beam, in which the bars were designed considering their tensile strength. This mode of failure of the concrete beam is the one that uses the GFRP bars to their maximum, however, it is the form that requires the greatest care, due to the brittle form of rupture. The maximum load supported by the beam was 69.8 kN for an 11.3 mm deflection. At that moment, there was a rupture of one of the GFRP bars, shown in the graph in Figure 5 by the abrupt drop in the load to maintain the displacement rate constant. In addition, it is possible to observe the rupture of the other two bars in the displacements around 13.2 mm and 14 mm. Figure 7 shows the ruptured bars, through the crack that caused the beam to break.

Analyzing the graphs presented in Figure 5, the steel-reinforced beam presented a greater maximum load and displacement corresponding to the smaller load when compared to the beam reinforced with GFRP. In percentage terms, beam VA23 supported a load 9.3% higher than beam VV23, that is, 76.32 kN and 69.8 kN, respectively. In addition, the GFRP beam had a displacement 26% greater than the beam reinforced with steel against tension, at its maximum load. Also, it should be noted that until they started to crack, the two beams presented the same stiffness. This behavior can be explained by the fact that the tensile stress is absorbed by the concrete, with the collaboration of the tension reinforcement starting after the cracking. After that, for the same load level, beam VV23 showed greater displacements, a fact that can be easily explained by the lower longitudinal elastic modulus of the GFRP bars when compared to the same property in steel, 48 GPa and 210 GPa, respectively. In addition, after cracking, the behavior of the GFRP-reinforced beam is practically linear until it reaches its maximum load. This behavior is given by the linearity of the stress x strain curve of the bars made of composite materials.

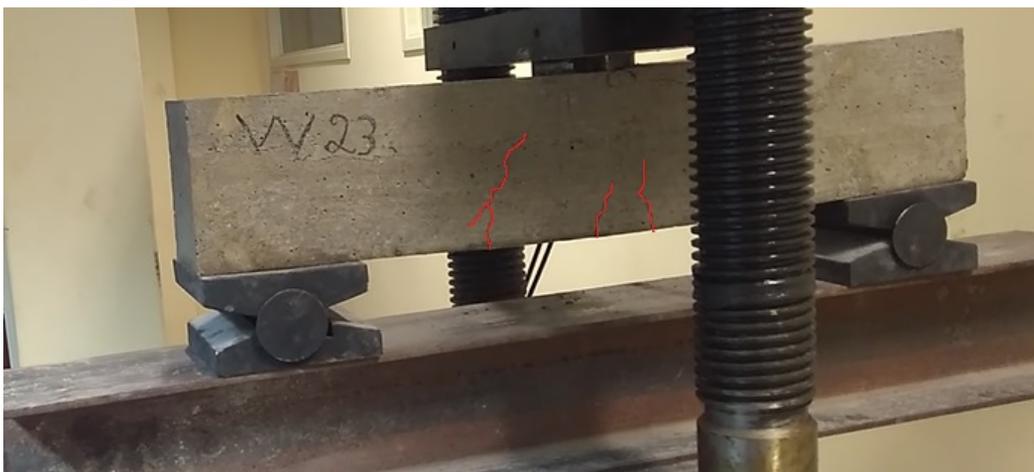
Figure 6. Cracks observed in the VV23 beam.

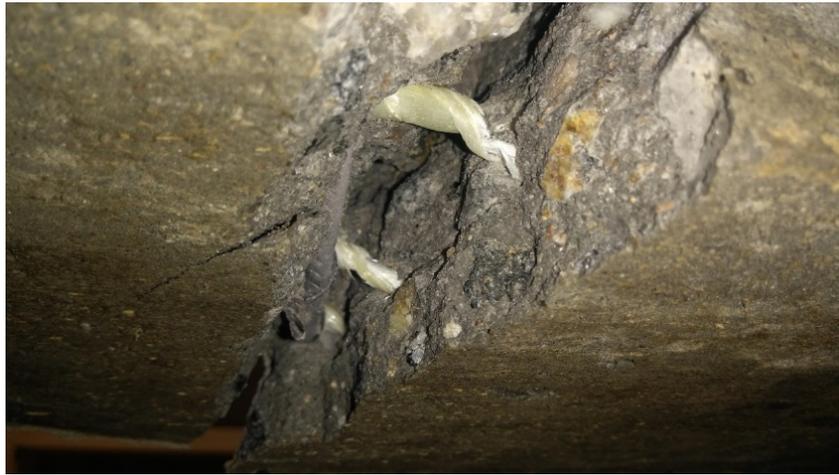
Figure 7. Rupture of the GFRP bars of the VV23.

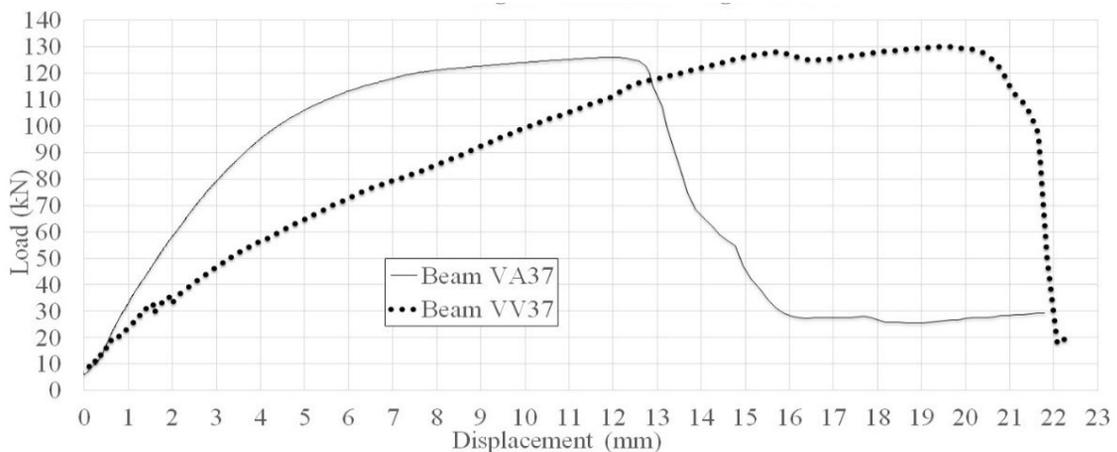
Figure 8. Load vs displacement curves of the 37.5 kN beams.

The load x displacement curves obtained during the tests with beams VA37 and VV37 are shown in Figure 8.

When analyzing Figure 8, which shows the overlapped curves of the steel-reinforced beam, VA37, and the GFRP-reinforced beam, VV37, it can be observed that the GFRP beam presented a higher load, about 3% greater. Also, the deflection found was 64% higher for the maximum load of the GFRP beam, when compared to the displacement of the maximum load of the steel beam. The same behavior was obtained for the 23.5 kN beams, due to the elastic modulus of the GFRP bars being lower than that of steel bars.

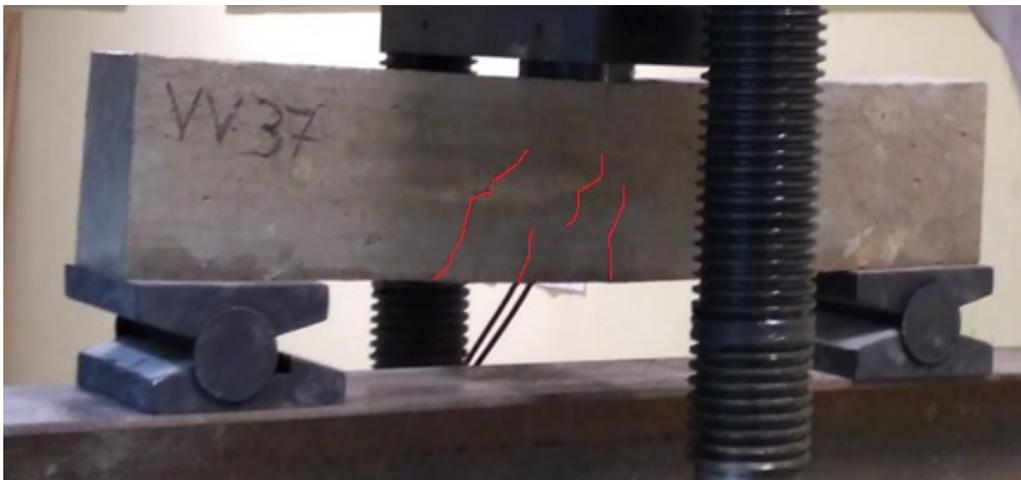
Figure 9. Cracks observed in beam VV37.

The maximum load supported by beam VV37 was 130.13 kN, with a corresponding deflection of 19.6 mm. Figure 9 shows the cracks that appeared during the test, the first of which appeared with a load of approximately 20 kN, as can be seen in Figure 8 through the disturbance in the load so the press could adjust and apply the displacement at a constant rate again. Other cracks occur near 35 kN, when the GFRP bars become more important in absorbing the tensile stress generated by the bending of the beam. It should be noted that up to a load of approximately 130 kN, the beam's behavior was almost linear, suggesting the actual collaboration of the bars for the absorption of stress. The rupture occurred abruptly, indicated by the drop in load applied to the beam for a displacement of about of 21 mm. Before the rupture, there was "crackling" due to concrete crushing; it is believed that the concrete reached its compression limit when the beam displacements were between 16 and 20 mm, approximately.

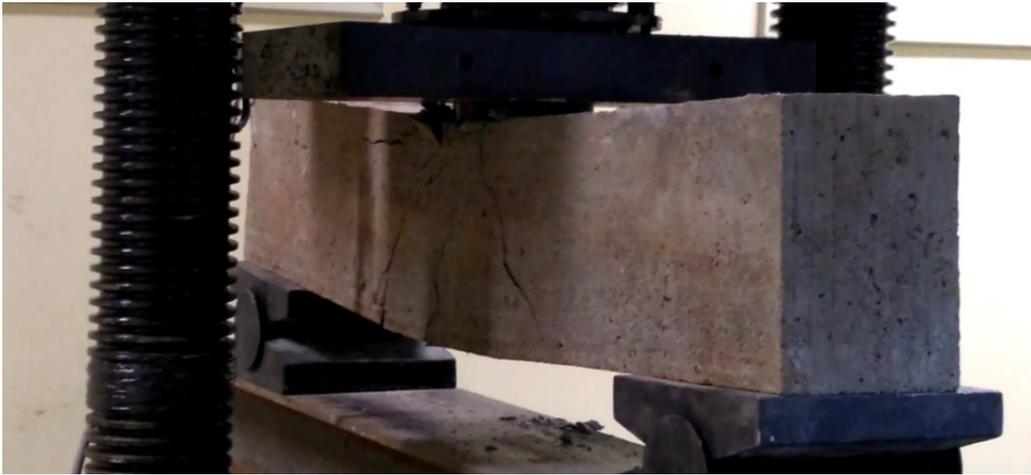
Figure 10. Rupture of beam VA57.

The VA57 beam supported a load of 143.8 kN, with a corresponding deflection of 18.6 mm. Figure 10 shows the cracks that caused the beam to rupture, which occurred due to flexural stresses. Figure 11 presents the load x displacement curves of the beams designed for the 57 kN load.

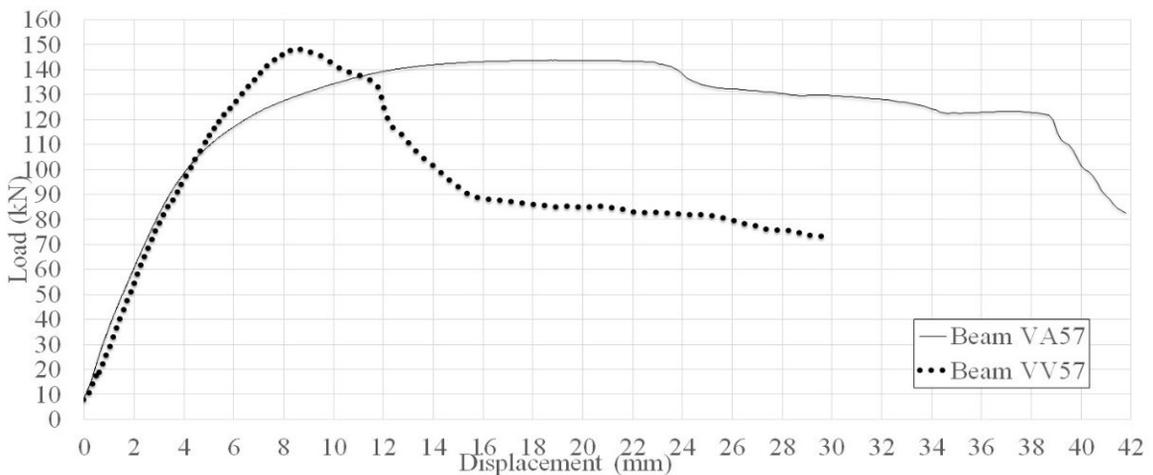
Figure 11. Load vs displacement curves of the 57 kN beams.

An analysis of the VA57 beam shows that it behaved linearly up to a load of approximately 100 kN, indicating the effective collaboration of the tensile reinforcement, possibly working in the elastic regime. After this load level, it is believed that the steel entered its plastic phase, that is, it yielded, absorbing stresses up to a displacement level of 23 mm, when it is believed that concrete crushing began. It is noteworthy that this beam was designed with a position relative to the neutral line close to 0.45 (domain 3), which indicates failure of the element with concrete crushing and steel in the plastic regime. Failure said to be ductile with intense cracking and compressed concrete reaching its resistant capacity, which meets the rupture mode found in the test.

The VV57 beam supported a maximum load of 148.3 kN for an 8.5 mm deflection. The graph in Figure 11 shows the actual collaboration of the GFRP bars for beam strength, due to the linear behavior of the load x displacement curve of VV57 until the maximum load (148.3 kN). This behavior is typical of fiber-reinforced polymer bars. After the maximum load, the press was forced to decrease the load applied to the beam so that it could maintain a constant displacement rate, due to the loss of stiffness caused by the start of concrete crushing, going up to a displacement of about 16 mm.

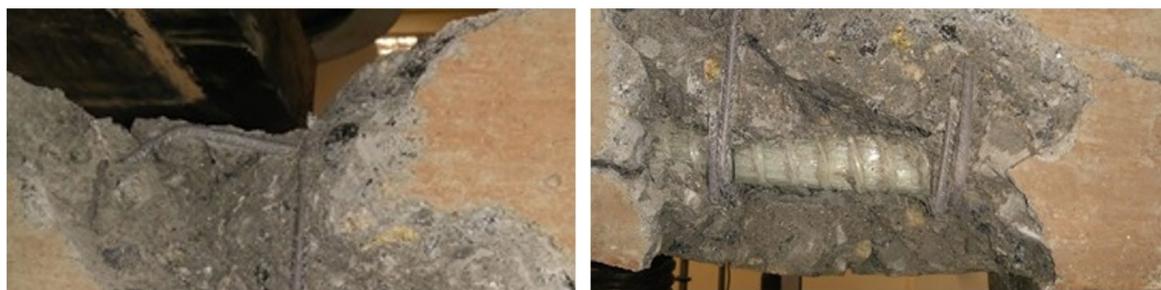
Figure 12. a. Crushed concrete. b. Intact GFRP bars.

As an important information, it should be said that the GFRP area for the 57 kN load was designed by predicting beam failure by concrete crushing with underutilization of the resistant capacity of the bars, which can be seen in Figure 12, which translates the behavior expected in the test. The same Figure 12a shows how the excess compression deformed the upper reinforcement, while the lower reinforcement, shown in Figure 12b, did not reach its maximum capacity.

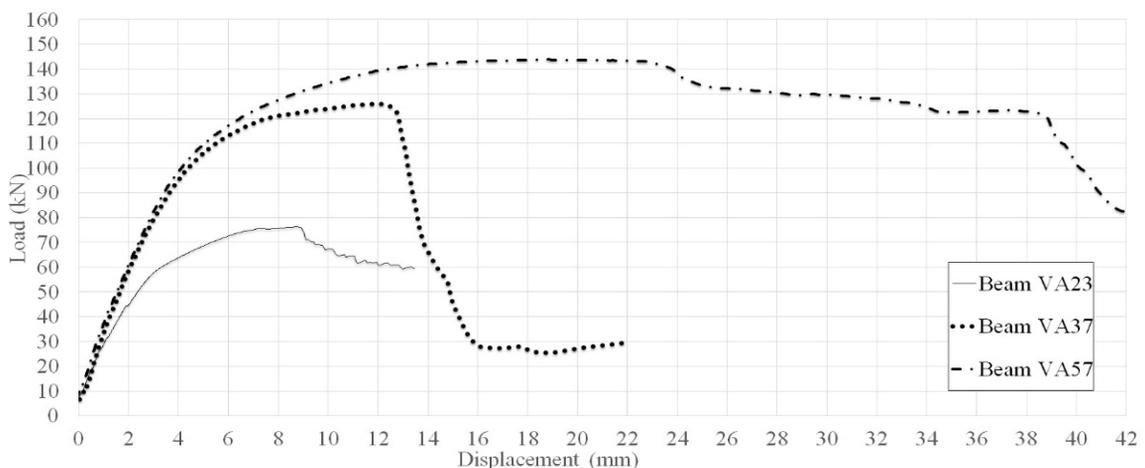
Figure 13. Load vs displacement curves - Beams reinforced with steel.

Figure 13 shows the load x displacement curves of the beams that used steel to resist the tensile stresses caused by the bending moment. All beams had curves with a very similar shape, with changes in the strength and also the stiffness scales, mainly for beam VA23 when compared to beams VA37 and VA57. This is the expected behavior for beams designed to have good ductility, as recommended by standards for design. In addition, there is a change in stiffness of the beams when they enter stage III (reinforcement yield), especially beams VA37 and VA57 (load greater than 110 kN), where VA57 had less deformation compared to VA37 due to higher reinforcement rate.

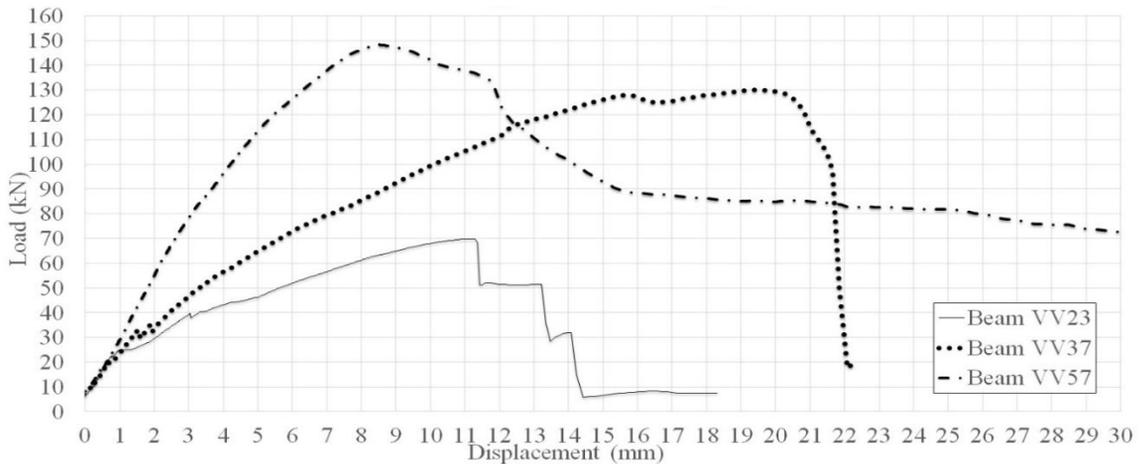
Figure 14. Load vs displacement curves - Beams reinforced with GFRP.

Figure 14 shows that the GFRP beams had a sudden drop in strength after reaching their maximum load. This was due to the brittle behavior of the concrete and GFRP that were used. Beams VV23 and VV37 completely lost their load capacities after reaching their maximum load, even though they have different modes of failure, with the first, for beam VV23, caused by the tensile rupture of the bars, and the second, for beam VV37, by concrete crushing. It is important to note that the modes of failure obtained with the tests faithfully followed the modes of failure detailed in the design process.

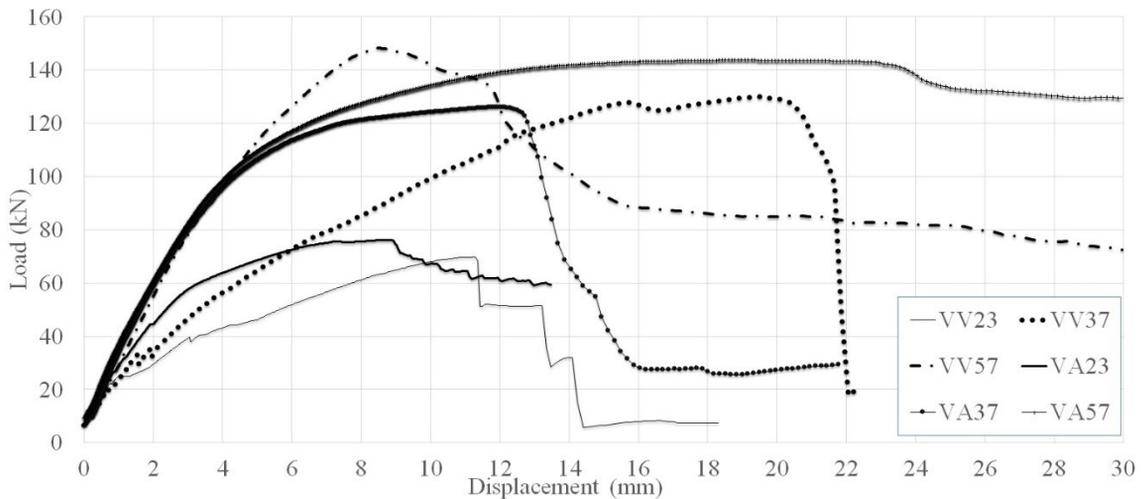
Figure 15. Load vs displacement curves for all beams.

Figure 15 shows that beam VV57 behaved similarly to the beams reinforced with steel bars, VA37 and VA57, mainly until the steel bars yielded. After that, VV57 presented greater stiffness in relation to the other two beams until reaching its maximum load capacity. This is due to the reinforcement area of this beam being much higher than the reinforcement of beams VA37 and VA57, that is, 5.22 and 3.33 times higher, respectively, thus compensating for its low longitudinal elastic modulus. However, beam VV57 had significantly lower deflection than beams reinforced with steel bars when comparing the maximum loads, which is a negative factor, due to the greater fragility of this material.
