Terracing Recovers the Quality of a Riverbank Soil Degraded by Water Erosion in Brazilian Semiarid

Soil physical-hydraulic properties are among the most important indicators for evaluating soil quality. This study aimed to experimentally demonstrate how the construction of terraces can affect physical-hydraulic properties of a soil degraded by water erosion on the banks of the Salitre river, tributary of the São Francisco river. An area in advanced stage of degradation by water erosion was delimited for the construction of a level bench terrace. The experiment was conducted for two years. Soil physical-hydraulic properties were determined before and after terracing. Time-domain reflectometry (TDR) was used to measure soil water storage (mm). This study demonstrated that terracing positively affected soil physical-hydraulic properties in the previously degraded area, allowed the increase in the retention and availability of water in the soil, thus is an ecologically beneficial practice for recovery of degraded soils on the banks of the Salitre river.

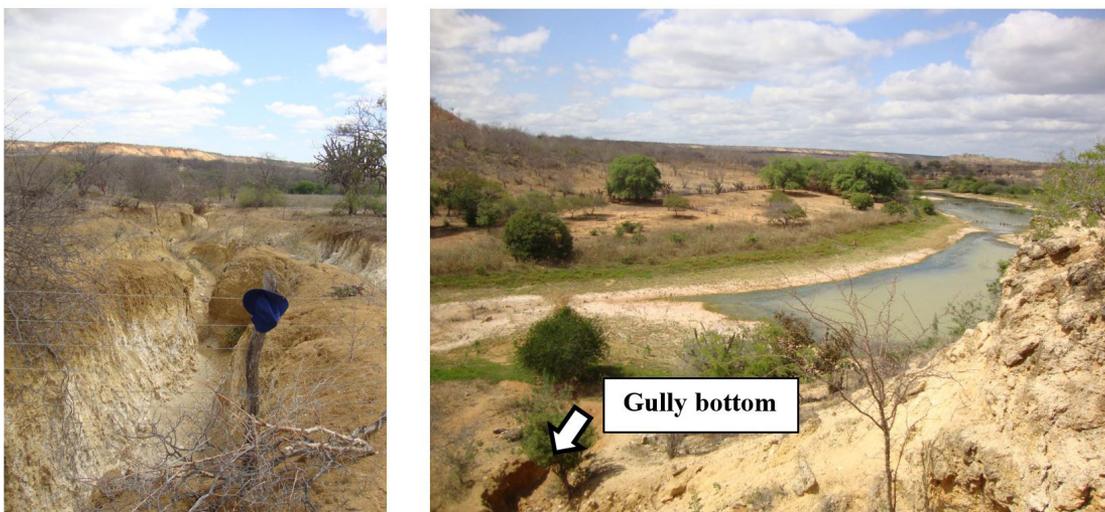
Figure 1. Typical gullies on the Salitre riverbanks (*left*); and sedimentation in the Salitre river (*right*).

formed by the intense process of linear erosion, which moves large portions of sediments from the slopes to the Salitre river channel (Figure 1). According Poesen et al. (2003) gully erosion is defined as the erosion process whereby runoff water accumulates and often recurs in narrow channels and, over short periods, removes the soil from this narrow area to considerable depths. The main causes of gully formation are anthropogenic factors, as the clearing of native forests and tilling of fallow lands (Sidorchuk, 1999).

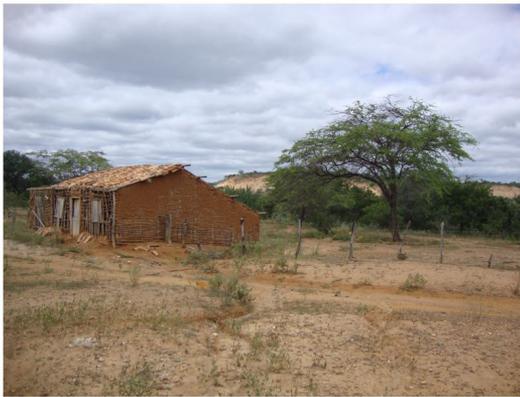
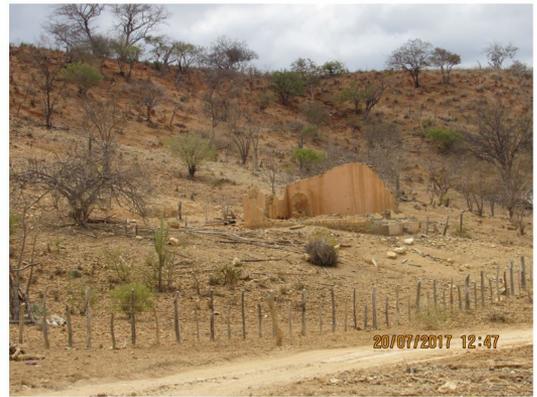
Figure 2. Marks of soil erosion and early signs of desertification in the Salitre river basin.

Indeed, according to Figure 2, in the middle course of the Salitre river there are marks of environmental degradation associated with abandoned houses, configuring a probable beginning of a desertification process.

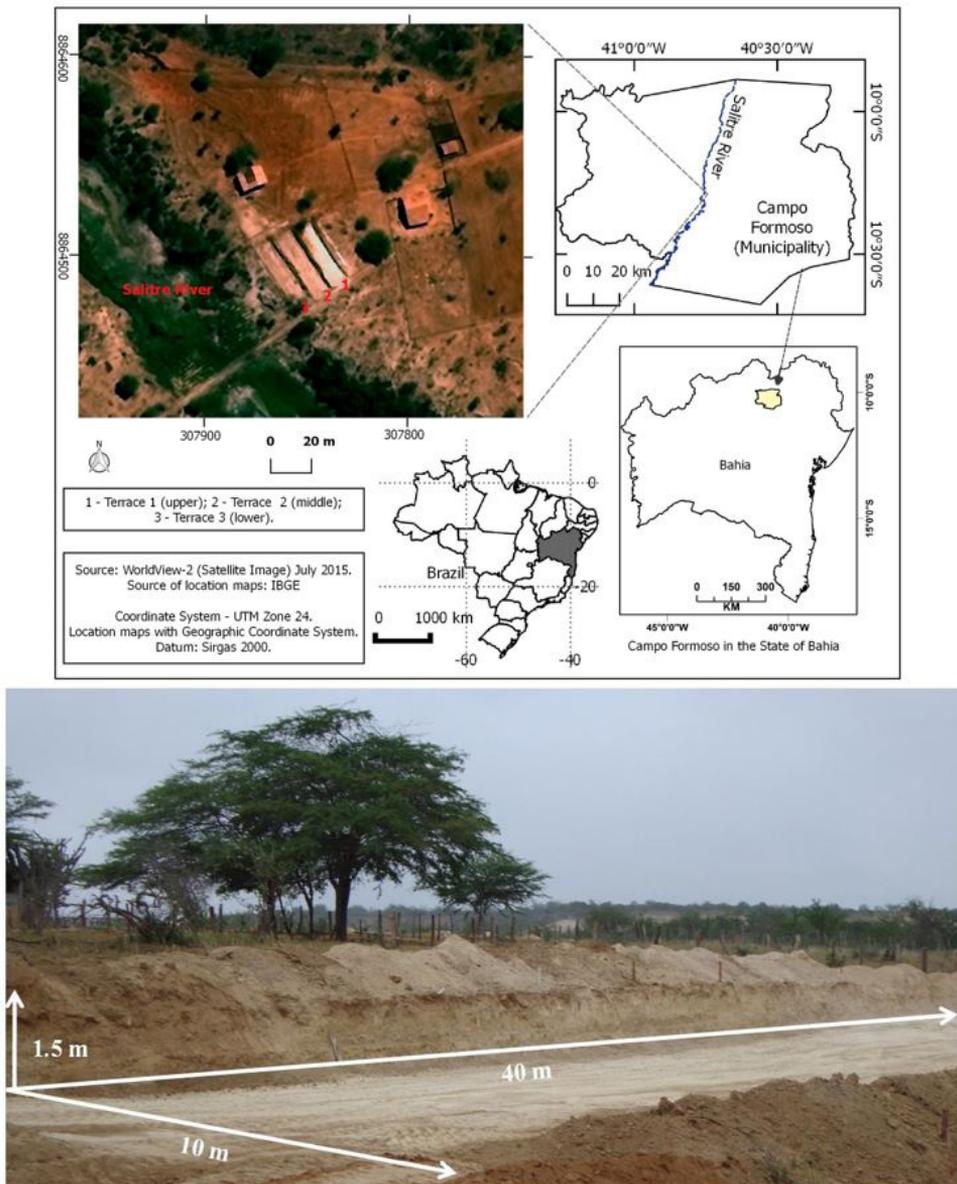
Figure 3. Geographic location of the experimental area (*top*); and view of the upper bench built (*bottom*).

In May 2015 an experimental area of 1,200 m² in advanced degree of degradation by water erosion with slope of 17%, was delimited on the bank of the Salitre river. The delimited area had two gullies erosions, which were filled by moving soil from the degraded area. Posteriorly, a bench terrace was constructed. In order to do so, we used the 18-hour service of a backhoe. Figure 3 (*top*) presents the geographic location

of the experimental area, showing the terrace built. The terrace was composed of three 10 x 40 m benches (Figure 3 - *bottom*).

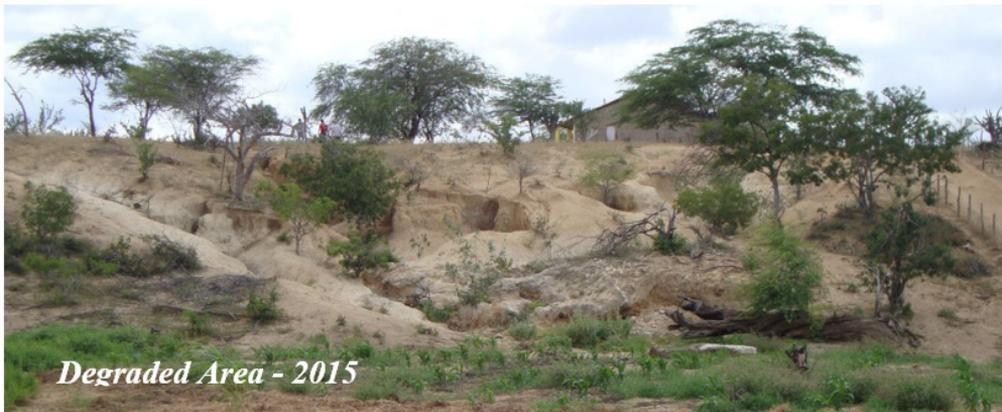
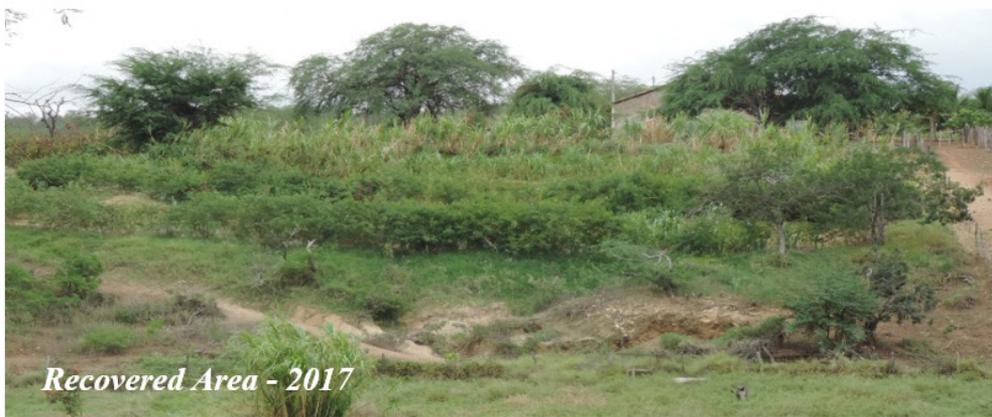
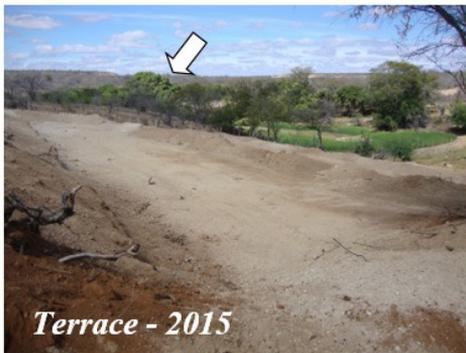
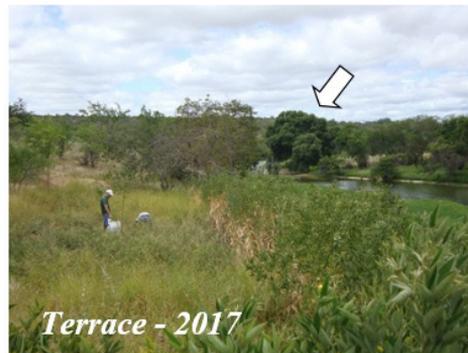
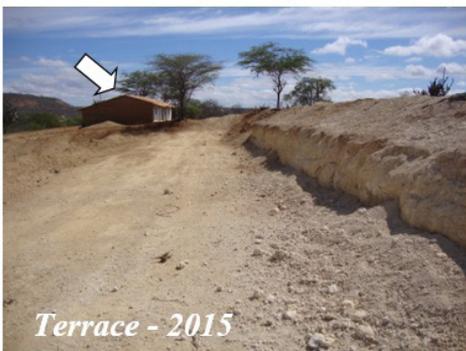
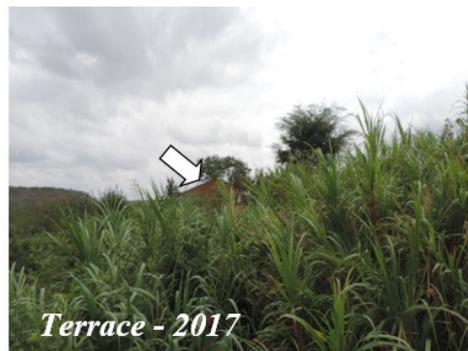
Figure 4. Photographic evidence of recovery of a degraded area on the banks of the Salitre river, tributary of the São Francisco river.

Some photos from the photographic monitoring carried out between 2015 and 2017 are shown in Figure 4. Indeed, these results are a demonstration of the actual possibility of vegetation recovery, thus minimizing the risk of soil erosion on the banks of the Salitre river, tributary of the São Francisco river. Perhaps, the same tractor-hour time commonly used in government programs for the desilting of rivers, including the Salitre river, as can be verified in CODEVASF (2017), can be used in practices that allow riverbanks to be revegetated.

After both rainy periods, the terraces remained preserved and new gullies did not form in the terraced area. The terraces acted as effective barriers against erosion, attenuating the erosive forces of the runoff formed uphill. Barriers against erosion are widely used to recover degraded areas because they reduce the erosive energy of the runoff and increase rainwater infiltration into the soil (Fernández & Vega, 2016; Kimiti et al., 2017; Gispert et al., 2017), thus presenting themselves as an effective option to avoid water erosion in the middle course of the Salitre river. Despite all these positive effects, the terraces alone may not be effective in the studied region due to the long drought periods. Long drought periods, also common in the São Francisco basin, require the integration of irrigation in the projects and programs of riparian revegetation.

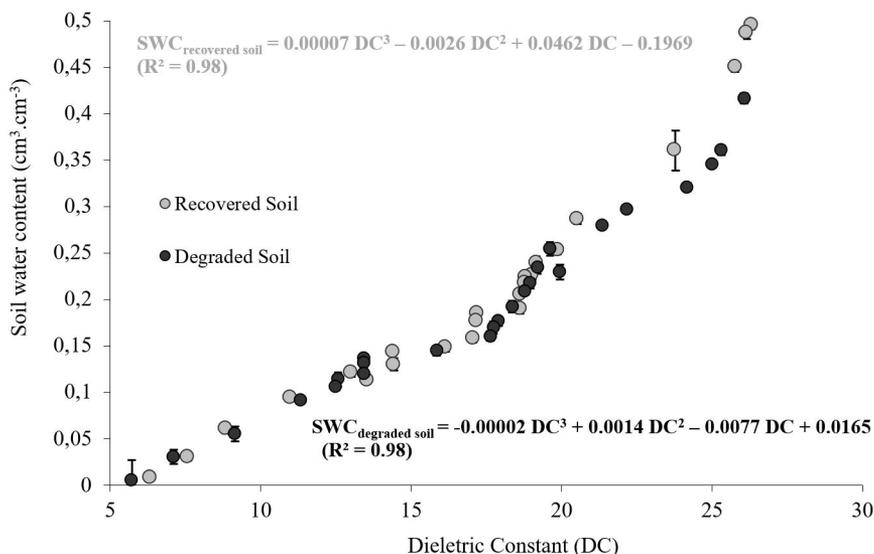
Figure 5. Relationships between Dielectric Constant (DC) and soil water content (SWC) for recovered and degraded soils.

Figure 5 presents the DC x SWC relationships obtained for the soils of the area under degradation and two years after the terraces were built:

For $DC > 25$ the gravimetric soil water content was higher in the terraced area than in the degraded area. According to Ledieu et al. (1986), the dielectric constant of a soil (DC) depends on the proportion between the components air ($DC \sim 1$), water ($DC \sim 81$) and soil particles ($DC \sim 4$). Any alteration in the features texture, structure, density and porosity of a soil affects the “DC” value attributed to the soil particles. If, for the same DC, a soil began to show higher SWC, an increase in soil water retention capacity is assumed, which favors revegetation in a degraded area.

The Soil Water Pressure head (SWP) x SWC relationship corroborates the obtained DC x SWC relationship. After terracing and revegetation, water retention characteristics were altered in the previously degraded soil, which began to retain more water over the entire range of pressure, from 0 to -15 m H_2O . Consequently, there were alterations in soil hydraulic properties (Table 1). Considering the total available water (AW) as the difference between the SWC values related to SWP of -1 and -15 m H_2O , it can be observed that AW was changed after the terracing. Increment in SWC for the same SWP indicates improvement in soil physical-hydraulic characteristics, besides favoring plant growth and vegetation recovery (Li & Shao, 2006). On the other hand, low water availability in the soil is the main constraint in the control of desertification (Li et al., 2004). It is verified, therefore, that the intervention in the area through the construction of terraces allowed the increase in the retention and availability of water in the soil. Thus, the data of Table 1 are particularly useful for projects of environmental intervention in
