Quality analysis of galvanized pipes applied to natural gas installations in civil construction

Fernando Benedicto Mainier¹, Rodolfo Gomes Shamá dos Santos¹,
Humberto Nogueira Farneze²

¹ Escola de Engenharia, Universidade Federal Fluminense, Niterói, Rio de Janeiro, Brasil.

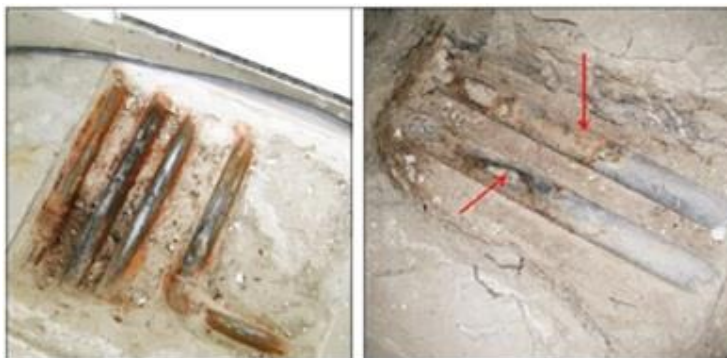
The natural gas distribution companies in some Brazilian cities currently use galvanized pipes manufactured by the hot-dip zinc process for residential and commercial buildings that are supported by Brazilian Standards ABNT [1-3]. However, there has recently been a notable increase in external corrosion processes, especially in the subfloor (mortar beds), as shown in Figure 1.

Some corrosion was so serious that major renovations and the installation of new pipes by several construction companies was required, even before the five-year warranty expired, resulting in damage, inconvenience to tenants and residents, and especially the enormous risk of gas leaks, fires and consequent explosions.

Figure 1: Aspects of external corrosion on galvanized steel pipes.

Mainier [4] attributed many of these issues to the premature corrosion of galvanized steel pipes, which are due to the poor quality of their coatings and/or the chemical additives used for mortars. Once placed to the subfloors (mortar beds), these can result in corrosion of the zinc coating, which leads to localised corrosion points (holes) in the carbon steel and eventual gas leaks.

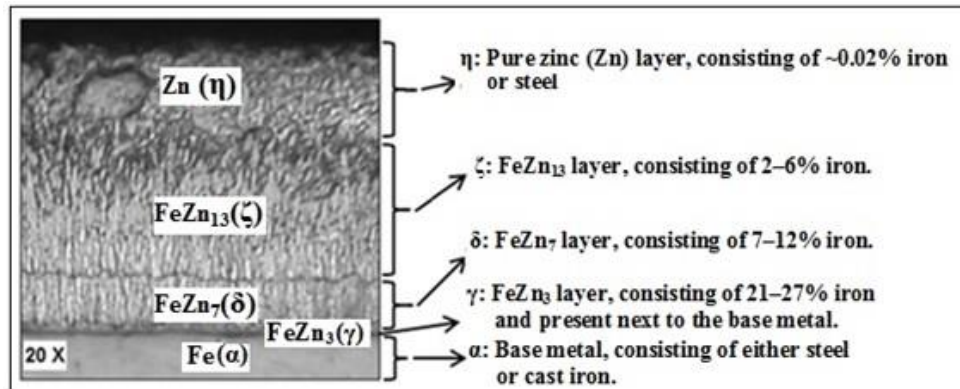
The metallurgical reaction that occurs between carbon steel and zinc is a unique feature of hot-dip zinc galvanizing barrier protection. Under normal conditions, the obtained coating is formed by intermetallic zinc-iron alloy layers (γ , δ and ξ) and a layer of nearly pure zinc (η ; 0.02% Fe), as shown in Figure 3.

Figure 3: Micrograph of the alloy (Zn-Fe) layers (20×magnification), with basic descriptions of their respective compositions.

Temperatures higher than the indicated the range lead to greater diffusion between the iron and zinc, which causes greater dissolution of the steel and a higher iron concentration in the final coating as a consequence. This higher iron concentration in the intermetallic layers generates a shorter and more fragile coating of the carbon steel. Higher temperatures also have a serious effect on the life of the vessel, as the reaction of the zinc with the walls of the vessel becomes more intense. The coated article is then cooled at the end of the operation, leaving it ready for any further operations. A layer of sacrificial or cathodic protection forms during the cooling process to protect the steel [6-8].

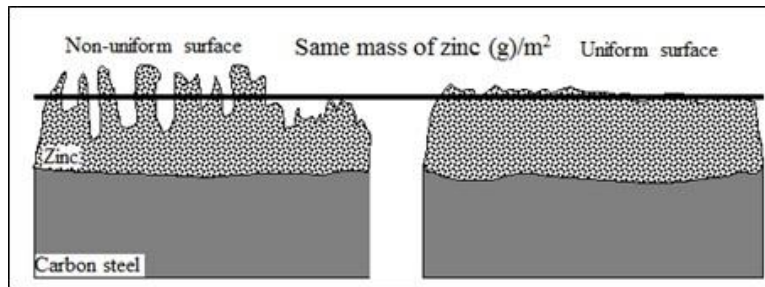
Figure 4 illustrates the adherence of the zinc layer to carbon steel in two moments, highlighting that a certain degree of variability may exist for a given mass of zinc/m² on the surface. It therefore follows that the zinc coating can meet the standard for the mass of zinc/m², but it may not meet the specification for a uniform zinc layer and thus become subject to more localised corrosion as a consequence.

Figure 4: Visualisation of a non-uniform (left) and uniform (right) zinc layer on carbon steel.

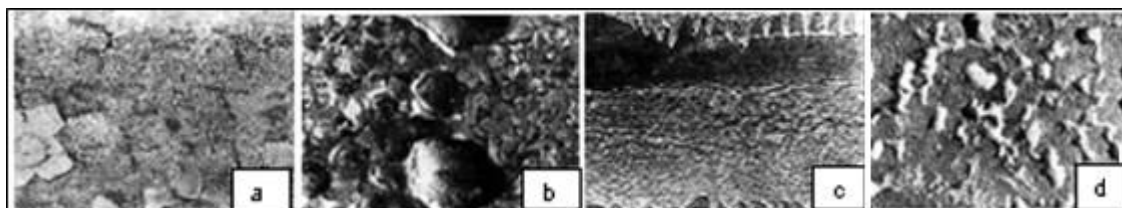
Finally, the zinc coating must be continuous, uniform, adherent and free from defects, including oxidation, peeling or detachment, run-off, porosity, bubbles, ripples, lumps, roughness and bare points (Figure 5), which may compromise the performance and durability of this coating under normal use. The preliminary inspection must therefore verify the articles, identify the tubes and fittings with defects, and then correct these defects, when possible.

Figure 5: Zinc coating defects: a) Peeling. b) Bubbles. c) Runs. d) Oxidation.

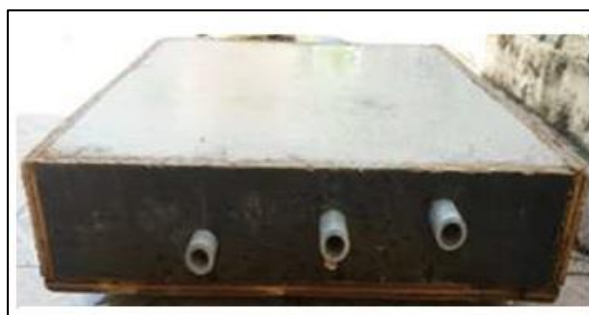
Figure 7: Wooden box, galvanized pipes and mortar, consisting of a 1:3 cement: sand mixture and little water.

The curing time of the concrete was 14 days [16], with the various tests conducted after the concrete was dry. A spray of 200 mL municipal water was applied four days a week on the surface of the concrete body during the exposure time, while other bodies were totally dry. The exposure times of each experiment were fixed at 40, 90 and 180 days. After the tests were completed, the galvanized pipes were exposed by cutting the concrete into 5 cm \times 5 cm squares with a manual saw and then removing it with a chisel (Figure 8), where the galvanized pipes could then be inspected to identify the degree and extent of corrosion.

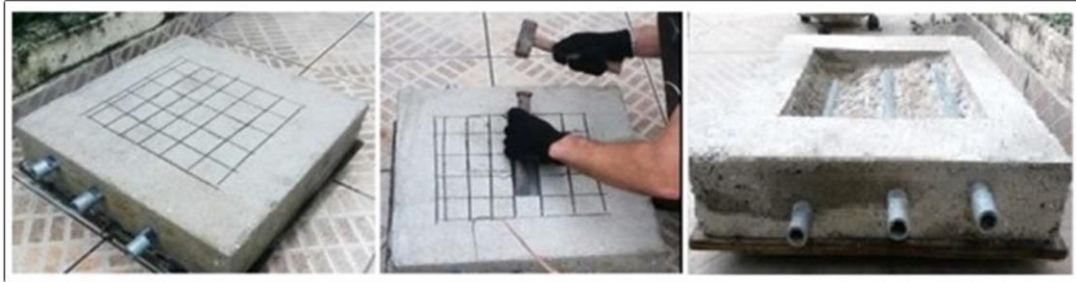
Figure 8: Cutting into the concrete body to evaluate the galvanized tubes.

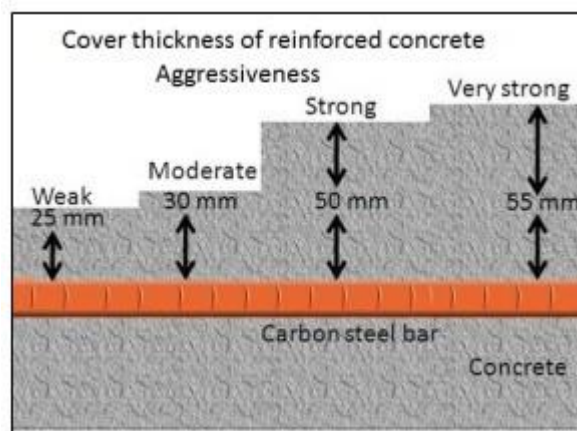
It is important to note that the cover thicknesses of concrete used in the tests was based on the parameters, guidelines and procedures outlined in civil construction. The general recommendations depend on the aggressiveness (weak, moderate, strong and very strong) of the corrosive medium. The cover thicknesses of concrete can therefore vary from 25 to 55 mm, as shown in Figure 9 [17].

Figure 9: Cover thickness of reinforced concrete [17].

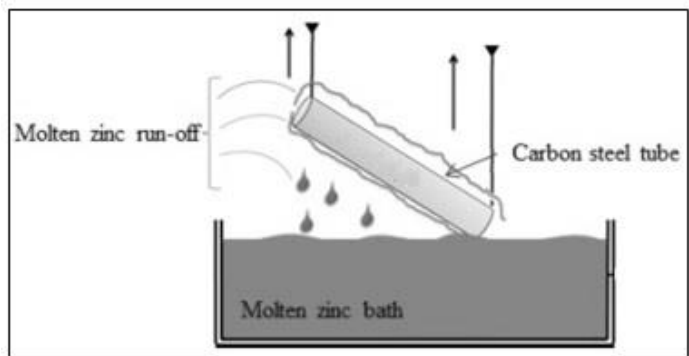
The non-uniformity of the zinc layer deposited on the carbon steel pipe can be due of various control parameters in molten zinc bath that occur during processing, which include the immersion time, the temperature, inadequate cleaning of the surface [6-8] and the inclination of tube for the draining of the liquid zinc during the removal of the tube from molten zinc bath (Figure 10).

Figure 10: Hot-dip zinc galvanizing process.

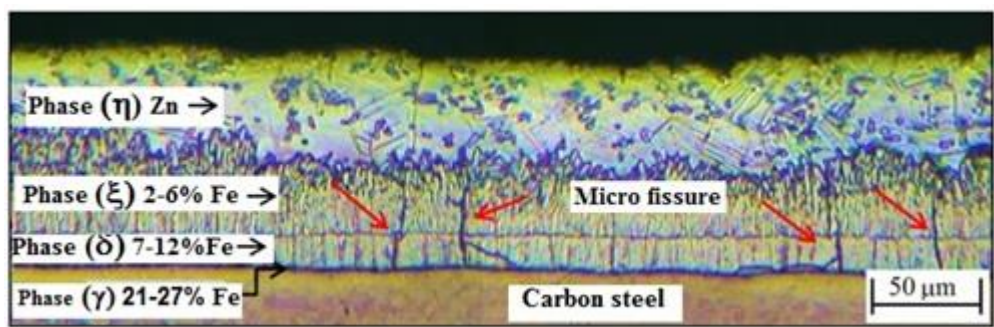
The micrograph in Figure 11 shows a sample taken from an unused tube, with a thickness of > 50 μ m that is uniform according to the Preece test. It shows the solid structure with the various phases resulting from the diffusion of carbon steel with molten zinc. The three Fe-Zn phases are well defined, with each possessing an appropriate and regular thickness without much variation, although micro fissures are present. Such micro fissures in the regions can possibly provide poor adherence to the carbon steel.

Figure 11: Micrograph of the zinc layer on carbon steel showing the γ , δ , ζ and η phases.

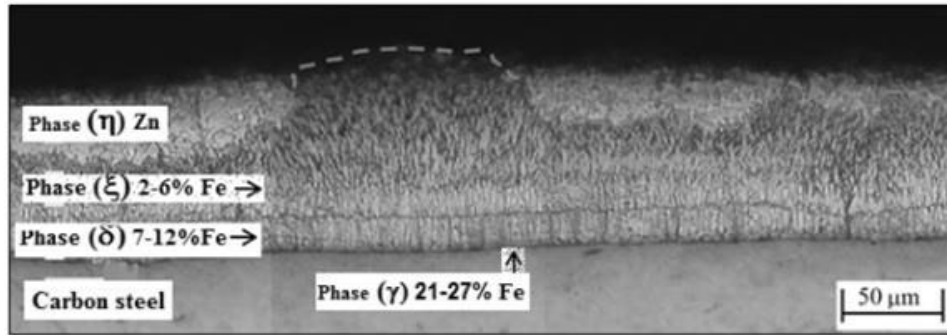
The micrographs shown in Figures 12 to 17 are from unused tubes that did not obtain good results in the uniformity tests (Preece test). Figures 12 and 13 show a disproportionate growth of the ζ phase (consisting of 2–6% iron) layer compared to irregular and thin η phase (pure zinc) layer. The micrographs in Figures 14 and 15 show a layer of zinc exceeding 50 μ m, with cracks and the occasional absence of the zinc layer, confirming that non-uniformity can provide localised corrosion points. The micrograph presented in Figures 16 were from the tubes removed from the floor, as shown in Figure 1, where clear discontinuities and the occasional absence of the zinc layer on the surface of the carbon steel are observed.

Figure 12: Micrograph highlighting the disproportionate growth of the ζ phase in comparison to the η phase

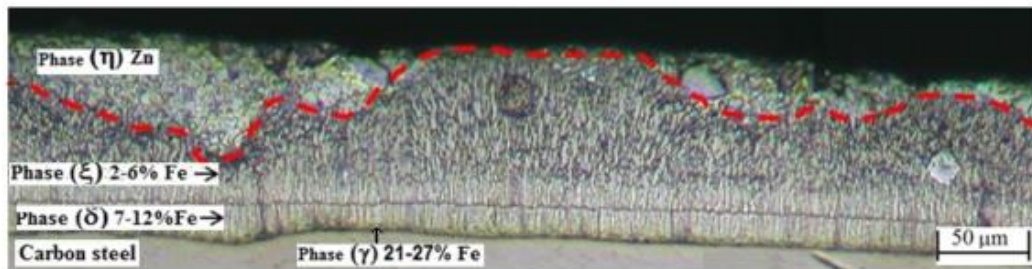
Figure 13: Micrograph highlighting the disproportionate growth of the ζ phase in comparison to the η phase.

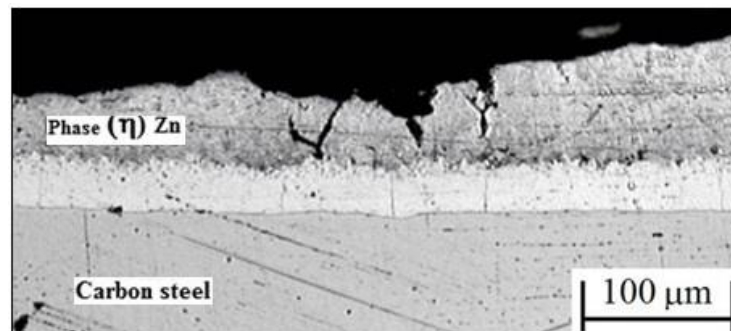
Figure 14: Micrograph of a zinc layer exceeding 50 μ m, with cracks.

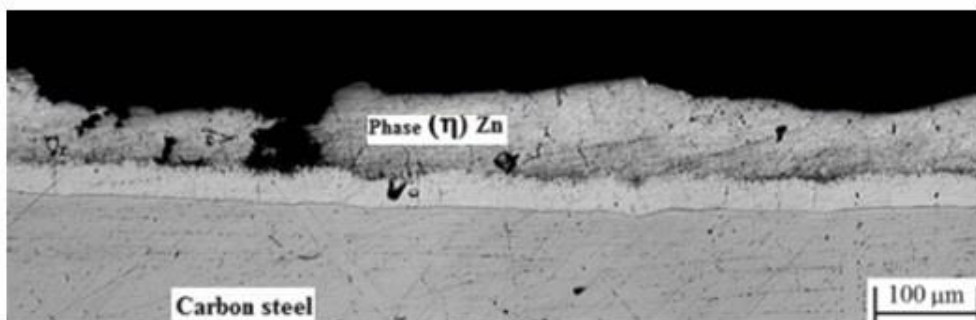
Figure 15: Micrograph of a zinc layer exceeding 50 μ m, with the occasional absence of the pure zinc layer.

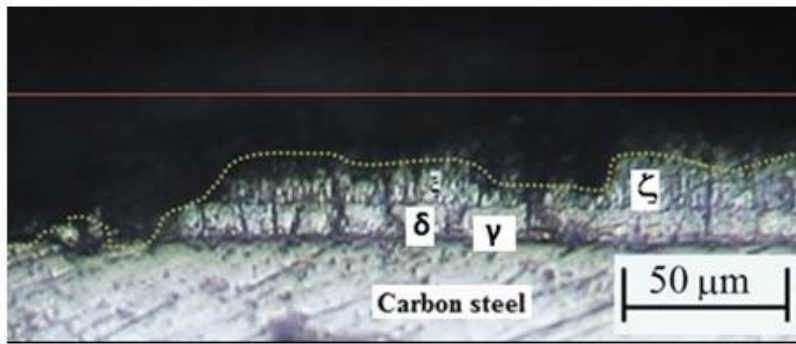
Figure 16: Micrograph showing the discontinuity and absence of a zinc layer on a carbon steel surface.

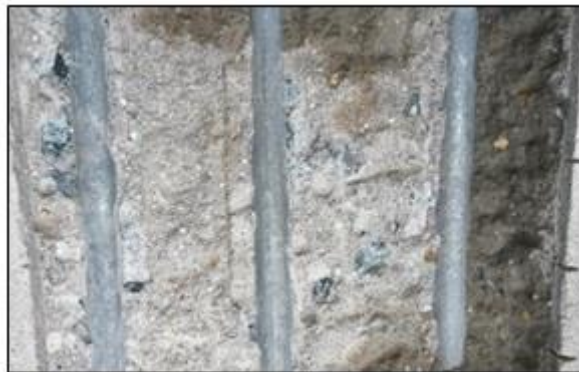
The galvanized tubes were removed from the dry environment experiment shown in Figure 17, where there was no wetting with municipal water sprinkling. They were completely dry and no localised corrosion points were observed, with only a tenuous common and protective zinc hydroxide formation. Furthermore, no localised corrosion was observed on the tubes with discontinuities.

Figure 17: Galvanized tubes in the dry environment experiment (without water spray).

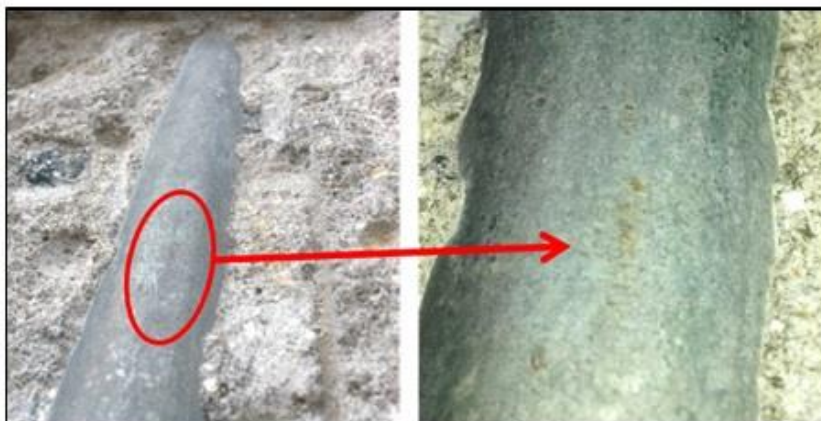
The experiments with water spray showed that some galvanized tubes (Figure 18) presented localised corrosion points, primarily consisting of discontinuities similar to those shown in the previous micrographs.

There is no doubt that the tubes at lower depths in the concrete floor and in the highest water absorption areas promote corrosion in the galvanized tubes. Furthermore, tubes with irregularities or discontinuities in the zinc coating are subject to more localised corrosion.

Figure 18: Localized corrosion points.

- It is common for natural gas pipes pass under the hallways of residential buildings and/or offices, often within 1 to 2 cm of the floor. It is therefore essential to have warnings that indicate the passage of such pipes for safety purposes. Kitchens and service areas that are subject to the permeation of water and cleaning products must have good waterproofing to ensure the galvanized tubes and natural gas conductors are not compromised.
