# Corrosion in Haas expanders with and without use of an antimicrobial agent: an *in situ* study

**Objectives:** The purpose of this study was to evaluate *in situ* the occurrence of corrosion in the soldering point areas between the wire, silver brazing and band in Haas expanders. **Material and Methods:** Thirty-four 7-12-year-old patients who needed maxillary expansion with a Haas expander were randomly assigned to two groups of 17 individuals each, according to the oral hygiene protocol adopted during the orthodontic treatment: Group I (control), toothbrushing with a fluoride dentifrice and Group II (experimental), toothbrushing with the same dentifrice plus 0.12% chlorhexidine gluconate (Periogard®) mouthrinses twice a week. The appliances were removed after approximately 4 months. Fragments of the appliances containing a metallic band with a soldered wire were sectioned at random for examination by stereomicroscopy, scanning electron microscopy (SEM) and energy dispersive x-ray spectroscopy (EDS). Data were analyzed statistically by Fisher's test at 5% significance level. **Results:** The analysis by optical microscopy revealed areas with color change suggestive of corrosion

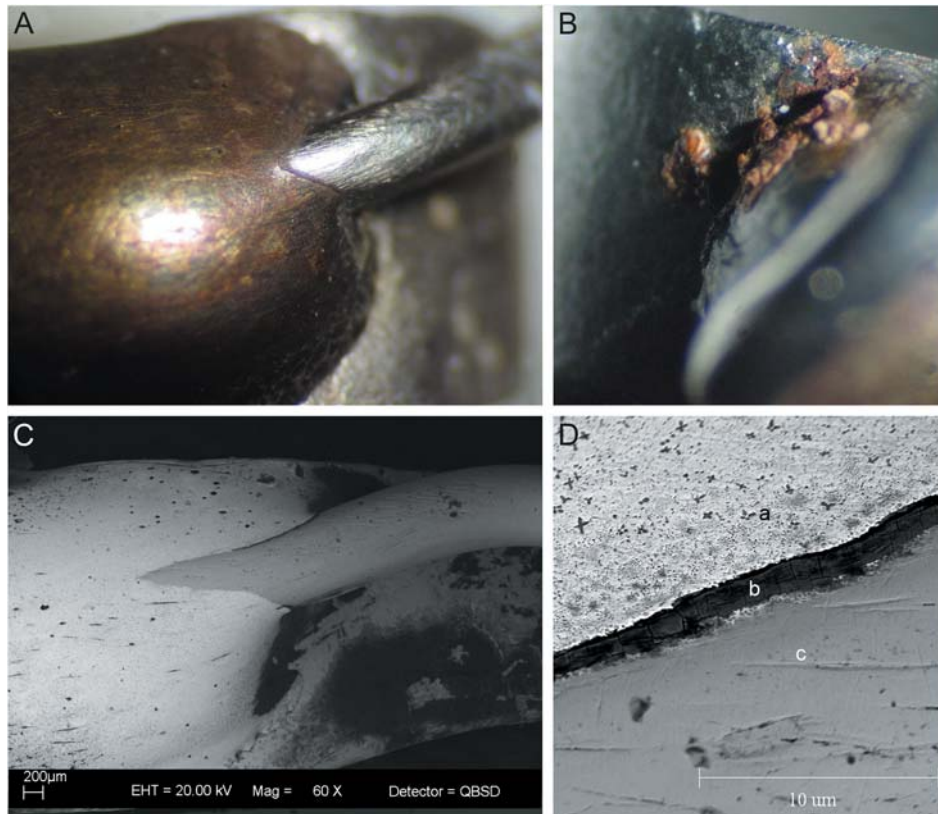
**Figure 1-** A: Stereomicroscopic analysis of a representative Group I specimen showing color change in the band/silver brazing/wire joint.  $\times 20$  magnification. B: Close-up view of A showing color change suggestive of corrosion at the band/silver brazing/wire joint.  $\times 40$  magnification. C: Scanning electron microscopy (SEM) micrograph showing the band/silver brazing/wire joint to be analyzed by energy dispersive x-ray spectroscopy (EDS).  $\times 60$  magnification. D: Areas of Ag solder (a), material-to-material interface (b) and orthodontic wire (c) analyzed by EDS with four-quadrant electron backscatter detectors QBSD detectors

The analysis of the images obtained under optical stereomicroscopy revealed areas of color change suggestive of corrosion in the soldering point areas (wire/silver brazing/band region) in all specimens of both groups (Figure 1A and B), with no

The regions suggestive of corrosion were submitted to SEM examination (Figure 1C) with EDS analysis (Figure 1D). Graphs representative of the qualitative readings of the specimens of Groups I and II are presented in Figures 2 and 3.

Although the methodology of the present study does not allow determining accurately which factors caused corrosion, alterations occurred in the wire/silver brazing/band joints, since a dark line suggestive of corrosion was observed on the alloy by optical microscopy and SEM, though without significant difference between the groups.

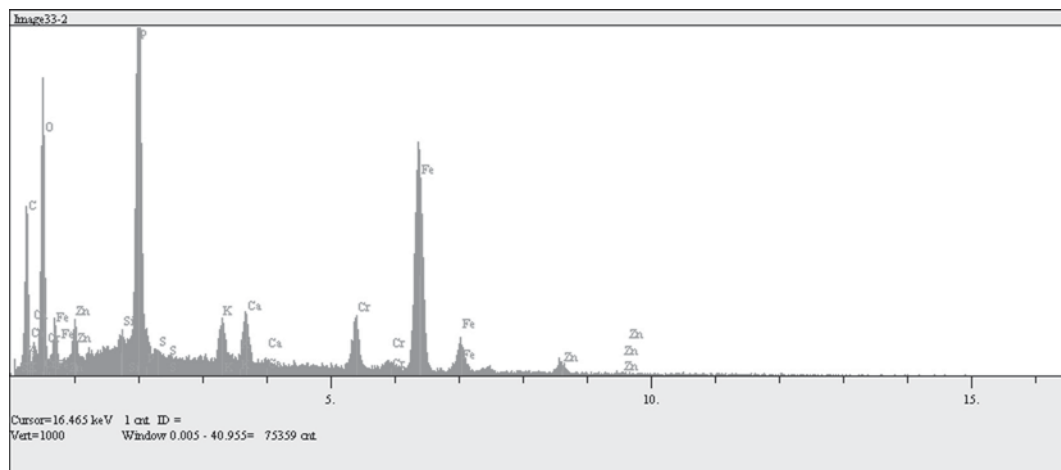
**Figure 2-** Quantitative energy dispersive x-ray spectroscopy (EDS) reading representative of areas of color change suggestive of corrosion in the soldered region in contact with the band and the wire in a Group I specimen (control)

In both groups, the soldered areas in contact with the band and the wire presented Fe, Cr, O, C and P peaks. Expressive Ni peaks were not observed in either of the groups.

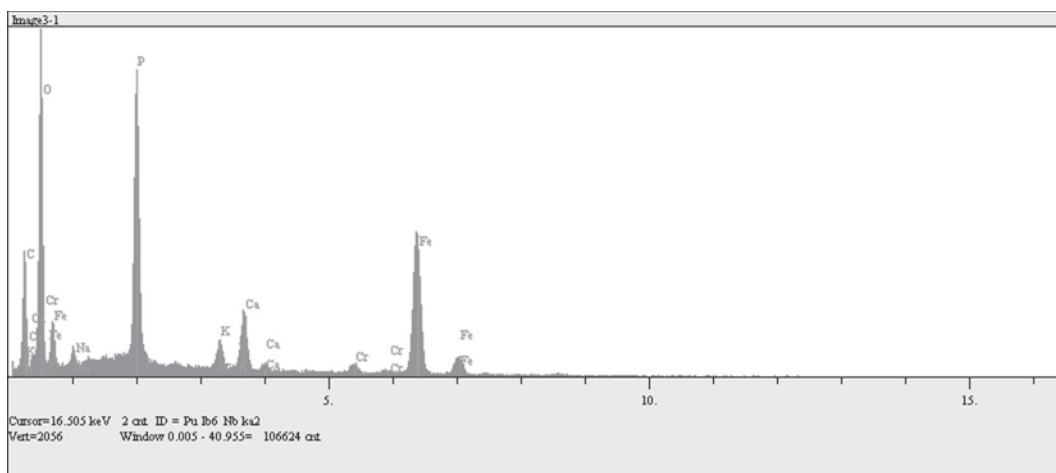
**Figure 3-** Quantitative energy dispersive x-ray spectroscopy (EDS) reading representative of areas of color change suggestive of corrosion in the soldered region in contact with the band and the wire in a Group II specimen (Periogard® mouthrinse)

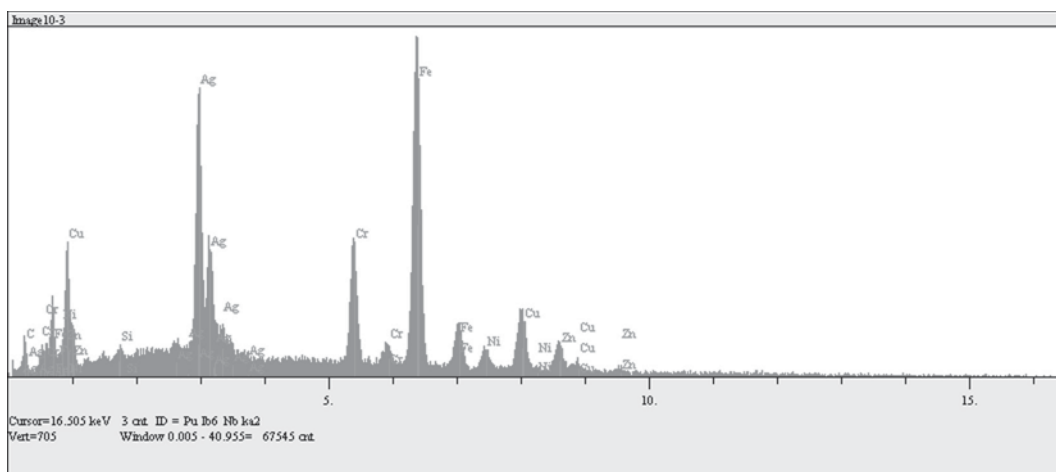
**Figure 4-** Quantitative reading of the composition of the stainless steel wire showing absence of corrosion

Figure 4 illustrates the reading obtained in a non-assayed region of an orthodontic wire of a Haas expander. No area of corrosion was visible under optical stereomicroscopy, demonstrating how the peaks of chemical elements behave in this situation.
