LAND REHABILITATION WITH THE USE OF BIOLOGICAL GEOTEXTILES, IN TWO DIFFERENT COUNTRIES

Reabilitação de Solos com Uso de Geotêxteis Biodegradáveis em dois Países

ABSTRACT: *This paper assesses the role of biological geotextiles on non-agricultural erosion environments, based on studies in the mine tailings Gauteng Province (South Africa) and urban area of São Luis City (Brazil). Gauteng Province (South Africa) has suffered immense problems related to sustainable rehabilitation of mine dumps. This is a huge challenge, as wastes are highly susceptible to both water and wind erosion. Establishing a grass cover to reduce erosion is the dominant reclamation method. Covering the slopes with biological geotextiles might constitute another option for mining companies to reduce erosion and aid natural re-vegetation. The objective of the waste part of this study was to determine the beneficial effect of palm mat cover on erosion control, using rainfall simulation. Results clearly illustrated that application of palm-mats more than halved the sediment load in runoff, thereby having the potential to effectively stabilize tailing dam slopes. Covering tailings with palm-mats did not reduce runo

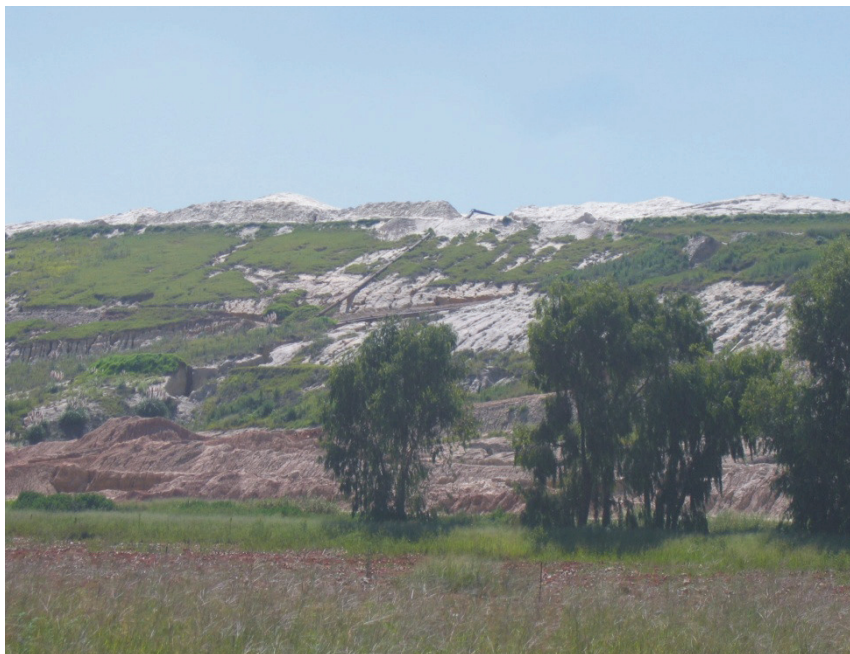
Figure 2: 'Mega-dump' of reprocessed gold tailings, south-east of Springs, Gauteng Province. Heavy rains in February 2008 led to landslides that denuded large parts of the previously vegetated slope.

Krugersdorp in the west part of Johannesburg and Soweto to Boksburg in the east and on to Springs (Figure 2). This waste belt is situated in a densely populated urban area.

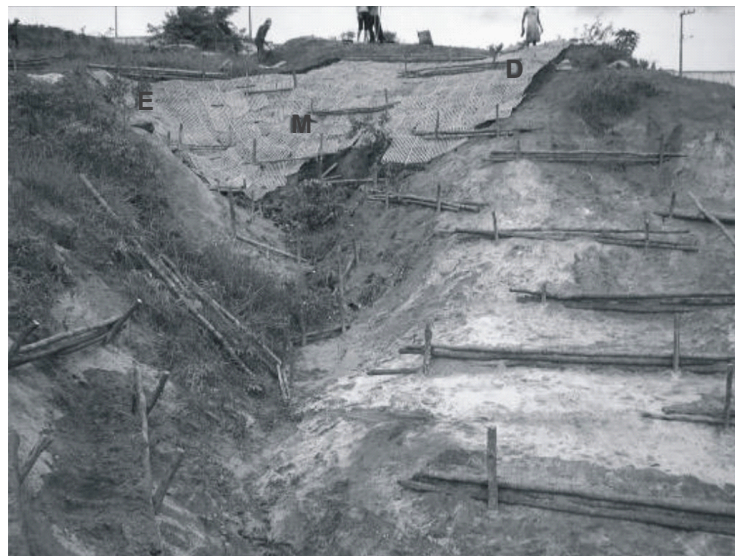
Figure 3: Area 3 of the rehabilitated area, with work in progress. E, M and D were reshaped exclusively by manual labour, São Luís, Brazil. Source: LAGESOLOS, 2008.

techniques included: 1. Buriti geotextiles in association with barriers of wooden stakes (Figure 3) and the construction of terraces along contour lines; 2. Analysis of sediment particle-size; and 3. Photo comparison of vegetation cover development.

The rehabilitation work in Sacavém was divided into three areas, presented in Figures 4 and 5, because of local relief characteristics. Areas 1-3 (Figure 6) were constructed with men and tractors; areas 4-8 (Figure 6) were made in the higher parts with a tractor; and areas E, M and D (Figure 3) were reshaped exclusively by manual labour.

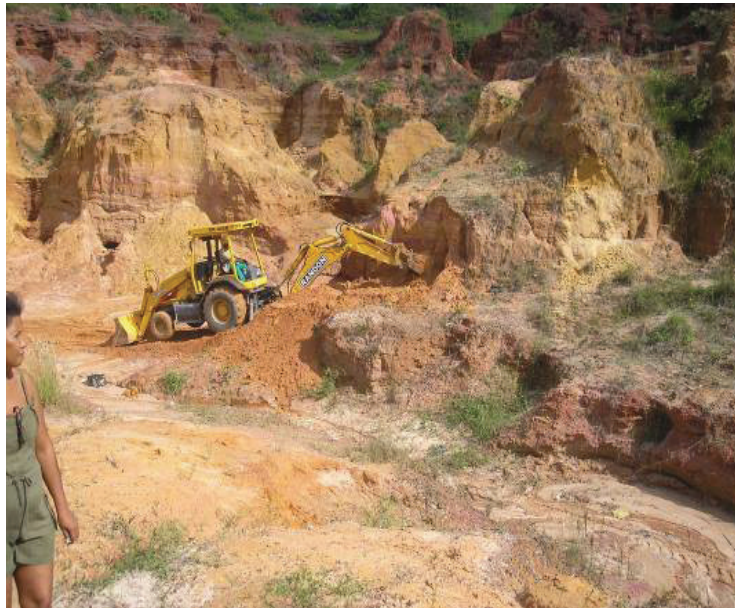
Figure 5: Initial work in areas 4-8. Source: LAGESOLOS, 2008.

caesalpiniae folia) was used on the higher parts of the gully, to protect the topsoil. The rehabilitated area was fertilized with 500 kg ha⁻¹ of NPK (4-14-8) and decomposing palm was added to topsoil, as a source of organic matter. The project employed 10 local men for six days, who conducted the work using hand-held tools (Figure 4). A tractor (type backhoe loader) was used for two days to construct the terraces (Figure 5).

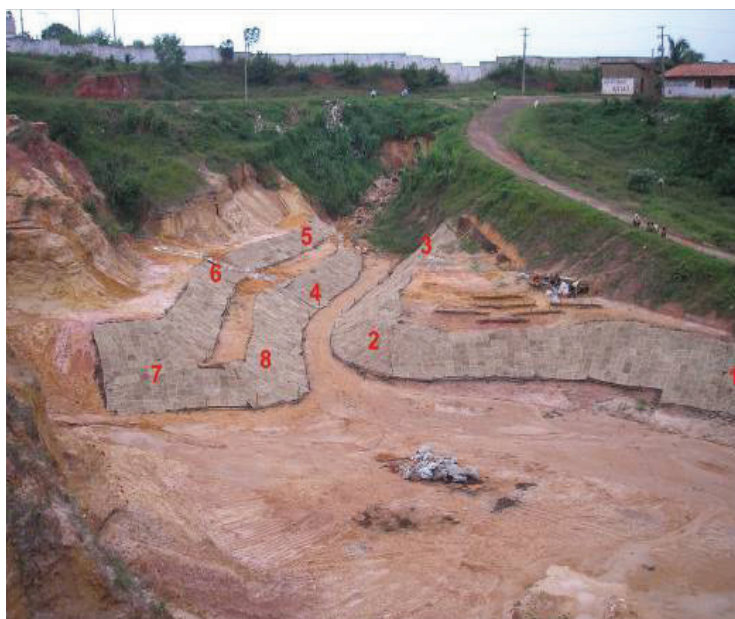
Figure 6: Rehabilitated areas with cover of buriti geotextiles, Sacavém Community, São Luís, Brazil (Areas 1-3 were constructed with men and tractors; areas 4-8 were made in the higher parts with a tractor). Source: LAGESOLOS, 2008.

In Part 1 (Figure 6: areas 1-3) the team used biological geotextiles and organic matter from decomposing palms, seeds and inserted barriers of wooden stakes along contour lines. This area had formed due the concentration of runoff from the street above the gully (Figure 7).

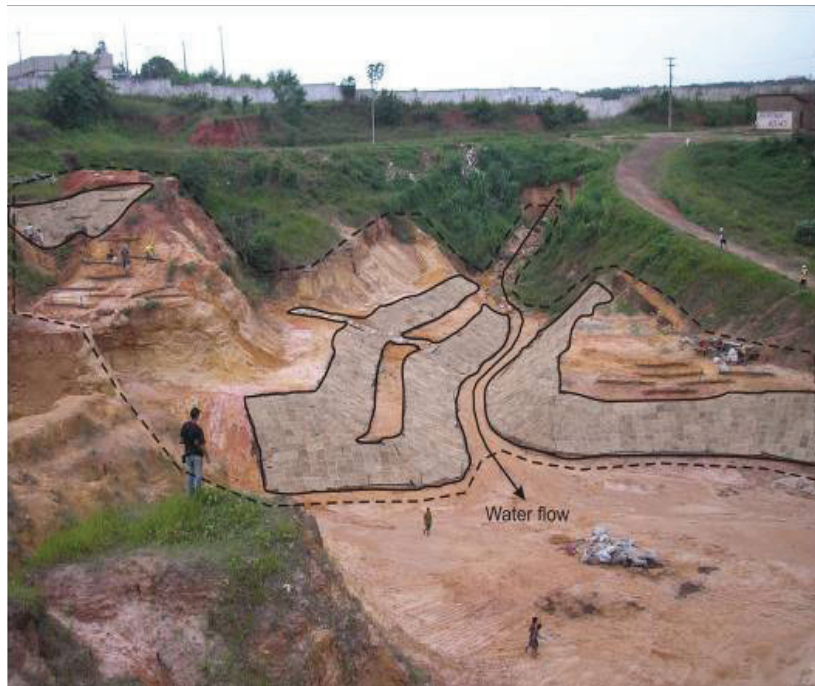
Figure 7: Continuous lines: areas rehabilitated with Buriti palm mats.

Hatched lines: the rehabilitated area in Sacavém Community, São Luís, Brazil. Source: LAGESOLOS, 2008.

Area 3 was made by men using Buriti biological geotextiles, organic matter from decomposing organic material (palm trees and leaves), wooden stakes and the planting of shrubs, as inaccessibility prevented tractor work. To reshape the internal part of the gully, we used techniques to minimize water flow energy, using many barriers of wooden stakes (Figure 3) and the application of biological geotextiles, grass seeds and organic matter from decomposing palm leaves. On the barriers, Sabiá bushes were planted to stabilize the topsoil. The rehabilitated area in Sacavém Community is ~2000 m² and ~800 m² is covered with Buriti biological geotextiles (Figure 7).

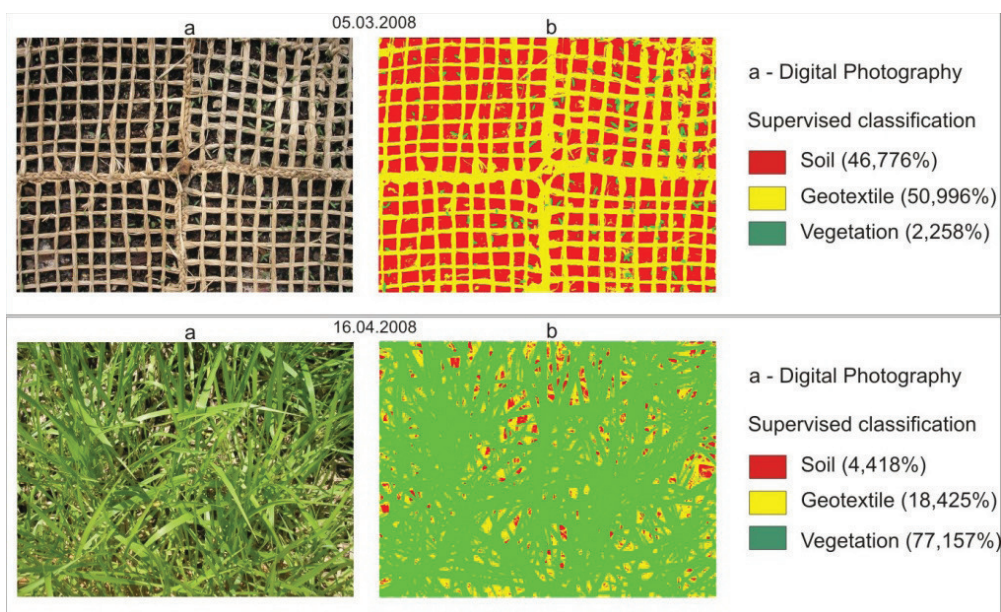
Figure 8: Photo comparison of vegetation cover developing in Sacavém community, São Luís, Brazil.

size distribution, using EMBRAPA (1997) protocols. Vegetation cover index was monitored and assessed on Sacavém rehabilitation site, using photographs and supervised classification tools available in Arcgis 9.3, which can perform pixel-based classification. The progress of vegetation cover was monitored weekly from March 2008 to May 2008. These photos were taken at the same point, using wood stakes on the rehabilitated slope.

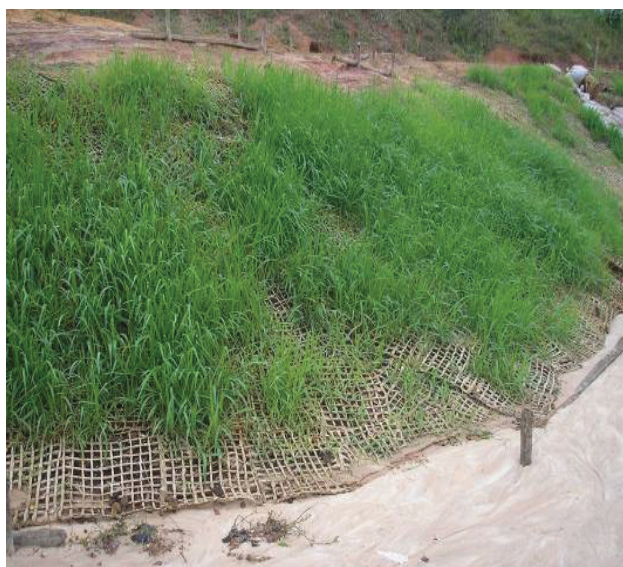
Figure 9: Grass development, one-month after rehabilitation, Sacavém community, SãoLuís, Brazil. Source: LAGESOLOS, 2008.

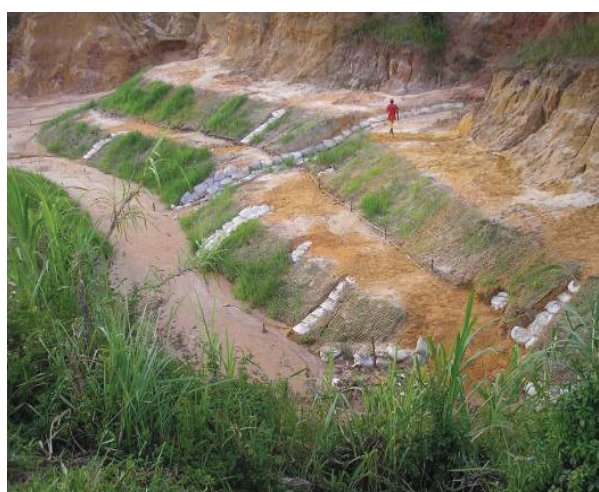
Figure 10: Maintenance work at the rehabilitated area one month after rehabilitation, Sacavém community, São Luís, Brazil. Source: LAGESOLOS, 2008.V

For one month after the rehabilitation work São Luís City experienced intense and prolonged rains (Table 4), which presented attendant problems for the rehabilitation work. However, we again employed local people to work on site maintenance (Figure
