## ORIGINAL ARTICLE

# Assessment of stiffness and structural behavior of reinforced concrete beams rehabilitated with CFRP and crack injection

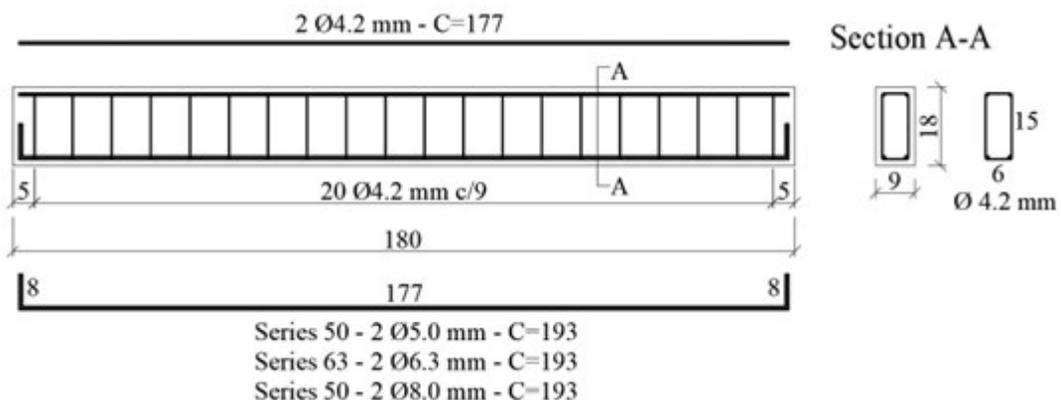
Figure 1. Schematics of original undamaged specimens. Dimensions in centimeters unless otherwise specified.

This study employed nine specimens that were initially produced in the context of Lima's [12] research. The dimensions of all beams were 9 x 18 x 180 cm. The beams' concrete had a water/cement ratio of 0.60 and three different steel reinforcement ratios, resulting in three different groups of three specimens with the same reinforcement ratio in each group. Figure 1 displays general schematics of the beams.

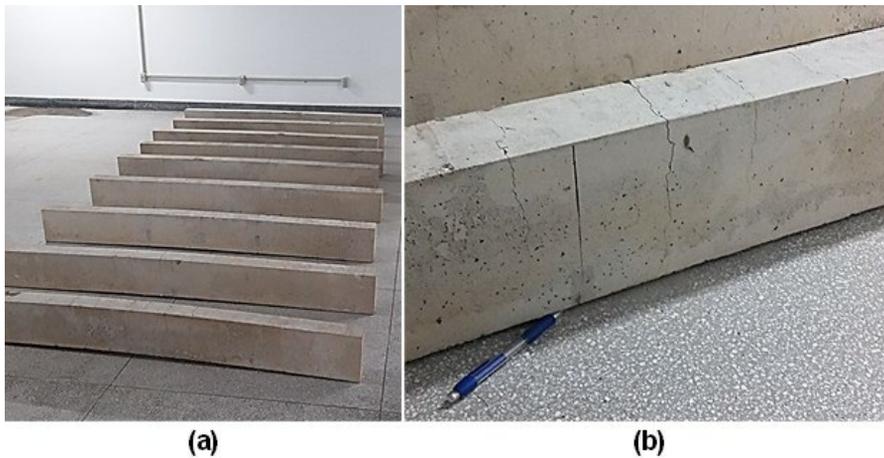
**Figure 2.** Original specimens after mechanical damage (a); detail of cracking and permanent deflection (b).

The original models were subjected to bending tests, with a vertically induced load from top to bottom, causing tensile stress on the element’s lower surface. In these tests all models failed due to steel yielding. The tests also caused permanent deflection in all models. The models were displayed with the surface that suffered tension turned upwards to facilitate the observation of deflections and cracks as shown in Figure 2. The beams’ state of degradation after the bending test performed by Lima [12] – before rehabilitation procedures – can also be seen in this figure.

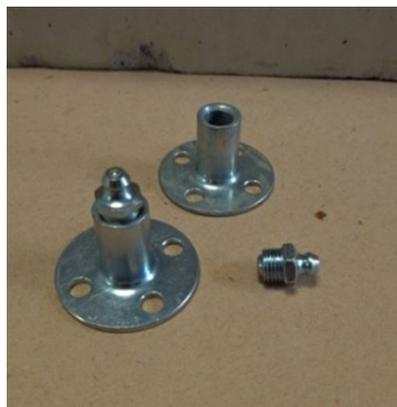
**Figure 3.** Surface packers.

Due to the models' small size, surface packers were utilized in the injection process (Figure 3), same procedure utilized by Ekenel and Myers [13], Nikopour and Nehdi [14] and Griffin et al. [15]. The alternative would be to employ borehole packers, which is an invasive procedure that could cause damage to the models and undermine the final rehabilitation process.

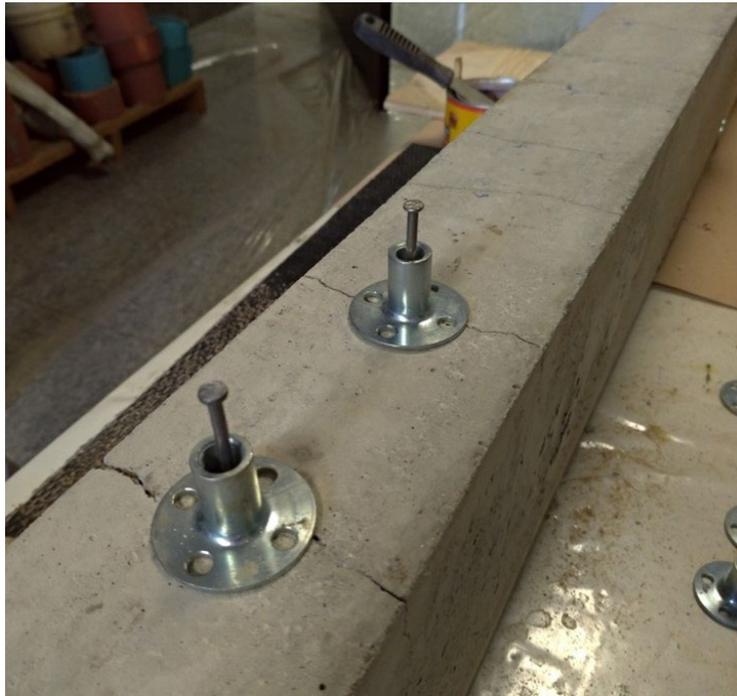
**Figure 4.** Surface packers secured with nails.

For one single crack, epoxy resin manufacturers usually recommend a distance between surface packers smaller than the structural element's thickness. In the models employed in this study, the cracks spanned the entire width of the transversal section, which was small. For this reason, only one surface packer was placed over each crack, contributing to the resin's penetration. The packers were secured with a nail after being glued to the specimen. The placement of the surface packers is displayed in Figure 4.

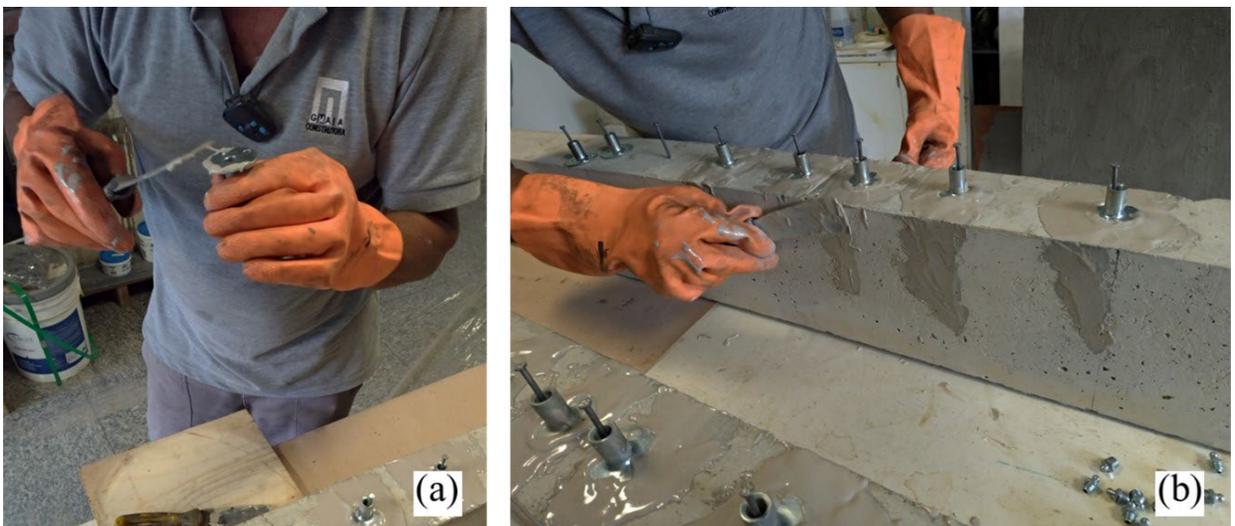
**Figure 5.** Gluing of surface packers (a); sealing the cracks (b).

After the beams were cleaned, the cracks were sealed and the surface packers were glued with an epoxy adhesive and secured with nails. In Figure 5 one can observe the gluing of the surface packers and the superficial sealing of each crack, which extended through the entire lateral section. All cracks visible to the naked eye on the surface of the model that underwent tension were injected.

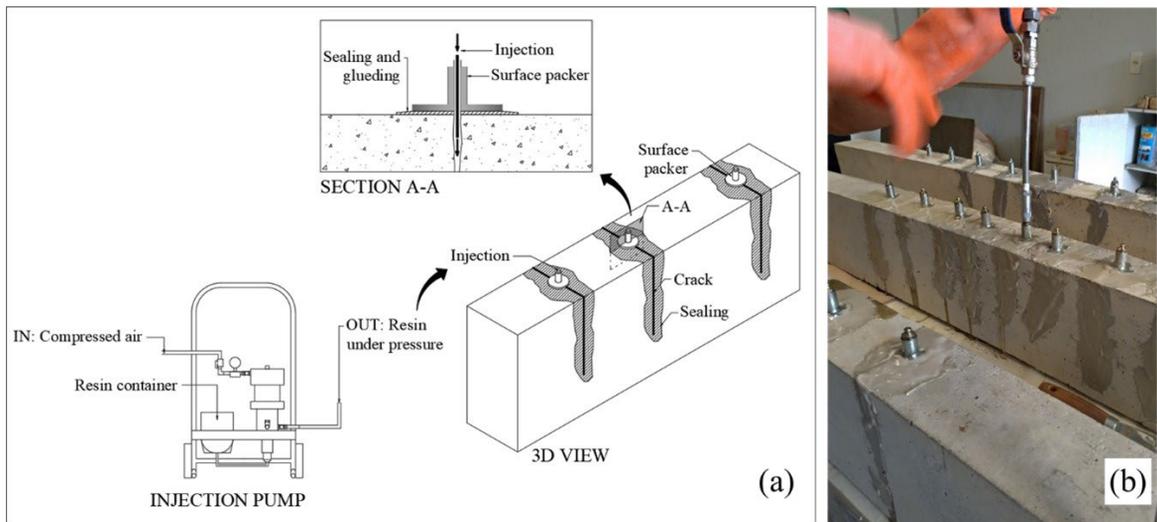
Figure 6. General schematics of crack injection in the models (a); crack injection procedure (b)

The cracks received epoxy resin injections after the sealing adhesive finished curing. The bicomponent resin was mixed and all cracks were injected as shown in Figure 6.

The entire injection process was performed with pressures varying between 35 bar and 100 bar, values below the 200 bar recommended by the manufacturer as the maximum pressure for crack injection. The injection procedure of each crack was finished when the injected material overflowed.

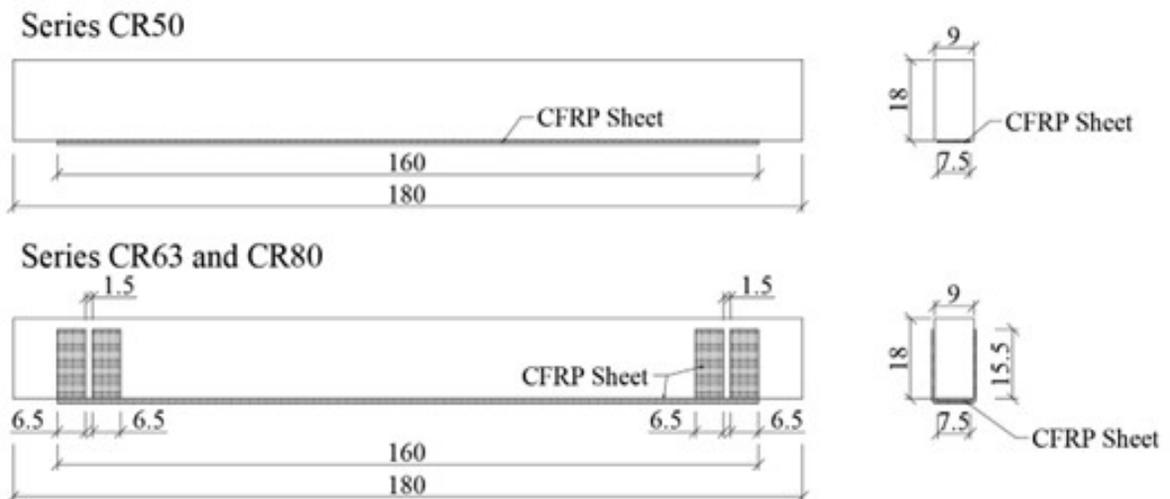
Figure 7. Schematics of beams reinforced with CFRP sheet. Dimensions in centimeters.

The flexural reinforcement was designed according to the ACI 440.2R [8]. The ultimate load reached in each specimen of Lima's [12] work was adopted as design criteria. All elements were reinforced with a single layer of CFRP. For specimens CR63 and CR80, where ultimate loads surpassed that of specimen CR50, a transverse anchorage was necessary in order to meet criteria established in the ACI 440.2R [8]. Figure 7 displays the schematics of beams reinforced with CFRP. Table 4 indicates the physical and mechanical characteristics of materials employed in the reinforcement.

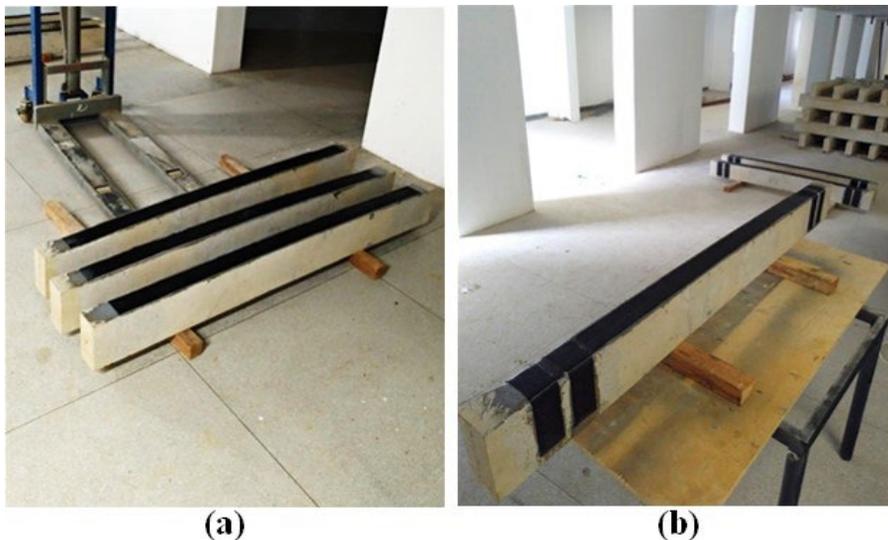
**Figure 8.** Beams reinforced with CFRP without anchorage (a), and with anchorage (b).

The lamination resin was applied after the thixotropic adhesive finished curing, with the sheet already attached. A foam paint roller was used to drench the CFRP sheet in the lamination resin, ensuring that the carbon fiber sheet was completely soaked with resin. Figure 8 shows part of the beam specimens after the rehabilitation process, highlighting the lower faces where the CFRP sheet was applied.

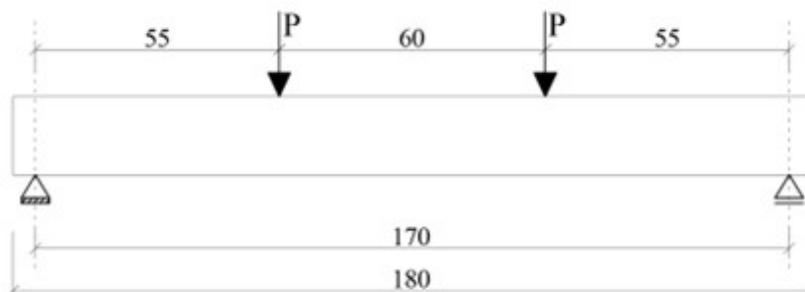
**Figure 9.** Bending test structural model. Dimensions in centimeters

The bending test followed the same procedure employed in the reference experiments conducted by Lima [12]. The Stuttgart Test configuration was adopted, with four load application points. Loads were applied 55 cm away from supports and were 60 cm apart, as shown in Figure 9.

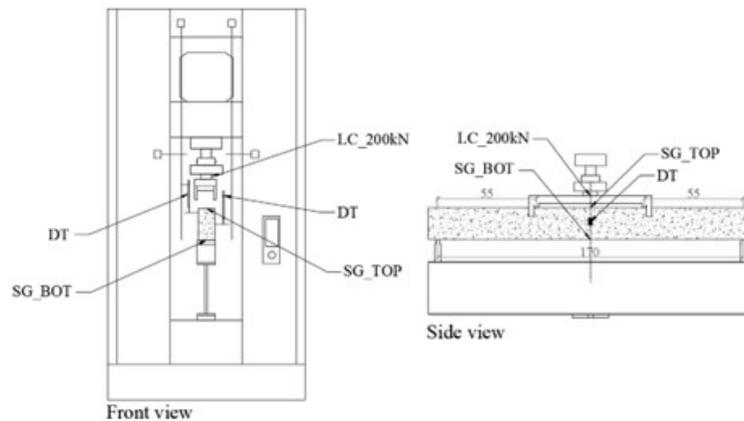
**Figure 10.** Bending test assembly schematics. Dimensions in centimeters.

Two displacement transducers (DT) were installed in the center of the span in order to measure displacements. Additionally, two strain gauges were employed, both placed on the piece's central axis. One of the strain gauges was placed on the top of the element (SG\_TOP) and the other at the bottom (SG\_BOT) to measure deformations in the concrete and in the carbon fiber, respectively. A 200kN load cell was placed between the load transmission device and the actuator's spherical seating in the universal testing machine. Figure 10 displays the bending test's assembly schematics.

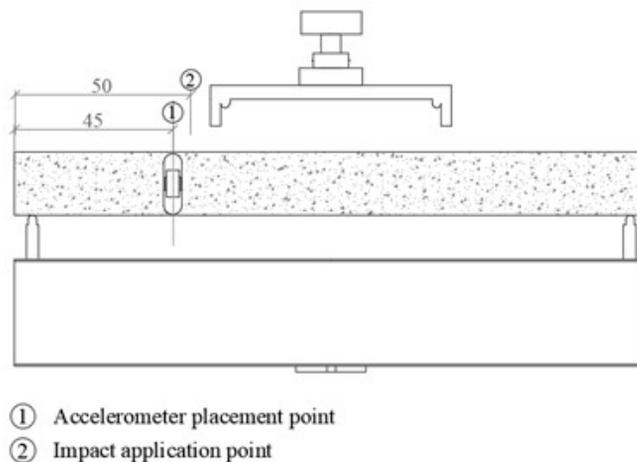
**Figure 11.** Accelerometer placement and impact application point in the vibration test.

The beams were instrumented as shown in Figure 11, with an accelerometer in position 1. The beam was struck with a rubber hammer in position 2 so that its fundamental frequency could be obtained.

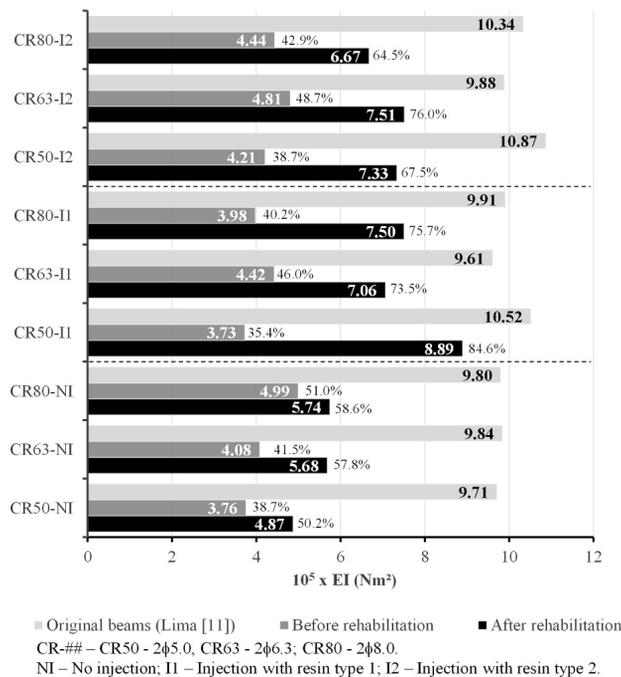
Figure 12. Estimated stiffness of the beams.

Based on acceleration and frequency values obtained in the vibration tests, the stiffness before and after structural rehabilitation was estimated through Equation 1. Figure 12 displays the stiffness of each beam specimen before and after rehabilitation, as well as the stiffness values of the original undamaged beams obtained by Lima [12].

After structural rehabilitation, elements that went through the injection process and were reinforced with CFRP (CR##-I1 and CR##-I2) displayed an average stiffness of 74% of the original beams’ stiffness, as observed in the results shown in Figure 12. In contrast, elements that were only reinforced with CFRP and were not injected (CR##-NI) displayed an average 55% of the original specimens’ stiffness. Therefore, in both cases (with and without crack injection) stiffness was higher than the estimated stiffness of damaged specimens before rehabilitation. It is also evident that specimens with crack injection (CR##-I1 and CR##-I2) displayed a stiffness superior to those only reinforced with

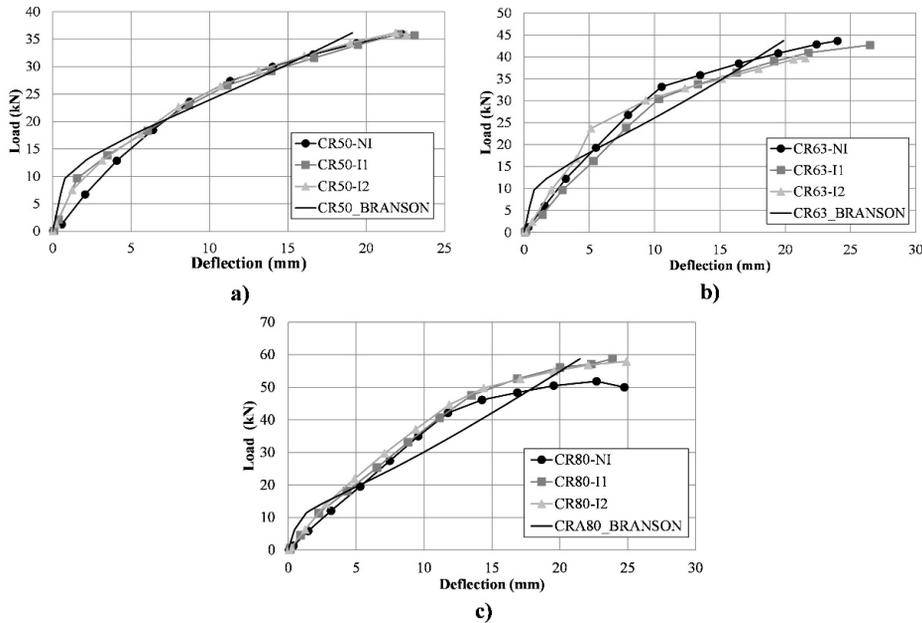
**Figure 13.** Load-deflection curves obtained in the bending test for beams: a) CR50; b) CR63; c) CR80. Load (kN) represents the sum of the loads ( $2P$ ) applied to the beam.

Figure 13 displays load-deflection curves obtained in the bending tests. In addition to test curves, one extra curve has been plotted based on the analytical model proposed by Branson [17], which considers the CFRP sheet in the same way as the reinforcement bars for purposes of cross-section homogenization.

By observing curve slopes in Figure 13, one can note a difference in element stiffness during initial load stages. This difference is related to the adoption of the structural rehabilitation process. Non-injected beams (CR##-NI) had a lower initial stiffness than injected beams, except for beam CR63-NI. This lower initial stiffness in non-injected specimens is consistent with the results obtained with vibration tests, displayed in Figure 12. Moreover, the difference in stiffness becomes less pronounced during load application and the stiffness decay level tends to be the same in all beams in stages with more elevated loads.

When experimental results and analytically estimated results are compared, it is evident that Branson's analytic model [17] predicts a higher initial stiffness. This model considers that the parts are uncracked at the beginning of the test. However, according to what has been observed in the vibration tests, in the case of rehabilitated elements, not even parts that underwent crack injections with epoxy resins displayed a stiffness level equal to that of uncracked parts. Therefore, the difference in stiffness during initial load stages that can be seen in the load-displacement curves is due to a degradation already present in all elements.

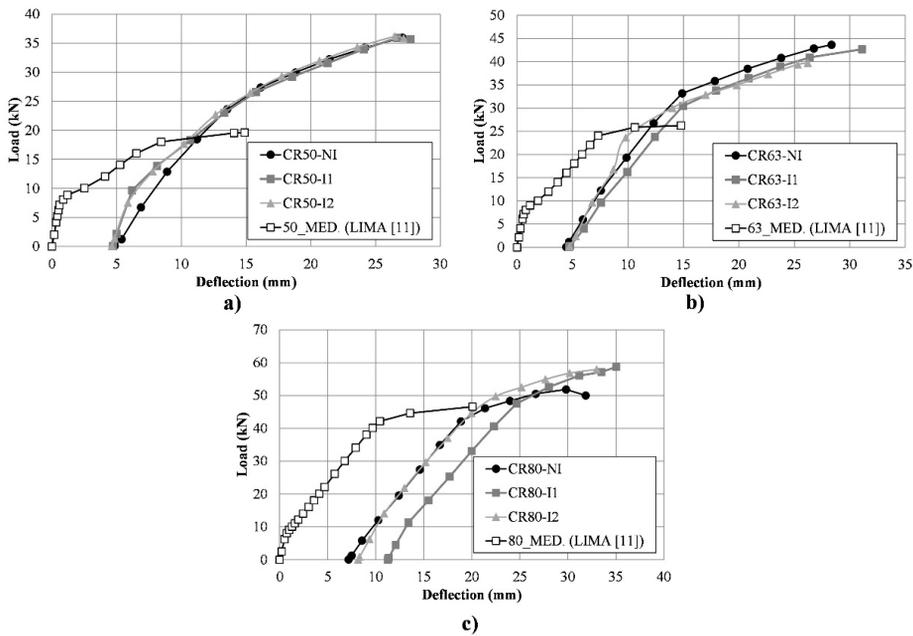
**Figure 14.** Load-deflection curves comparing rehabilitated beams with the original undamaged beams tested by Lima [12]: a) CR50; b) CR63; c) CR80. Load (kN) represents the sum of the loads (2P) applied to the beam.

Figure 14 displays load-displacement curves obtained through the bending test. The deflection relative to each load stage corresponds to the deflection obtained in the test added to the residual deflection measured prior to testing, according to figures presented in Table 1. The average curve of the original undamaged specimen tests obtained by Lima [12] is also displayed with each group of beams with the same reinforcement ratio. This allows for the comparison of the original specimens' behavior as tested by Lima [12] and after structural rehabilitation.

Based on Figure 14, one can note that non-injected elements (CR##-NI) presented a stiffness like that of the original beam in State II (##\_MED). In contrast, the stiffness of beams that underwent the crack injection procedure (CR##-I1 and CR##-I2) was lower in comparison to the original beam in State I (##\_MED), but higher in State II. After the injected beams' (CR##-I1 and CR##-I2) cracking load was reached, which is evident in the inclination change seen in the load-displacement curve, their stiffness remained close to that of the original beams in State II (##\_MED) and to that of the non-injected reinforced beams (CR##-NI).

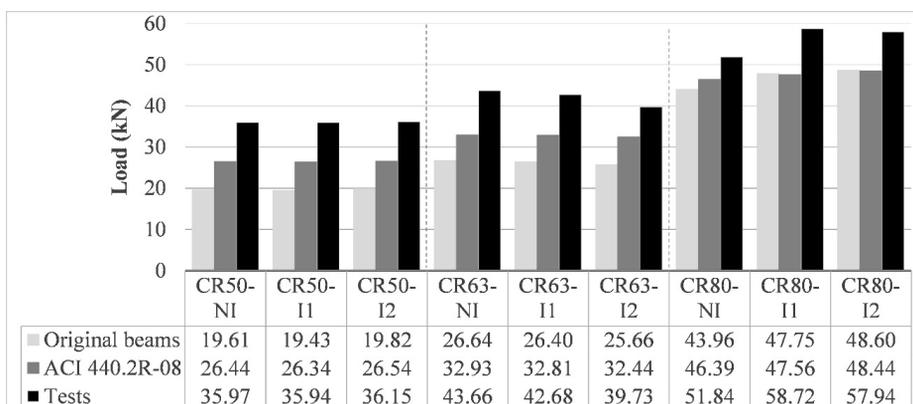
**Figure 15.** Ultimate loads obtained for the original beams based on design specifications in the ACI 440.2R [8] and through tests. Load (kN) represents the sum of the loads (2P) applied to the beam.

Figure 15 displays ultimate load values reached in the testing of the original undamaged beams and of the reinforced beams, as well as the ultimate load estimated according to design specifications in the ACI 440.2R [8]. The three specimens in each group, which had the same rebars and received reinforcements, displayed similar ultimate loads, indicating that the injection procedure did not influence the ultimate load level. CFRP sheet reinforcements significantly increased ultimate load, especially in the CR50 beams, which displayed an increase in resistance of 84% in comparison to the original undamaged specimens. Moreover, all ultimate loads in the tests surpassed those predicted by design specifications in the ACI 440.2R [8].

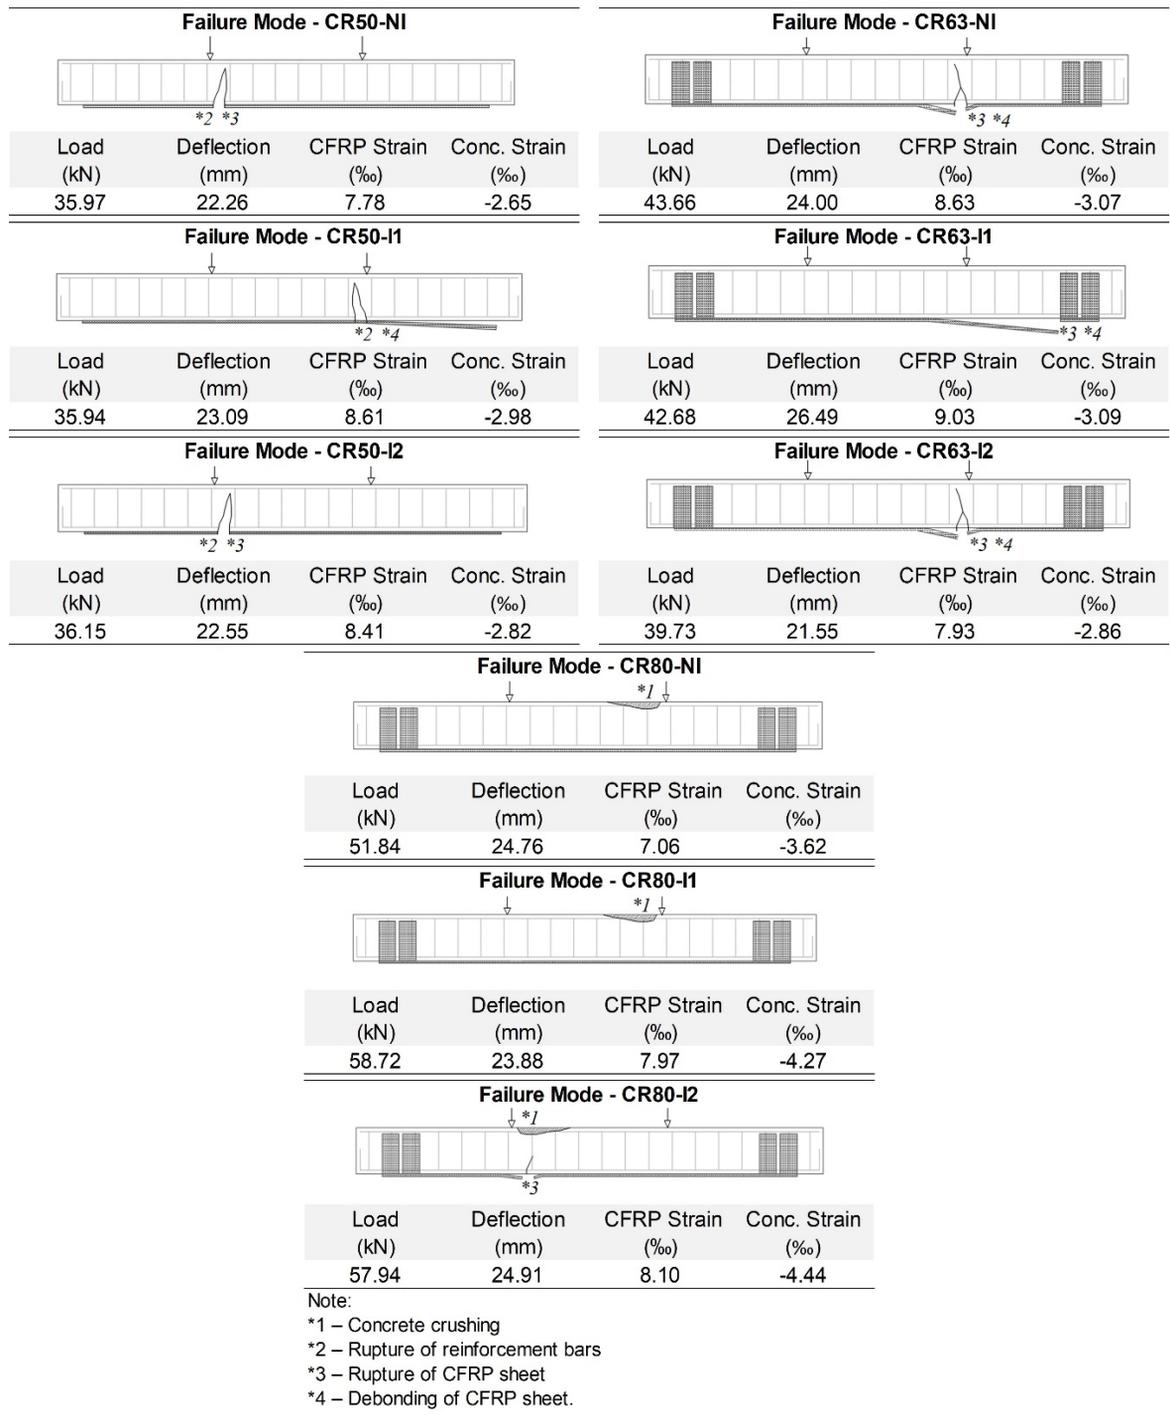
Figure 16. Failure modes displayed by the specimens. Load (kN) represents the sum of the loads (2P) applied to the beams.

Beams with the same reinforcement ratio displayed similar failure modes. The maximum values reached for load, deflection and deformation can be seen in Figure 16, along with a sketch exemplifying the failure mode of each beam. Note that concrete deflection and deformation results include residual values already present before the test.

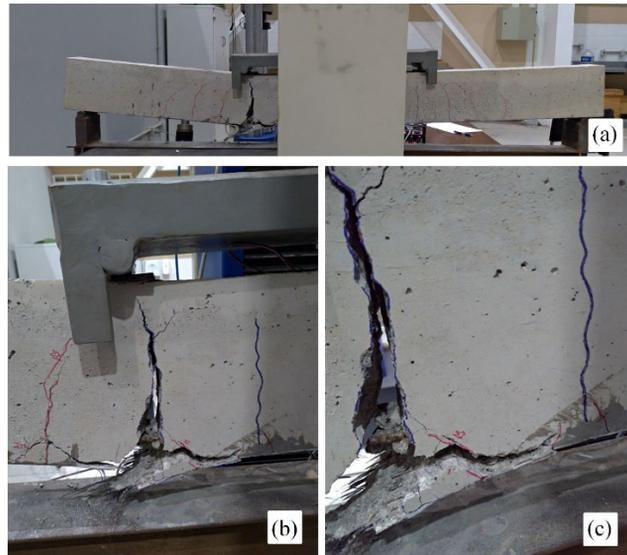
**Figure 17.** Failure of specimen CR50-NI (a); Detail of the specimen's failure location (b); Detail of the rupture of the CFRP sheet and positive reinforcement (c).

All CR50 beams displayed reinforcement bar failure associated to the rupture or debonding of the CFRP reinforcement. This indicates that the reinforcement bars ruptured first, causing the entire traction load to fall upon the CFRP reinforcement, causing its failure (Figure 17).

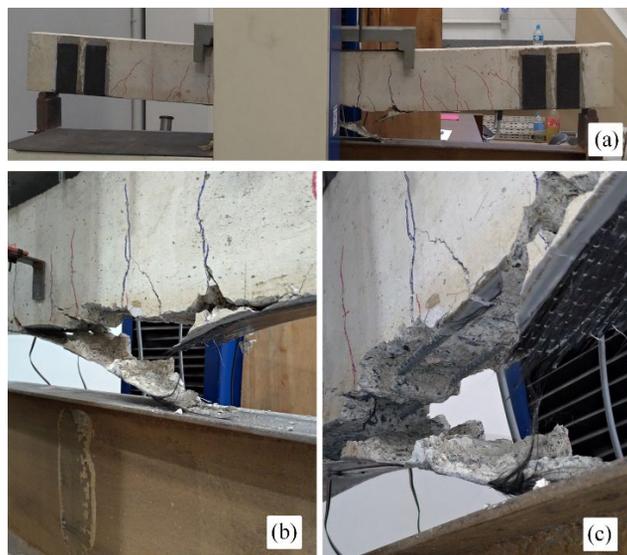
**Figure 18.** Failure of beam CR63-NI (a); Detail of the rupture and debonding of the CFRP sheet (b); Detail of the non-rupture of the positive reinforcement (c).

CR63 beams displayed failure due to the rupture of the CFRP sheet combined with its debonding from the concrete surface. A horizontal failure surface and a high cracking level were evident, characterizing failure due to the reinforcement's sudden peel off caused by shear cracks. The detachment of concrete parts previously joined to the reinforcement was also observed (Figure 18).

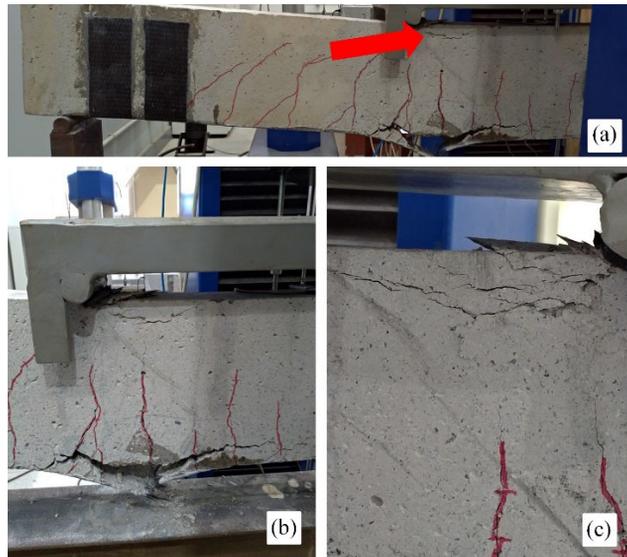
**Figure 19.** Failure of beam CR80-I2 (a); Detail of the crushed concrete and of the CFRP sheet rupture (b); Magnified detail of the crushed concrete (c).

All beams in the CR80 series displayed the same failure mode, which was the crushing of the compressed concrete. Figure 19 displays the failure mode seen in specimen CR80-I2. In all cases, the concrete's deformation was greater than 3.5%, corroborating its behavior. Moreover, CR80 beams showed a 20% difference in ultimate load in comparison to the ultimate load predicted by the ACI 440.2R [8], while for the other beams this difference was approximately 30%. This may be related to the failure mode, which occurred in the tensioned region in CR50 and CR63 elements and in the compressed region of CR80 elements.

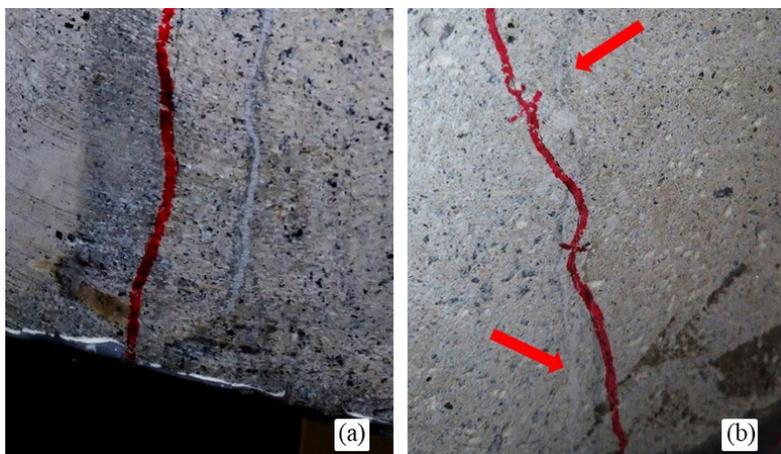
**Figure 20.** Detail of a new crack next to an injected crack (a); Detail of a new crack crossing an injected crack (b).

Non-injected beams suffered an increase in already-present cracks and the emergence of new cracks throughout the element. Specimens that received epoxy resin injections reached failure with a cracking pattern similar to that of non-injected specimens, but only displayed cracks that spawned during testing. Injected cracks did not reopen and new cracks appeared in the surroundings of those that had been injected, as shown in Figure 20. In some cases, the new cracks crossed previously injected cracks, confirming the efficacy of the injection process and the successful recovery of monolithism in the previously cracked region.
