Structural health assessment of a historical building by using in situ stress wave NDT: a case study in Iran

The aim of this study was to undertake the in situ evaluation of structural wood member in a historical building (Reza-Nejad) in Gorgan, Northern Iran using stress wave non-destructive testing (NDT). The Reza-Nejad was built approximately 80 years ago. This study is the second one after that conducted by (Madhoushi, 2016) on the use of non-destructive testing (NDT) for the investigation and health assessment of historical wooden buildings in Iran.

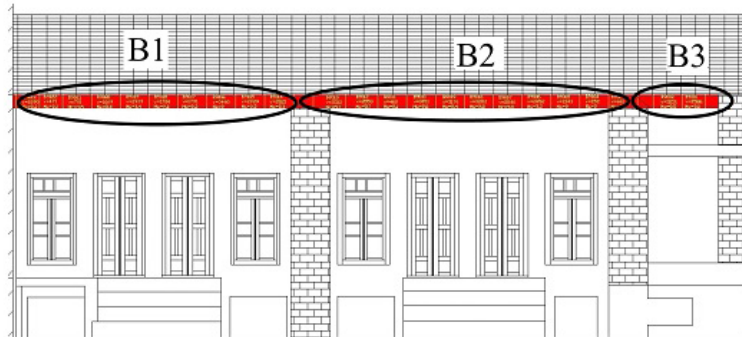
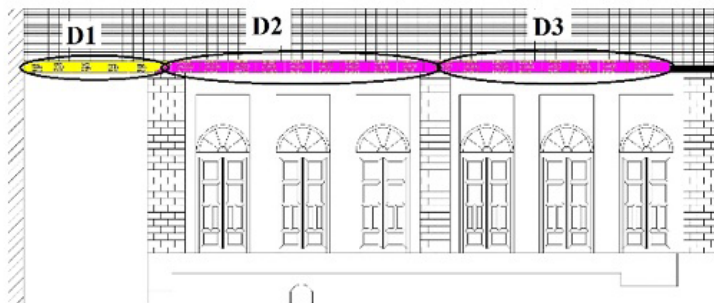
(a) Section A-A East,

(b) Section B-B North,

(c) Section C-C West,

(d) Section D-D South,

Fig. 6 Main plans of four sections of buildings and wood beams in a) A, b) B, c) C, and d) D (see Fig. 1 for more details).

Microscopic identification of samples showed that the load bearing wooden parts of the building were made of hardwood species native to the northern region of Iran including oak (*Quercus castaneaefolia*), lime tree (*Tilia begonifolia*), acer (*Acer insigne*), and beech (*Fagus orientalis*). Fig. 4 and 5 show the microscopical sample for transverse and tangential sections, respectively. The location of wood species in the building is shown in Fig.6 and Tab. 2.

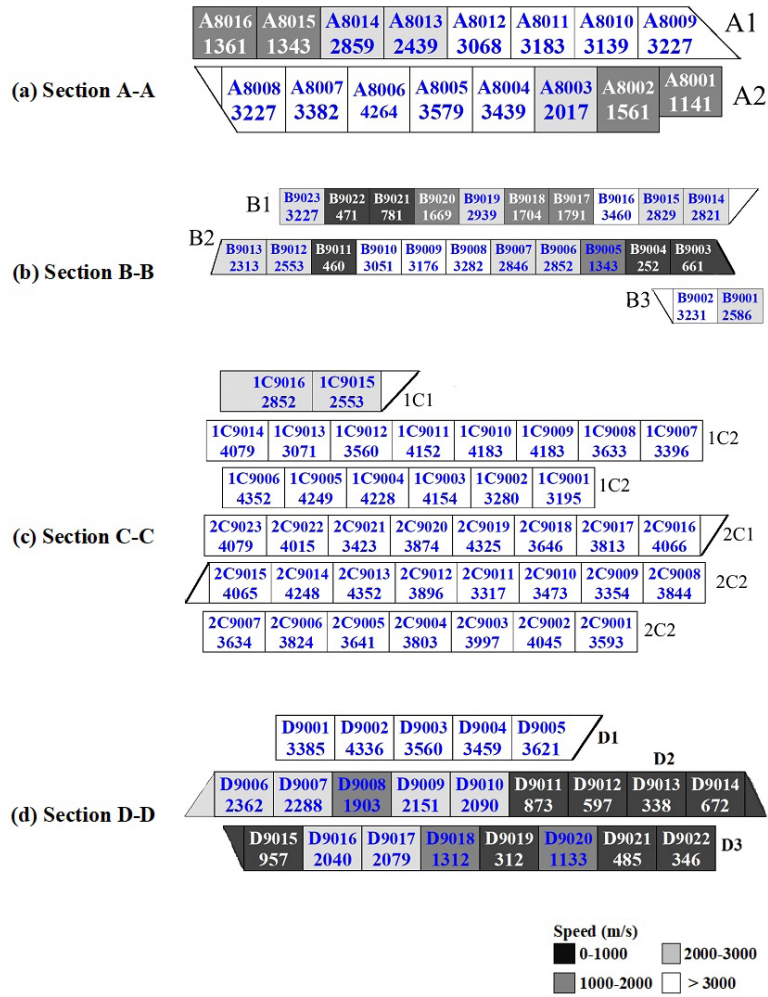
shown in Fig. 7, 8, 9 and 10, for each sample. The results indicated a low WS, mostly at the two ends of members, where insects' holes and decayed parts were most visible.

Fig. 7 WS in wood beam a) A, b) B, c) C, and d) D (see Fig. 6 for more details).

Furthermore, the results revealed that the WS is higher in sound members as compared with decayed ones. In addition, in members exposed to insects' attacks, humidity penetration and tensions caused by loading, more severe destruction was observed than in other members. More severe destructions were also observed in parts that were exposed to regional wind.

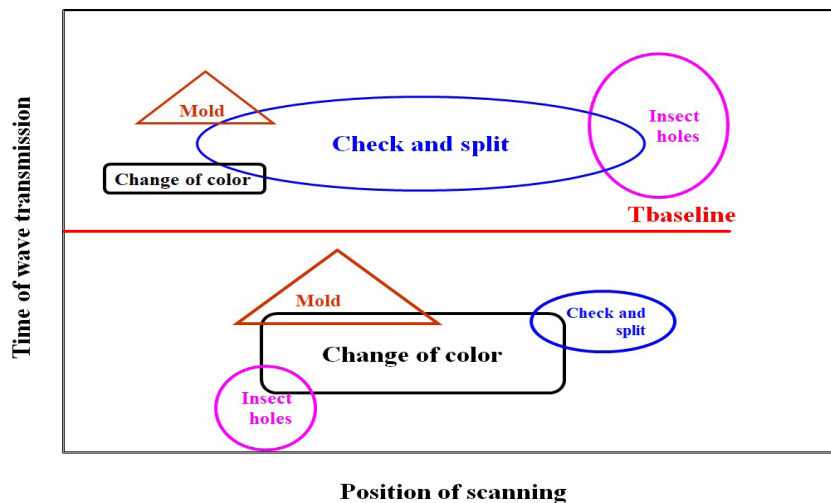
Moreover, the finding revealed that the WS wave should be considered and compared with the types of defects of area, especially with cracks and knots as Fig. 12

shows. This figure demonstrates these findings as a general pattern. These findings were not reported by previous investigations, as WS has majorly been used as an indicator and method of identification of defects without types of faults.

Fig. 12 Types of defects in comparison with control time (baseline).

Due to high relative humidity of climate, wood structures are exposed to faults in the northern region of Iran. However, their general appearance is adequate and acceptable. Wooden parts of the studied house suffered color alteration as well as fungus and insect attacks. TWT in wooden parts is dependent on the defect amount, thus, stress wave would move faster in healthy wooden parts than in destroyed ones. In some parts, there were severe defective members which are very critical from a safety point of view. The results indicated that for better decision making, the TWT should be accompanied by more investigation into the types of defect, especially in those parts where TWT are higher than control time.
