Analysis of reinforced concrete structures through the ultrasonic pulse velocity: technological parameters involved

Análise de estruturas de concreto armado através da velocidade de propagação do pulso ultrassônico: estudo de parâmetros tecnológicos intervenientes

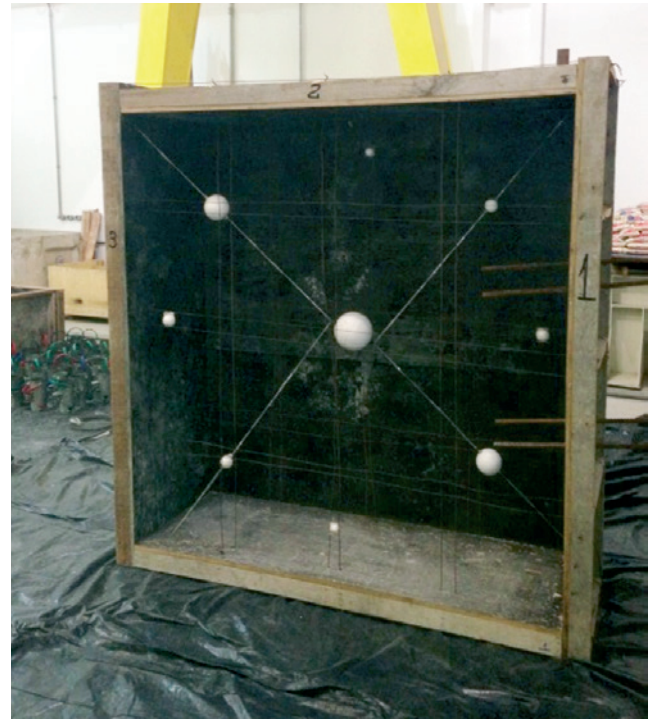
Figure 1
Position of styrofoam balls

To represent the existence of voids and failures of concrete, styrofoam balls were used with dimensions varying between 5, 10 and 15 cm, in different positions within the walls. The use of styrofoam is justified because of its density, which is quite lower than the concrete, not allowing the penetration of cement paste inside. All the styrofoam balls were fixed with nylon cord, so that each one remains on its place, avoiding the interference of one over the other.

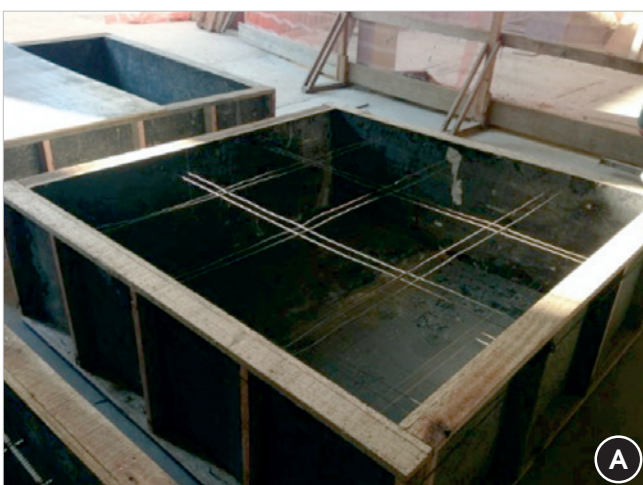
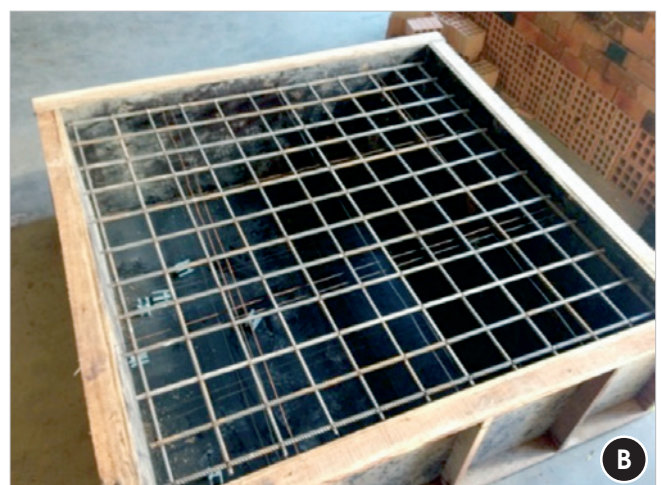
Figure 2
(a) wall without reinforcement (b) wall with reinforcement

used, with density of relatively high reinforcement, composed of structural steel bars of type CA-50 12.5 mm diameter, and spacing of 15 cm.

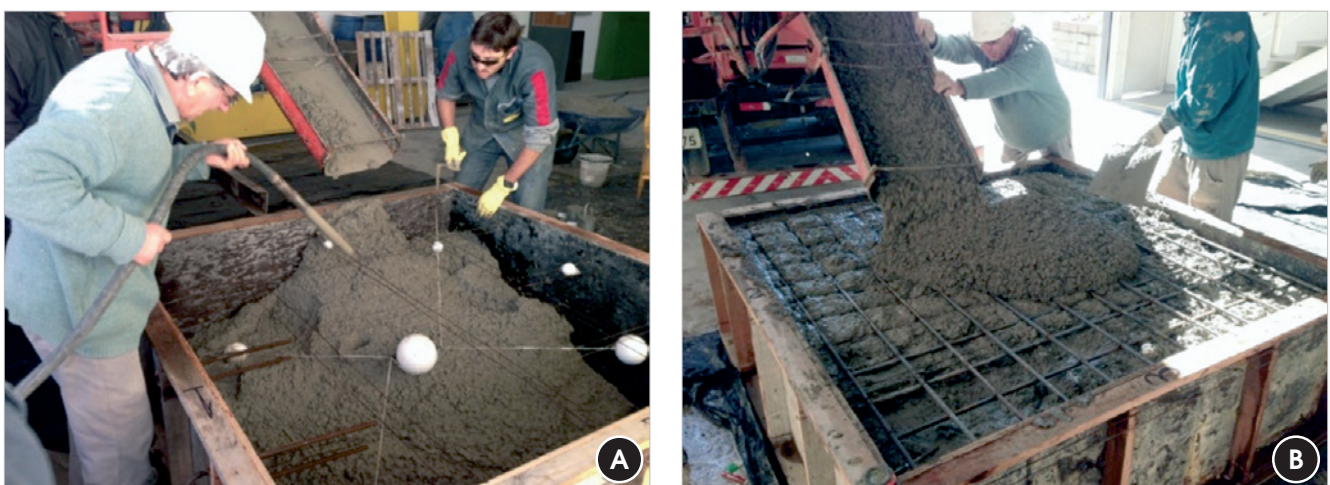
Figure 3
(a) concrete molds without reinforcement and (b) concrete molds with reinforcement

A vibrator needle type was used to concrete. The launch time of concrete was 2 hours. Due care was taken to avoid the displacement of voids (styrofoam balls). In figures 3 (a) and (b) are presented, respectively, the concreting of the element without reinforcement and the concreting of the element with reinforcement.

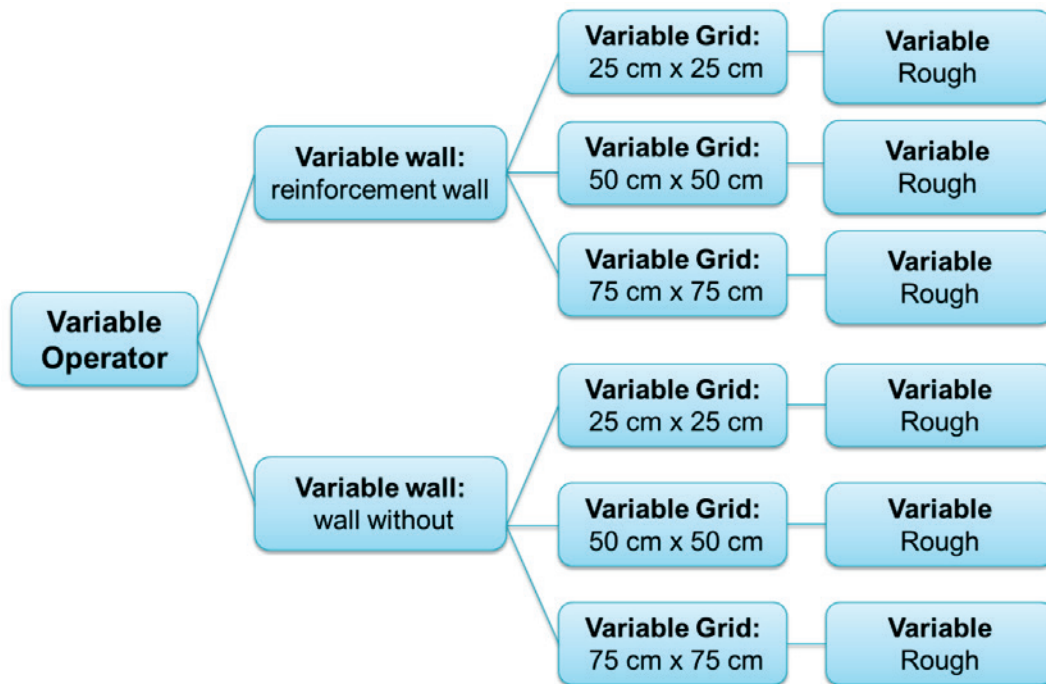
Figure 4
Reading processes

sistance of concrete in the UPV measures. Indirect readings were made as NBR 8802 guidelines [19]. For the coupling of transducers, it was used gel. In Figure 4, are shown the combinations of the readings performed. According to the process of readings presented, the two walls with horizontal, vertical and diagonal readings around each point have been mapped. These readings were grouped to-

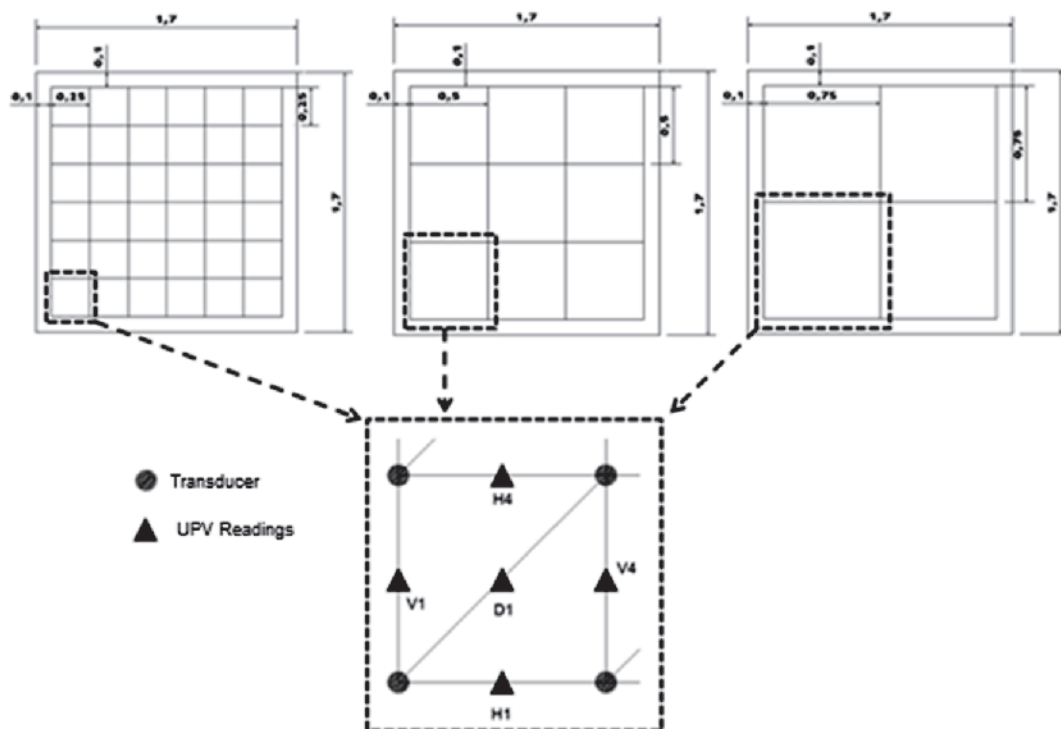
Figure 5
Reading procedure

At the time of carrying out the tests, predetermined points were used to locate accurately on a map, how long the wave takes to traverse the path between the transmitter-transducer and the transducer-receiver in accordance with their respective coordinate on the structure analyzed. Figure 5 shows how to

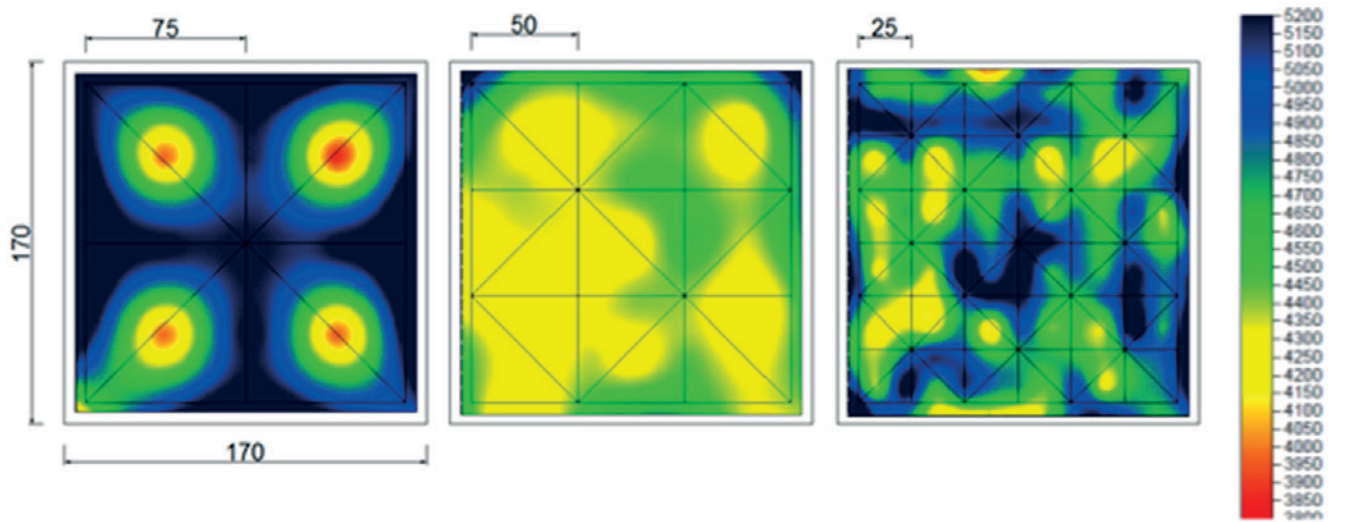
Figure 6
(a) 75 x 75 cm Grid (b) Grid 50 x 50 cm and (c) Grid 25 x 25

As discussed in item 3, three mesh spacing were used to determine changes in the type of response obtained through the mapping of the data in relation to the defect identification. In Figures 6 (a), (b) and (c), can be verified, respectively, the images generated in grid of 75 cm, 50 cm and 25 cm, which were held on the wall without reinforcement and on a smooth face. In the grid of 25 cm is gotten a total of 120 readings, on the grid of 50 cm, 33 readings, and 75 cm grid, 20 readings, all indirect ones.

As it can be seen, the image generated with 25 cm reading grid enabled better representation of different regions, more defined regions when compared to images obtained with readings of 50 cm and 75 cm. In this way, to the analysis of the effects of different variables it was used the grid of 25 cm reading.

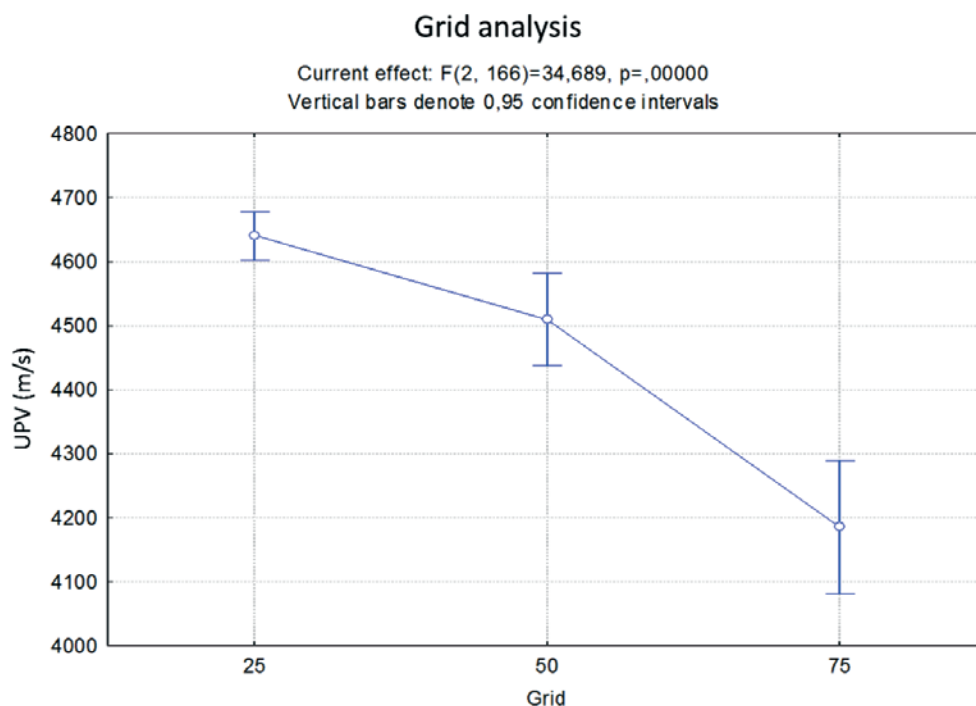
Figure 7
Influence of different grids

tect more sensible defects. When the diagnosis of a structure is the most significant extension search, less refined grids are already sufficient and facilitate both the execution of the tests and their analyses. To highlight the differences between grids presented in Figure 6, a statistical analysis was performed through variance (ANOVA), with the aim of comparing the UPV obtained for the different grids. Figure 7 graphically presents the results obtained.

It is possible to observe that the analysis gives us a probability close to zero (with a significance level of 95%), showing that the differences of UPV are significant, when you change the distance between the transducers. With the increase in the grid, it shows a tendency of reduction of the UPV, independent of the presence or absence of reinforcement. This result highlights the importance of maintaining the same distance between transducers, when carried out a survey of the homogeneity of a concrete structure. The mixing of distances within the same structure is not indicated, since it can put at risk the analyses, and may generate wrong interpretations, from velocity reduction with increasing distance, and not a region necessarily suspect.

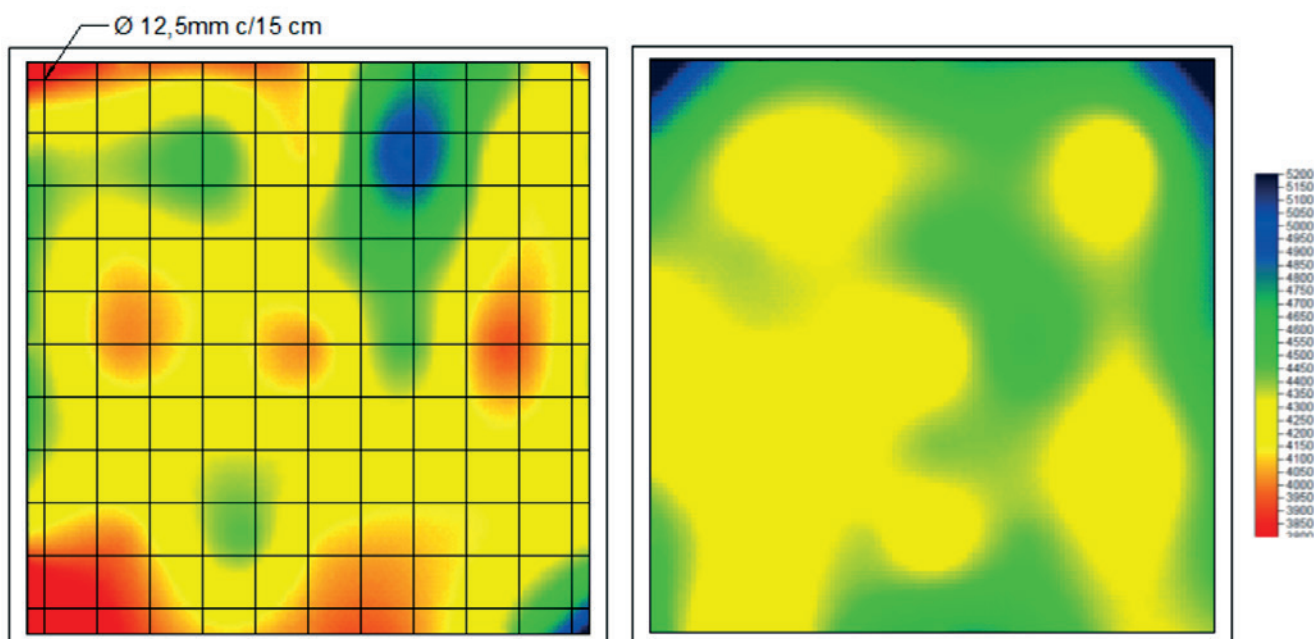
Figure 8

(a) images generated on the wall with reinforcement (b) images generated on the wall without reinforcement

Figures 8 (a) and (b) are, respectively, the images generated from reinforcement walls and walls without presence of reinforcement. Analyzing visually the images, it is possible to see some differences in coloration. These differences, although represent only a sharp reduction, are significant in the average of the velocity obtained with presence of reinforcement.

This behavior is not only contrary to what some authors claim, but is also contrary to the initial hypothesis of this research. About the homogeneity of the walls, the presence of reinforcement does not harm the interpretation of images, since the mapping of regions with different velocity was similar in both settings.

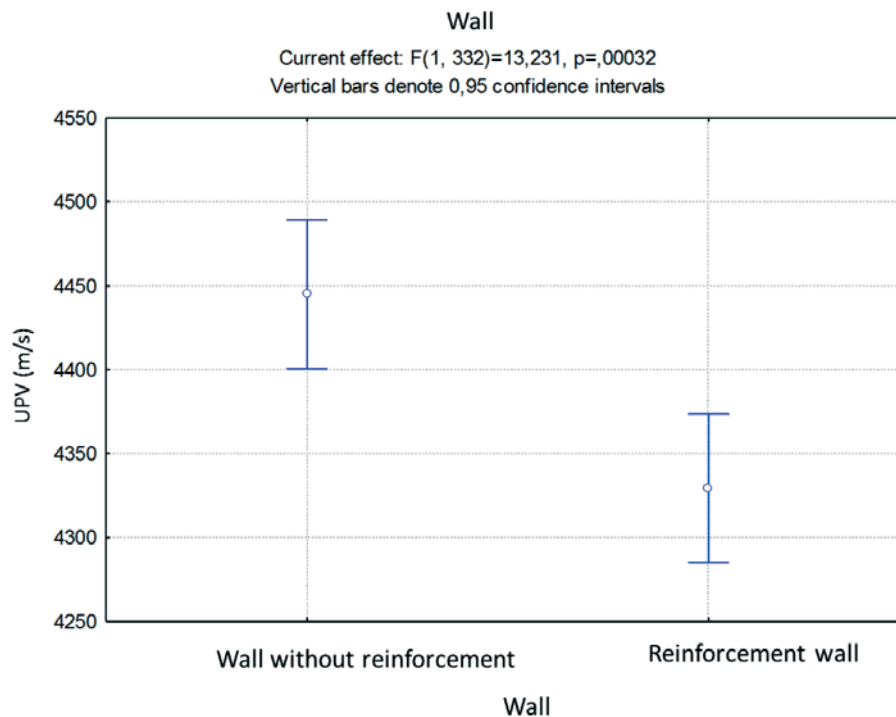
Figure 9
Influence of the presence of reinforcement

Figure 9 presents the statistical analysis that evaluates the significance of the presence of reinforcement in the analysis of UPV. It can be observed in the chart above, a slight tendency for the velocity on the wall without reinforcement being larger than on the wall with the presence of reinforcement. When all data were subjected to statistical analysis, the presence of reinforcement used led to significant changes in UPV, reduced UPV with 95% significance level.

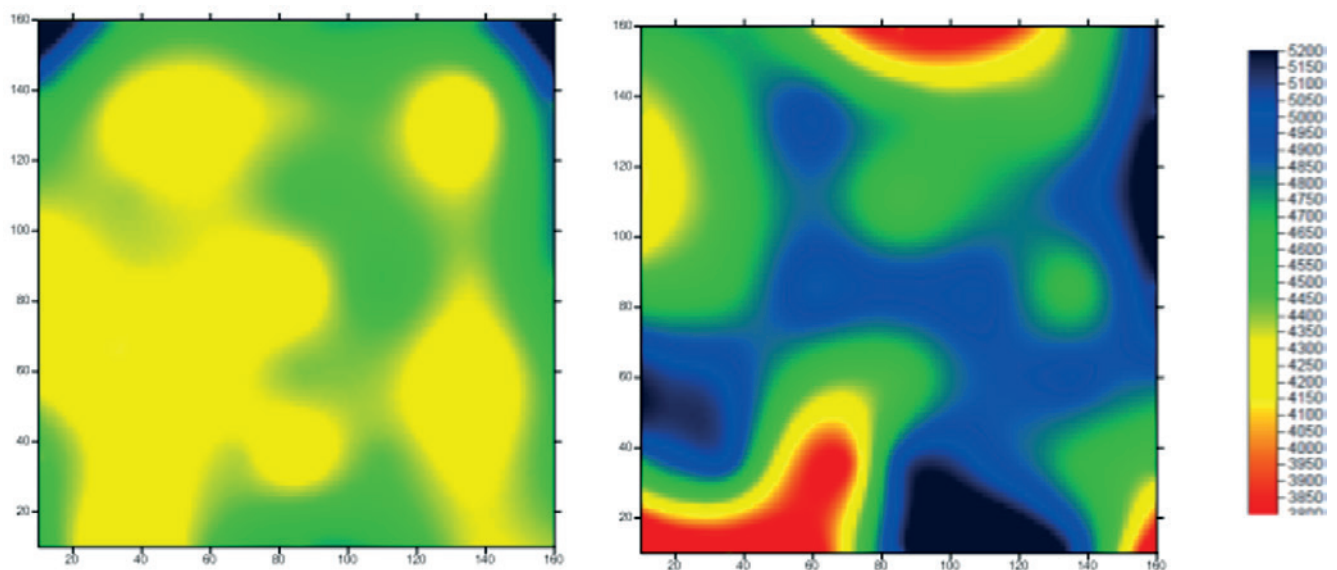
Figure 10
(a) images generated from the wall, with experienced operator (B) images generated from the wall with operator training phase

different operators was also held. This factor is relevant, because the field analyses demand often several operators working simultaneously. Figure 10 shows two images generated from velocity of two operators, one with experience in previous works and another on training phase, Figure 9 (a) and (b). Both readings were performed on the wall without presence of reinforcement. Analyzing Figure 9, it can observed that when the readings are made by experienced operator, the image shows more regular, both in colors as the average of the velocity. In the case of the inexperienced operator, were generated lower velocity and regions that could be interpreted as having problems inside the concrete.

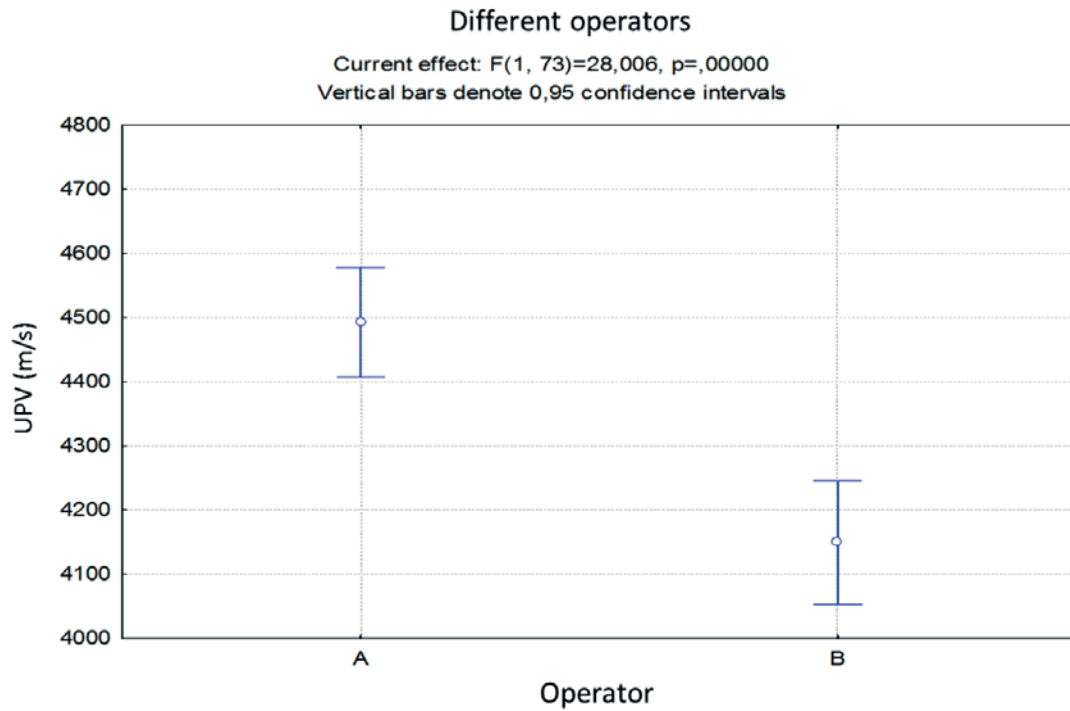
Figure 11
Influence of different operators

The analysis of Figure 11 proves exactly what had already been checked in the interpretations of the images generated by the computer program, in which the inexperienced operator obtained velocity significantly below those of experienced operator, generating differences in average of 300 m/s. From this, it is possible to conclude that it is of the utmost importance, for future work in the field, the training team that will perform these jobs. This training should

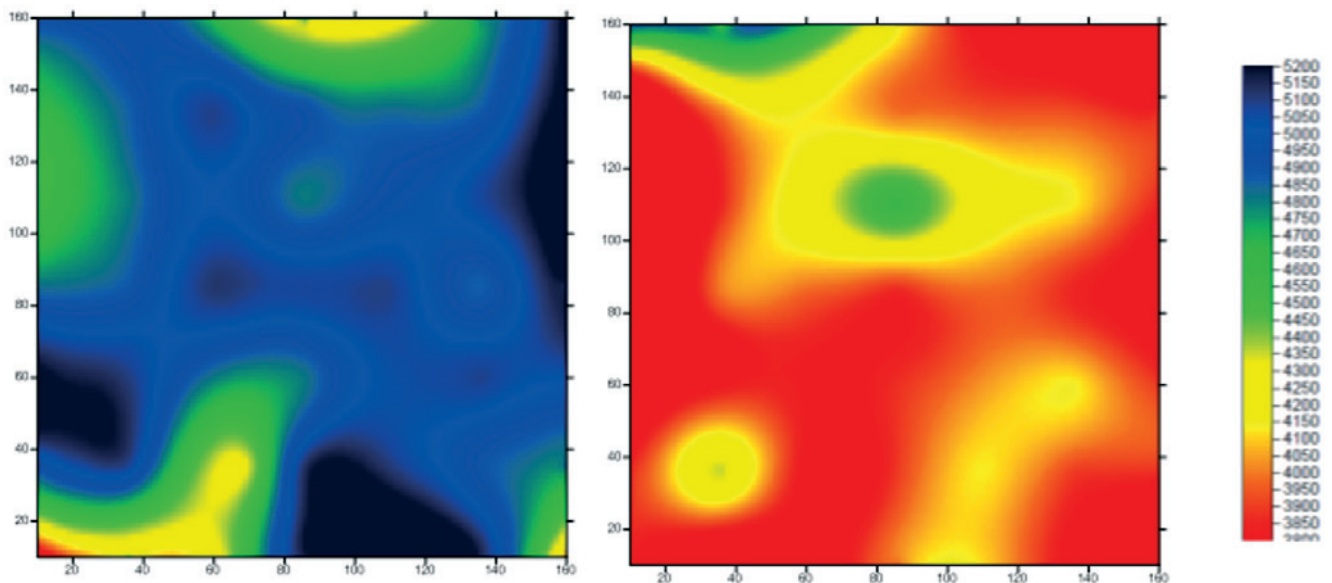
Figure 12
(a) images generated from the wall with smooth surface (b) images generated from the wall with rough surface

studied, one favourable for tests for been smooth, and the other with enough roughness, however, more found in situations of in situ inspections. Figures 12 (a) and (b) show the influence of smooth and rough surfaces, respectively.

It can be observed that the readings performed by a single operator, in the same structure, but with different surface roughness, are significantly different. With the image generated from the velocity

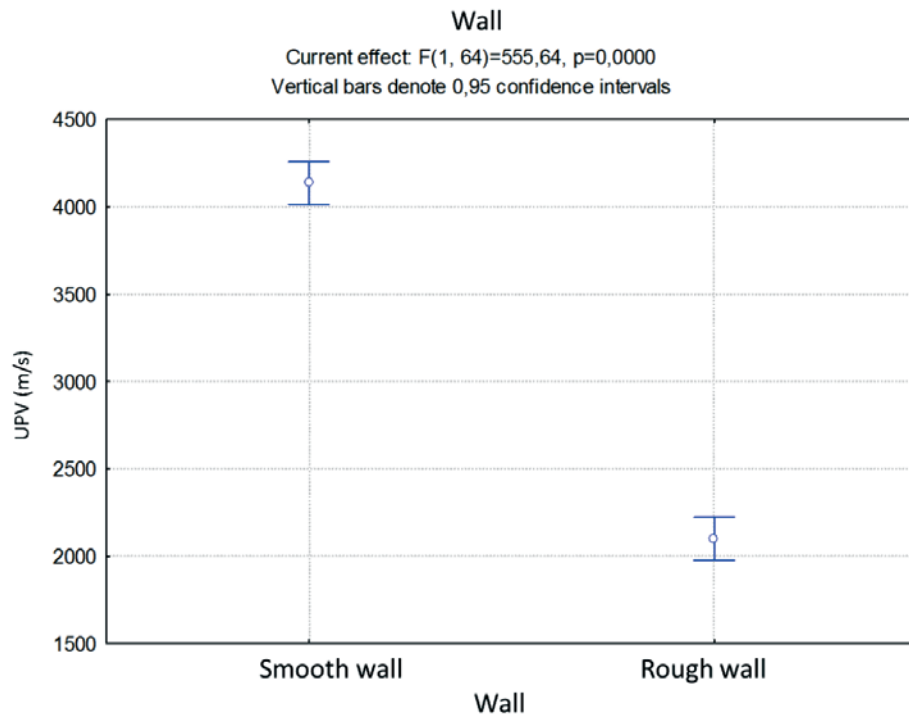
Figure 13
Influence of different surfaces

obtained in rough surface, it can be concluded that this setting nullifies any interpretation, due to any noise caused by these irregularities in the propagation of UPV. Figure 13 presents graphically the proof of this effect.

It can be concluded, from the chart, that the roughness on the surface of the concrete influences significantly the UPV values, decreasing them. It is concluded that, in situations where readings
