The effect of various polymer-based coating types on the biological corrosion resistance of mortar

Keywords: Mortar, microbiological corrosion, coating materials, sewerage systems.

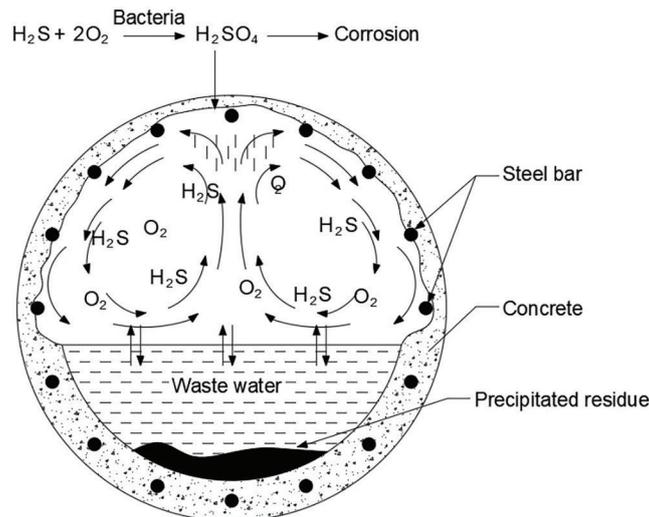
Figure 1: Formation of the H_2SO_4 in sewage systems.

Over time, deterioration is observed in the structural elements that constitute sewerage systems and these require repair. One of the most commonly encountered problems in sewerage systems is biological organisms that cause acid attack within the system. The economic loss resulting from microbiologically-induced corrosion and the resulting repair and maintenance costs cause billions of dollars of loss in European countries [1–3]. Microbiologically-induced corrosion leads to a decrease of approximately 50–70% in the service life of concrete structures [4]. Domestic wastewater is typically alkaline and does not damage concrete. However, this type of waste contains sulfur components. Sulfate and certain proteins in sewage wastes form hydrogen sulfide (H_2S), which is not extremely detrimental to concrete, in anaerobic (oxygen-free) environments [5, 6]. H_2S is a colorless gas that is heavier than air, possesses a characteristic rotten egg odor, and is commonly found in oil fields, sewage, and chemical industry areas. Anaerobic bacteria are organisms that do not require air and survive by receiving oxygen from sulfates [7]. These bacteria break down sulfates in the soil, subsurface or wastewater and release H_2S , which rapidly corrodes iron alloys. High temperatures accelerate the speed of the reaction. H_2S is separated from sewage due to factors such as the chemical balance, movement and turbulence of the environment, and melts within the moisture in the sewage walls. The H_2S released merges with the O_2 in the air and produces the H_2SO_4 , which is known as sulfuric acid (Figure 1) [8, 9].

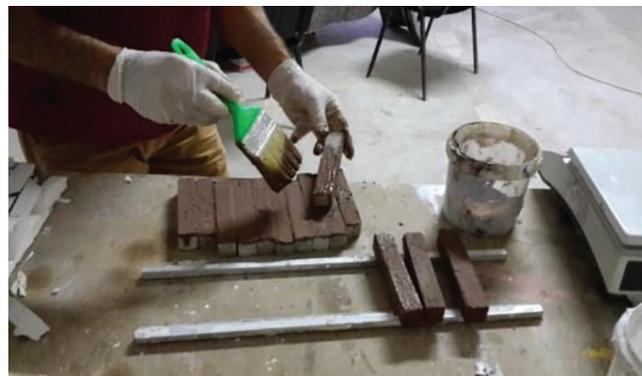
**Figure 2:** Coating the mortar samples with polyester, epoxy and crystallized waterproofing mortar.

A mortar mixer with a capacity of approximately 5 liters was used to produce the mortars. Following the dry mixing of the aggregate and cement for 1 minute, roughly two-thirds of the mixing water was added to the mortar mixture. The mixing process was continued for 3 minutes after the remaining water was added. The mixtures produced were poured into 25 × 25 × 180 mm prismatic molds. After 24 hours, the samples were removed from the molds and standard-cured for 28 days in 20 ± 2 °C lime-saturated water. On a stone cutting machine, 24 samples were divided in half, yielding 48 prismatic samples with dimensions of 25 × 25 × 90 mm. The coating components were prepared according to the manufacturer's specifications and applied to the concrete surface in one layer with a brush while wet and allowed to dry. The coating thickness of the coating ingredients that were applied in a single layer was not measured. As illustrated in Figure 2, 12 Epoxy (E), 12 Polyester (P), and 12 Crystallized (K) samples were applied to the samples as thin-film layers. After that, it was kept until it was completely dry, as illustrated in Figure 3.

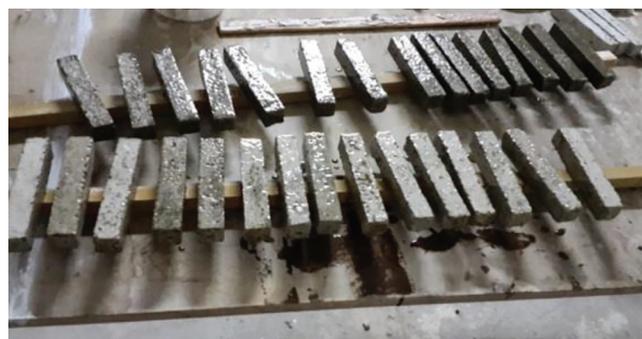
**Figure 3:** Drying the samples coated with polyester, epoxy and crystallized waterproofing mortar.

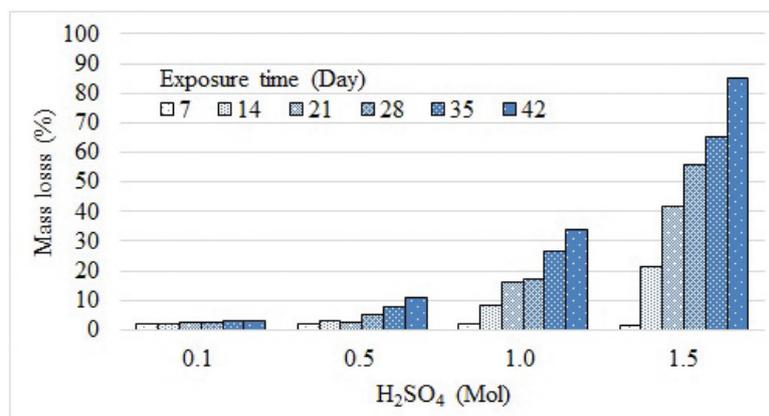
Figure 4: Weight losses of the samples coated with epoxy.

In the present study, sulfuric acid experiments were conducted using prismatic mortar samples of 25 × 25 × 90 mm. For 7, 14, 21, 28, 35, and 42 days, the samples were maintained in 0.1, 0.5, 1, 1.5 molar sulfuric acid solutions. Weight losses were calculated as a result of examining the corrosion of coated mortar samples in the H₂SO₄ solution over time, and the findings are shown in Figures 4–7, respectively.

When the molarity of the solution is maintained constant, hydrated products gradually move away from the environment, resulting in weight loss. The weight losses of the mortars increased over time in all batches, depending on the sulfuric acid molarity. Uncoated and polyester-coated samples exhibited higher losses than epoxy and crystallized waterproofing mortar. Particularly in the 1.5 M solution, losses neared 100%. In all molarities, uncoated control samples lost the most mass. In all molarities, 7 days of sulfuric acid exposure had a minor effect on epoxy-coated samples. At 0.1% molarity, weight loss stayed below 5% for the next few days.

When examined in terms of weight loss, it was determined that the most durable samples were those coated with epoxy. On the other hand, the samples coated with the crystallized waterproofing mortar produced similar results with the epoxy-coated samples. The highest loss in the epoxy-coated samples took place at the end of 42 days in the 1.5 M sulfuric acid solution at a rate of 85% while this rate was 95% in the samples coated with crystallized waterproofing mortar under the same conditions. The polyester-coated samples, on the other hand, reached 100% in 1.5 M sulfuric acid at the end of 28 days.

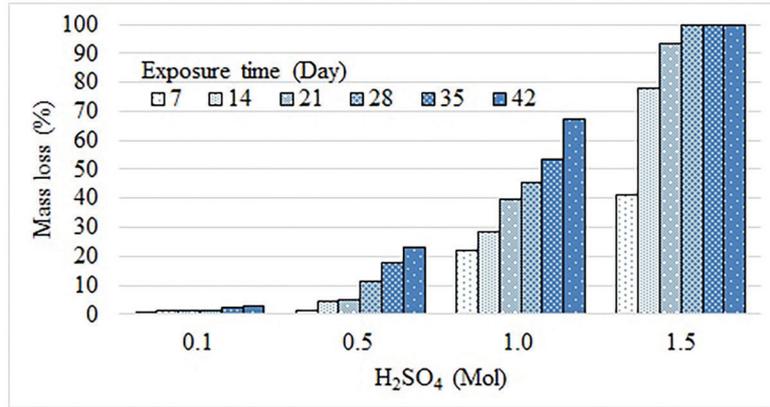
Figure 5: Weight losses of the samples coated with polyester.

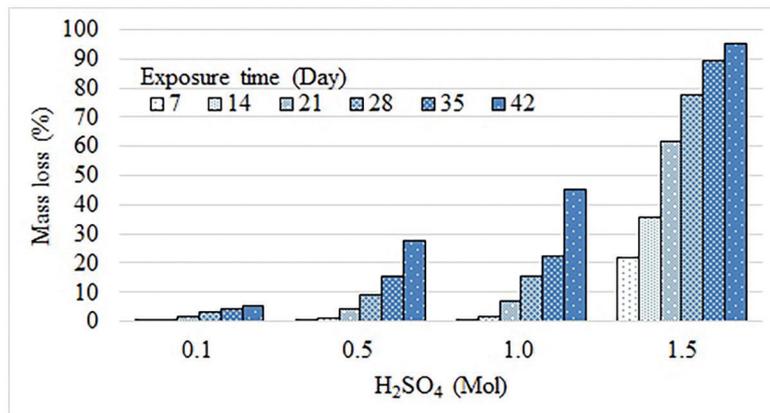
Figure 6: Weight losses of the samples coated with crystallized waterproofing mortar.

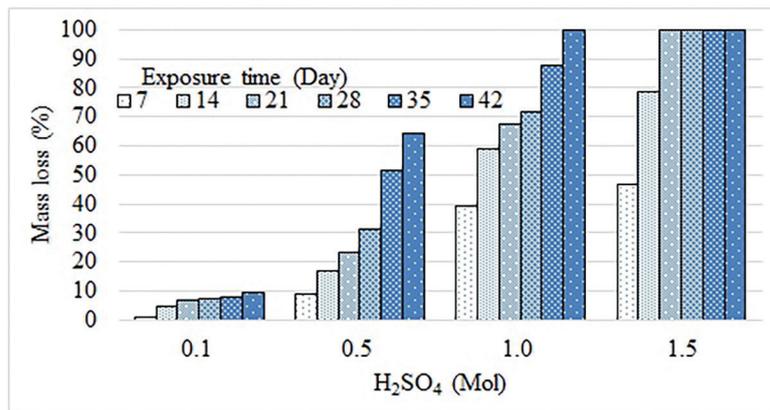
Figure 7: Weight losses of the uncoated control samples.

- As H_2SO_4 molarity increases, the corrosion of the samples subjected to its effects increased. The weight loss in the control samples was below 10% in 0.1 M acid while this rate reached 100% in 1.5 M acid. Samples coated with epoxy and crystallized waterproofing mortar generally exhibited less weight loss.
- Epoxy-covered samples suffered less damage within the H_2SO_4 solution of different molarities compared to the other types of coating.
- Polyester-coated samples demonstrated high rates of weight loss within acid levels of 0.1 M, 0.5 M, 1.0 M up to the final weeks while breakups were observed in most of the samples in 1.5 M acid at the end of week 3 and weight losses neared 100%.

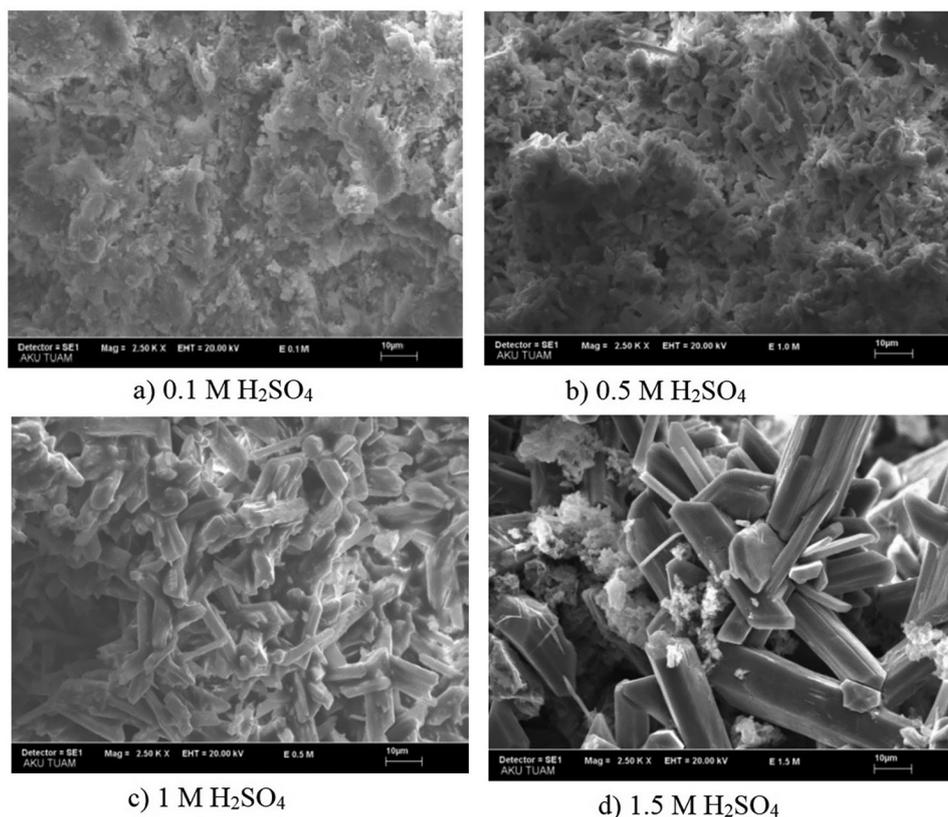
Figure 8: Microstructures of epoxy-coated samples stored in H_2SO_4 solutions of various molarities.

The component most vulnerable to acid attack is $\text{Ca}(\text{OH})_2$. Acid reactions vary in rate and intensity depending on acid type, exposure time, and acid density. The solubility of the calcium salt generated is, however, the most critical element. The damage caused by the compounds carried by water increases as the solubility increases. Softening and porosity appear in hardened concrete starting at the surface, depending on how the reactions progress. Furthermore, weak acids can become strong acids as a result of biological growth, as in sewer pipes. Figure 8 shows SEM images of epoxy coated samples stored in H_2SO_4 solutions of various molarities. When the microstructures of the epoxy coated samples are investigated, it can be seen that the hydrated products disintegrate in parallel with the increase in acid intensity.
