Flexural fatigue behavior of reinforced concrete T-beams strengthened with a composite of prestressed steel wire ropes embedded in polyurethane cement (PSWR-PUC)

Keywords: Reinforced concrete (RC) T-beams; Bending fatigue; Polyurethane cement (PUC); PSWR-PUC strengthening technique; Prestressed steel wire rope (PSWR).

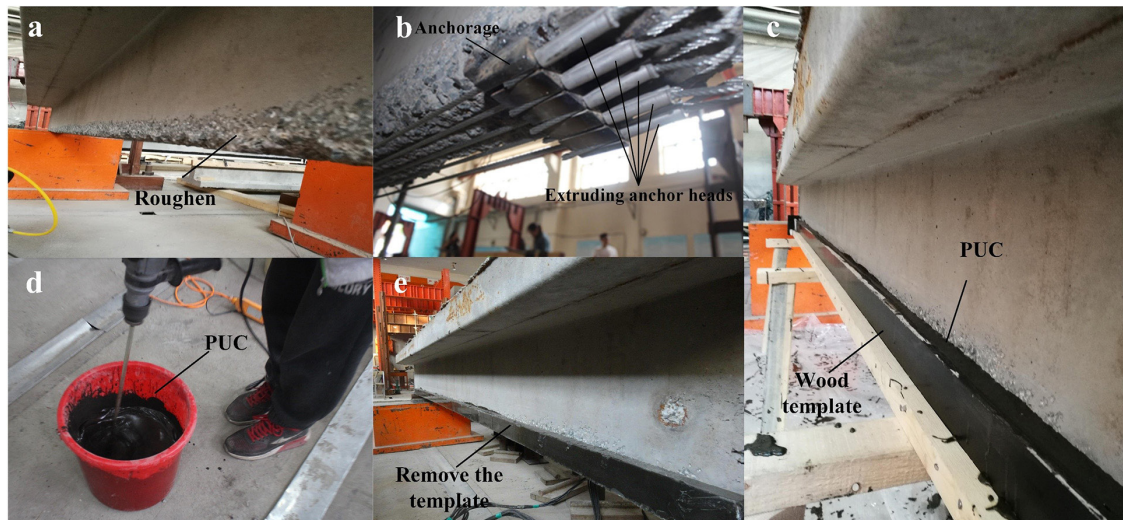
Figure 4: Operation procedure of PSWR-PUC reinforced beams: (a) concrete surface preparation, (b) tensioning and anchoring the prestressed wire rope, (c) fixing wood template and casting the PUC material, (d) Mixing and stirring the PUC material, (e) Removing the wood template.

The operation procedure of PSWR-PUC strengthening technology is shown in Figure 4.

Concrete surface preparation: In order to make the concrete surface bond reliably, the bonded surface of all the concrete beams is chiseled manually with a chisel hammer, and the coarse aggregate is leaked (Figure 4(a)).

Tensioning and anchoring the prestressed wire rope: Two grooves with a width of 100 mm were cut at each end of the beam, and anchors were welded to longitudinal steel bars. Each anchorage is similar to a button-hole anchorage, and the wire rope length is calculated according to the design tensile strength. The wire ropes are tensioned and anchored to the beam's end (Figure 4(b)).

Fixing wood template and casting the PUC material: A wooden template was erected at the bottom of the beam. The PUC material is stirred for 3 min and poured into the pre-set template (Figure 4(c) and (d)).

Removing the template: The wood template was removed after 1d (Figure 4(e)).

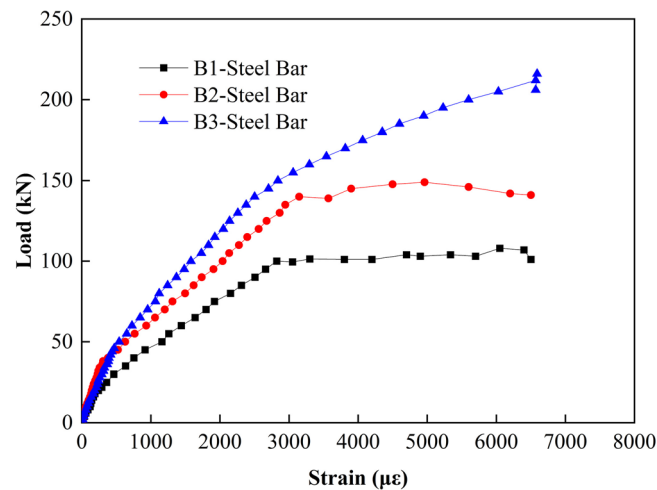
Figure 8: Load-strain of steel bar monotonic load.

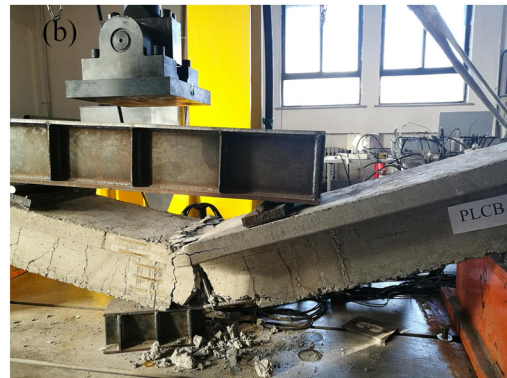
Figure 9: Failure mode of beam PLCB under fatigue load. (a) Curve of midspan deflection and number of cycles; (b) Steel bar fracture diagram of the beam PLCB.

The upper and lower limits of fatigue loads of beams PLCB, PLB1 and PLB2 are the same. The maximum value P_{max} of fatigue load is 70 kN, and the minimum value P_{min} is 20 kN, as shown in Table 2. The PLCB beam is subjected to a monotonic loading test, and the maximum load is 70 kN, the upper limit of fatigue load ($0.686P_{u1}$, P_{u1} is the ultimate load value of beam B1), and then relevant test parameters were collected. Under the action of fatigue load, cracks of beam PLCB expand rapidly and extend upward. Figure 9. shows the curve of midspan deflection and cycle times of beam PLCB. After the first 10,000 cycles, the midspan deflection of beam PLCB increases significantly, indicating that the damage accumulation is caused by cyclic load. During the subsequent loading cycles of 10,000 to 20,000 times, the deflection of the beam decreased slightly and then increased steadily to 500,000 times. However, after cyclic loading of 500,000 times, the width of the main crack in the middle span of the beam PLCB reaches 1.5mm, at which point the reinforcement may break or fail, causing the strain reading to terminate. At 626,000 times, the steel bar in the middle span broke, and then the crack extended to the top of the beam, leading to the fracture of the entire beam, as shown in Figure 9.

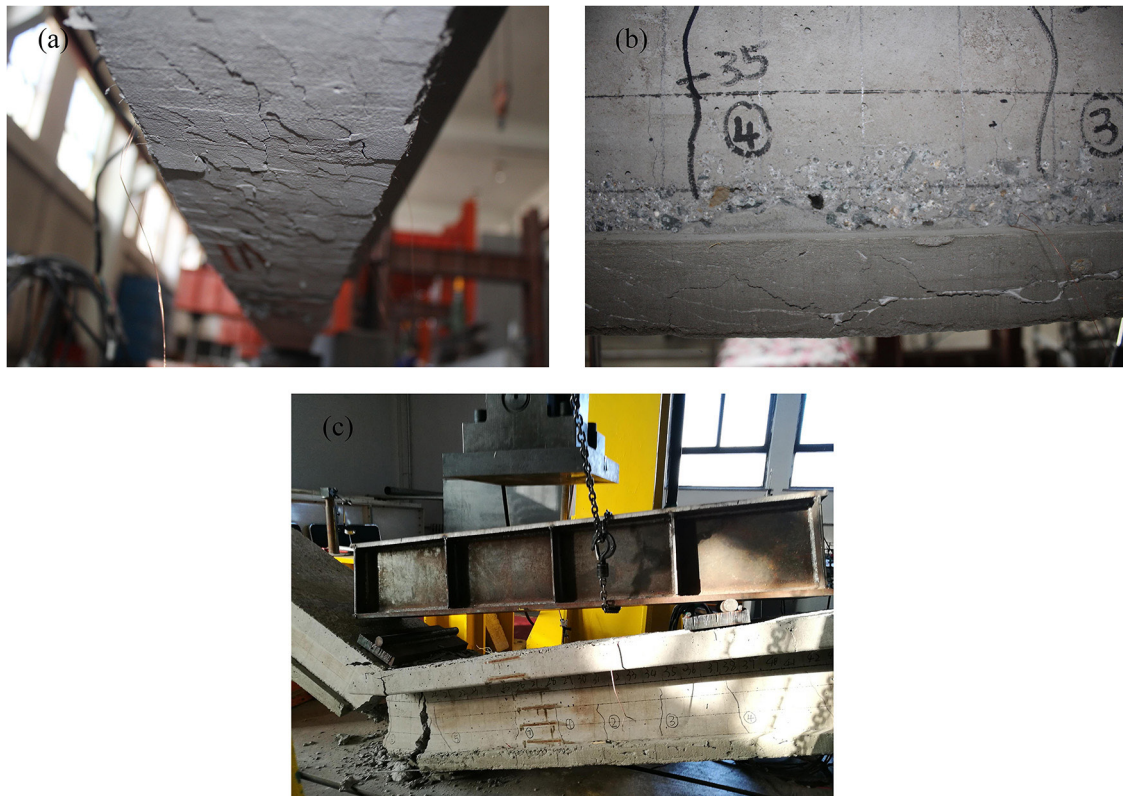
Figure 10: Midspan deflection and failure mode of beam PLB1 under fatigue load. (a) Cracking of polymer mortar; (b) Interlayer stripping of polymer mortar; (c) Steel bar fracture diagram of the beam PLB1.

The upper and lower fatigue limits of beam PLB1 are the same as those of beam PLCB. The PLB1 beam is subjected to a monotonic loading test, and the maximum load is 70 kN, and several vertical cracks appear in the polymer mortar along with the concrete cracking. At this time, the strain of the steel bar is 1147 microstrain, which is 63.8% of the control beam PLCB. Under the action of fatigue load, the crack width is about 0.2 mm when the number of cycles is 200,000. The width of one crack in the span is significantly larger than the other cracks and becomes the main crack. When the cycle reached 1,000,000 times, the polymer mortar surface appeared obvious mesh cracks, and the reinforcement layer and the concrete surface appeared peeling cracks, as shown in Figure 10(a) and (b). However, when the fatigue cycle reached 1,553,000 times, the beam made a sound, and the main steel bar at the bottom was broken. After 3 minutes, the five steel wires in the middle of the span were broken with a loud noise, the whole beam was broken into two sections, and the specimen was destroyed, as shown in Figure 10(c).

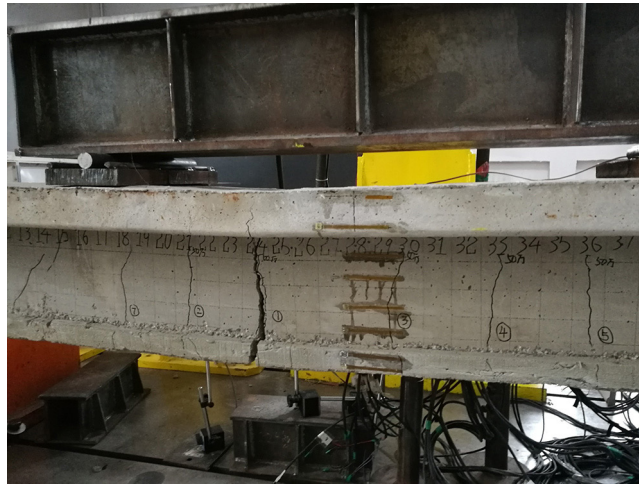
Figure 12: Fatigue failure diagram of beam PLB3.

When the upper and lower limits of fatigue loads are 70 kN and 20 kN, the two reinforced beams PLB1 and PLB2 have a large fatigue life. In order to further study the fatigue performance of different embedded materials, the upper limit value and load amplitude value of fatigue load are further increased. The maximum value of fatigue load P_{max} of beam PLB3 and PLB4 is 102 kN, and the minimum value P_{min} is 32 kN. In the static loading process, multiple vertical cracks appear along with the concrete in the polymer mortar of beam PLB3, and the cracks are concentrated in the pure bending section. The crack width of the beam body is about 0.18 mm. After unloading, the concrete cracks of the beam are closed, while the mortar cracks of the reinforcement layer are not completely closed, and the crack width is 0.03 mm. After 200,000 fatigue loads were applied, a crack in the middle of the span became wider and longer, and finally developed into the later main crack. At the same time, obvious mesh cracks appeared on the surface of the polymer mortar, and spalling cracks appeared on the surface of the reinforcement layer and concrete, which were also observed in the cyclic loading process of beam PLB1. During the fatigue loading, obvious horizontal cracks were found between the reinforced layer and the beam body. After half a million times of vibration, the vertical main crack in the span becomes wider. When the vibration reached 660,000 times, with a loud noise, five steel wires in the span broke, and the whole beam was completely destroyed. The damaged beam PLB3 is shown in Figure 12.

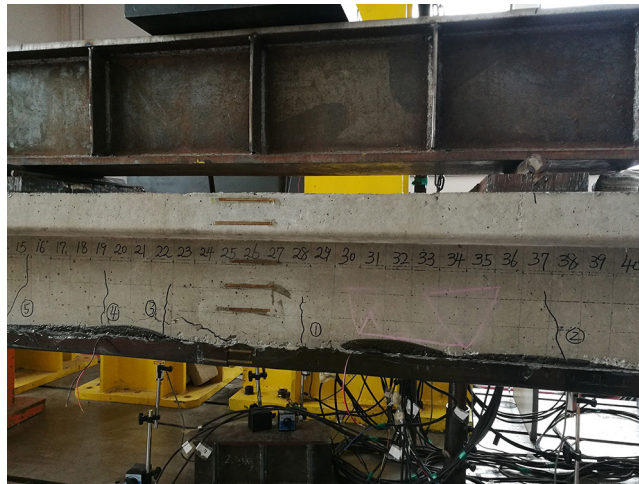
Figure 13: Fatigue failure diagram of beam PLB4.

The fatigue load value of beam PLB4 is the same as that of beam PLB3. After one million times of fatigue loading, cracks are distributed along the whole length of the beam, and the development of cracks is not obvious. After cyclic loading 2 million times, the beam is not damaged, the polyurethane cement is not broken, and the separation between the polyurethane cement and the concrete has not occurred, as shown in Figure 13.

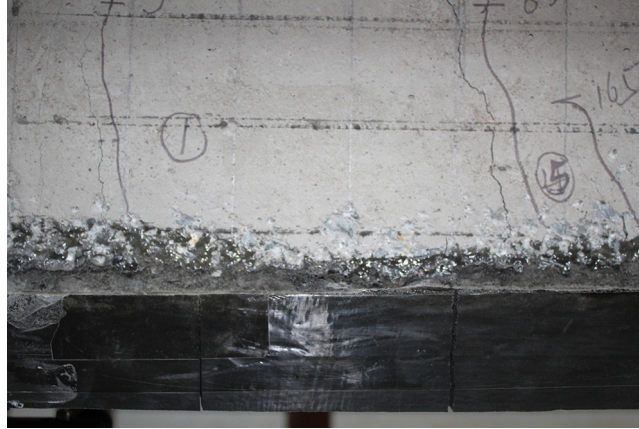
Figure 17: Failure mode of beam PLB2 under static load after fatigue test.

After 2,000,000 cycles, beams PLB2 and PLB4 were not damaged. Static load tests were carried out on the two beams to accurately obtain the static properties and residual bearing capacity of the beams after fatigue damage. The yield load of beam PLB2 is 130 kN, which is 5 kN smaller than that of beam B3. The cyclic load has no obvious effect on the strength of beam PLB2. When the load reached 170 kN, the strain of concrete increased more rapidly, and at the same time, the midspan deflection increased more significantly than before. When the load reaches 212 kN, the failure is caused by the fracture of the reinforcement layer, as shown in Figure 17.
