## A dig into the past: the first tieback wall

Case Study

This is an investigative work by the authors, all of them former students and employees at Tecnosolo Ltd, the company founded by our late Professor Costa Nunes, to find and photograph the first tieback wall designed and built in 1957 by Tecnosolo under Prof Costa Nunes' guidance.

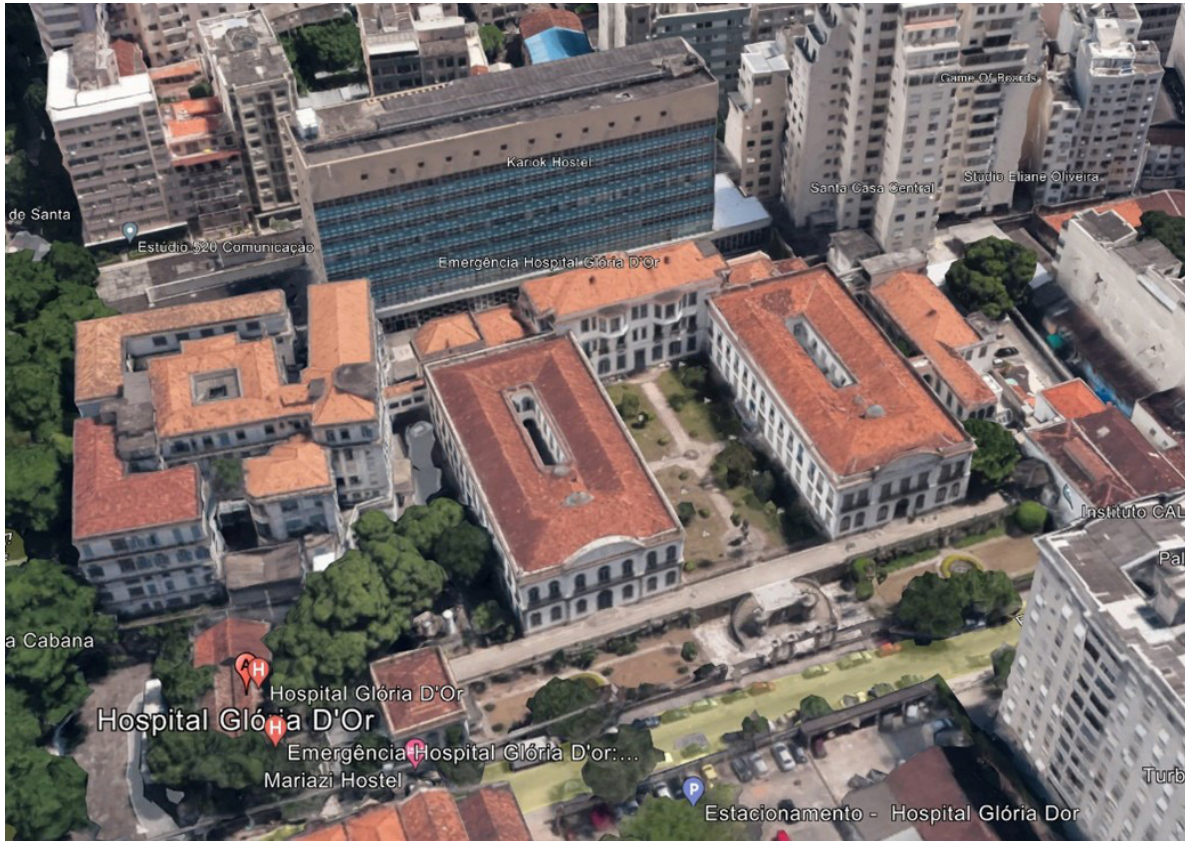
**Figure 2.** Site view, foreground: the old Beneficência Portuguesa Hospital, at the back of the Gloria D'Or Hospital in Rio de Janeiro city centre.

Today it is located between an old and the recent hospital building (Figure 2 and Figure 3) and it is difficult to access, hidden between two buildings (Figure 4).

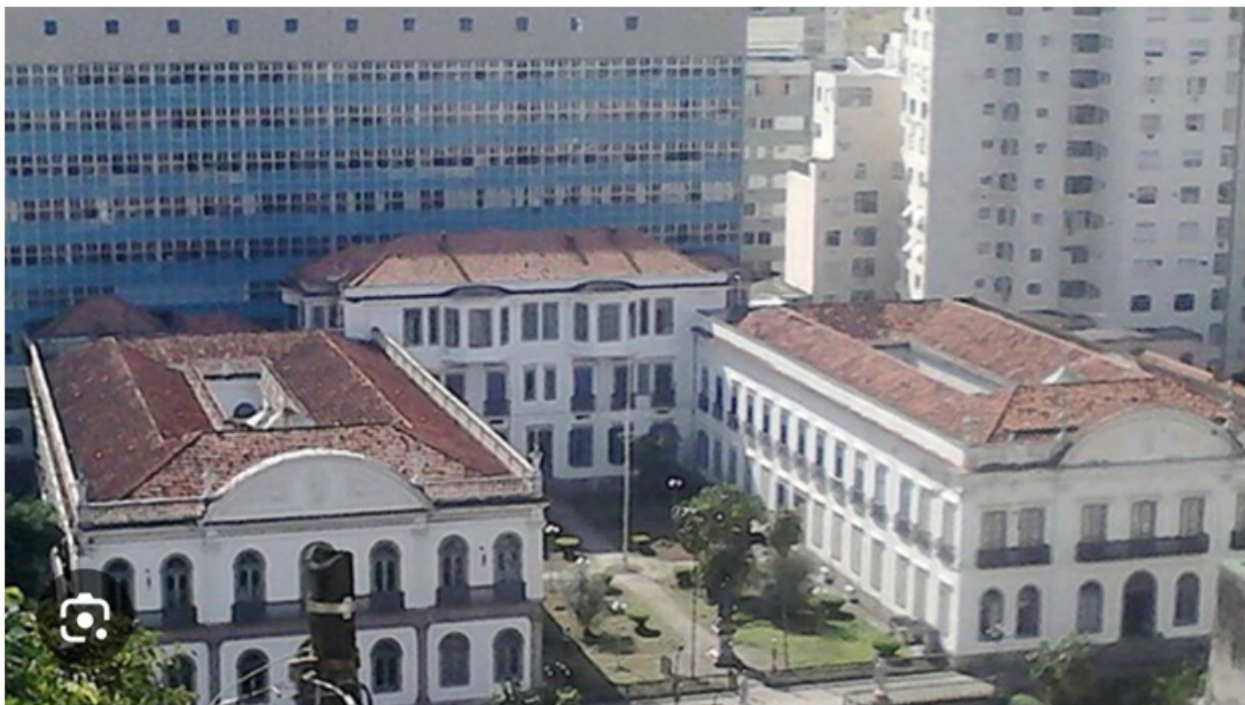
**Figure 3.** 19th Hospital (foreground) and the new hospital building (background).

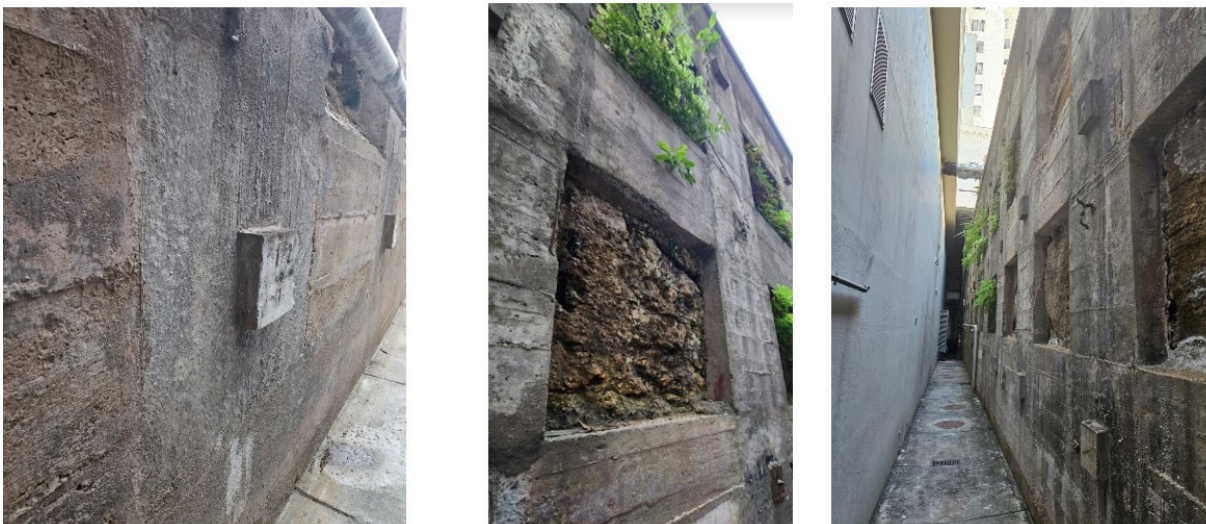
Figure 6 presents the 6 m high and some 50 m long wall sketches. Hunt & Costa Nunes (1978) described this innovative construction method taken from the top (Figure 7), replacing gravity walls which demanded a lot more excavation volume to be built.

Figure 7. Tieback wall pictures.

Professor Costa Nunes once told in his classes that he designed the upper part of the wall with a concrete grid, given the high cohesion of this residual soil. Nevertheless, he changed his design of later walls and used a concrete slab, replacing the grid. “Concrete grid only for rock slopes”, he said.

The Authors found that the ground anchors were 20 mm in diameter, certainly CA-50 steel-grade, which became available a few years before. All anchors were tested to 90% of the steel yield load (170 kN), then reduced to the working load of about 100 kN.
