Repairing of an Engine Block Through the Cold Gas Dynamic Spray Technology

Antonello Astarita^a, Fabrizio Coticelli^a, Umberto Prisco^{a,*}

^a Dept. of Chemical, Materials and Industrial Production Engineering, University of Napoli Federico II, Piazzale Tecchio 80, 80100, Napoli, Italy

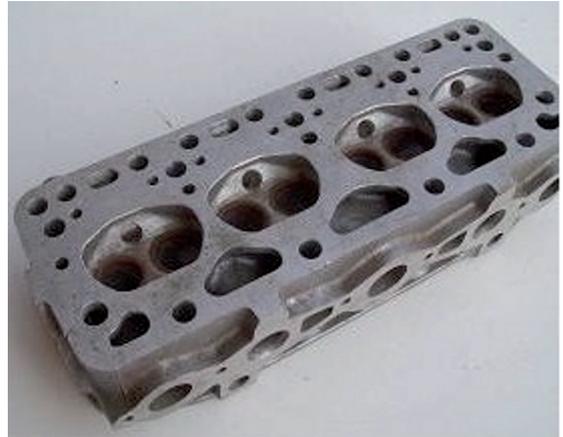
A commercial FIAT engine block was used for the experiments, Figure 1. Superficial damages were induced on the engine block through machining to reproduce possible damages that can occur during service. The engine block is made of A380 aluminum die casting alloy¹⁷; the chemical composition of this alloy is reported in Table 1. In particular, six different damages were produced: three were repaired through welding and three through cold spray. The samples to be repaired were cut from the engine block through hacksaw.

Figure 1: Engine block used in the experimentation.

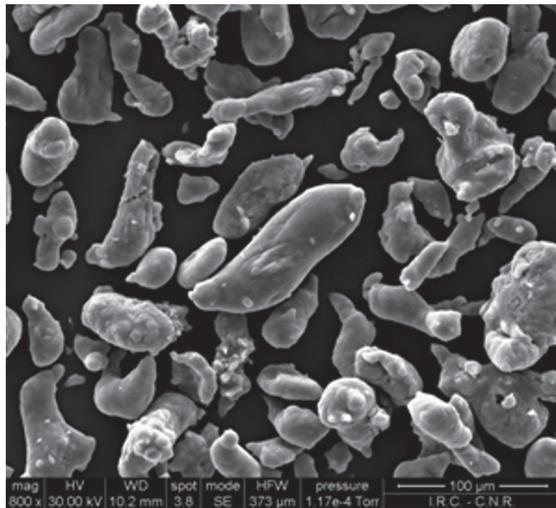
A sample repaired by using CGDS is shown in Figure 3. Before the CGDS a grit-blasting was carried out on the sample to improve the adhesion of the coating on the substrate material. A commercial white corundum grit of 0.6-0.7-mm diameter was used. The blasting pressure was 0.6 MPa. An Al-12% Si powder, with a composition very similar to the same Al-Si alloy used in the TIG process, was chosen for the cold spray repair, see Table 1. The powder is characterized by a mean particle diameter of 40 microns. A SEM micrograph of the powder used is shown in Figure 4.

**Figure 4:** SEM micrograph of the powders used for the cold spray repairing.

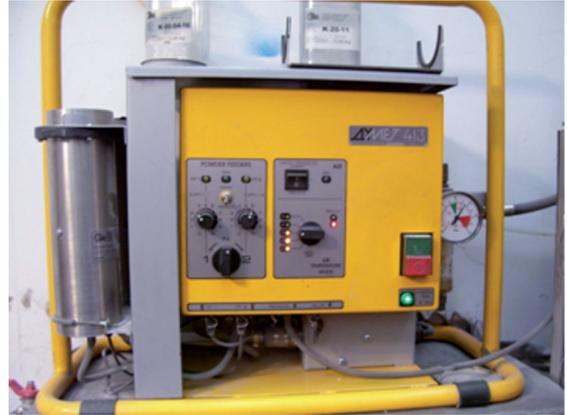
The powder was deposited using a low pressure Dymet 413 equipment, Figure 5, with nitrogen as carrier gas. The spray conditions were the following: the propellant gas was preheated to about 1000 °C, the gas pressure was chosen equal to 2 MPa, the spray distance was fixed in 40 mm, the particles velocity was fixed at 600 m/s and the transverse speed of the gun was chosen equal to 0.01 m/s.

**Figure 5:** Low pressure Dymet equipment used for the spraying process.
