Failure analysis in heat exchanger tubes from the top system of the regeneration tower of the hydrotreatment unit in an oil refinery: a case study

This work presents a failure analysis performed on tubes of a condenser of the top system of the diethanolamine regenerating tower of the oil cracked naphtha hydrotreating unit. The tubes are subjected to the aqueous flow of H_2S and diethanolamine in the external region and cooling water in the internal region.

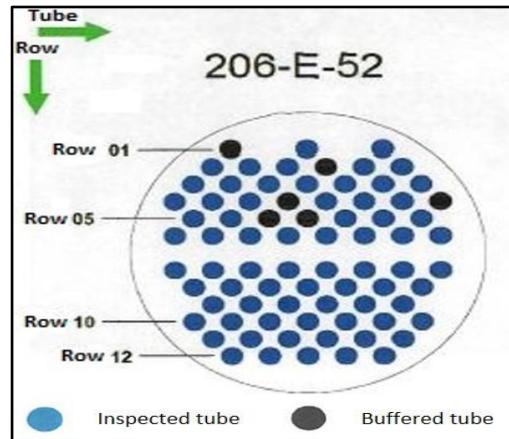
Figure 11: Schematic drawing of the ultrasonic test for measuring thickness in the tube.

Figure 11 shows the schematic drawing used to perform the ultrasonic thickness measurement test using the IRIS (Internal Rotation Inspection System) technique on the tubes of the heat exchanger. The representation is at a percentage level of loss of wall thickness of the tube, where a loss of 100% indicates that the tube has lost containment and is perforated and a percentage of 0% indicates that the tube is without thickness loss.

The concentration of tubes with thickness loss was the highest in the region of the upper pass of the tube bundle, a region that is located at the entrance of H_2S + DEA fluid, on the outside of the tubes; where the test indicated the origin of the corrosive process, that is, corrosion from “outside to inside”, due to the aggressive action of the fluid in the metallic material of the tubes. The greatest corrosion damage in the region of the upper pass of the tube bundle was aggravated by the impingement caused by the entrance of the fluid. IOFA *et al.* [19] demonstrated that H_2S at low pH or HS^- at medium pH forms a monolayer film through chemisorption on iron. The sulfide film formation involves the formation of cubic iron sulfide (FeS), tetragonal mackinawite (FeS_{1-x}), and hexagonal troilite [20]. The iron corrosion mechanism is described by reactions:
