## Physical chemistry research of a concrete dam with over 50 years of operation

Guaricana hydroelectric power plant concrete dam, located in the South of Brazil, was investigated after 49 years of operation. A part of the mortar was altered to ettringite, and other by-products. The inner defects in the fracture and polished sample surfaces were detected by CT and SEM. The samples were extracted from two parts of the dam from top to valley. Elemental chemical composition and phases were determined by EDS and XRD analysis. The reservoir water showed that it was less aggressive to the concrete structure. Percolated dam water analyses revealed a mortar-mass loss of 3 kg/year. Onsite visual inspection, mechanical tests, and other usual forms of investigation confirmed concrete deterioration, such as leaching, stalactites and stalagmites formation, alkali-aggregate reaction and ettringite. Furthermore, mortar damage was detected in a particular area according to the dam depth, and autogenous healing of cracks were visible in some parts of the inspected galleries.

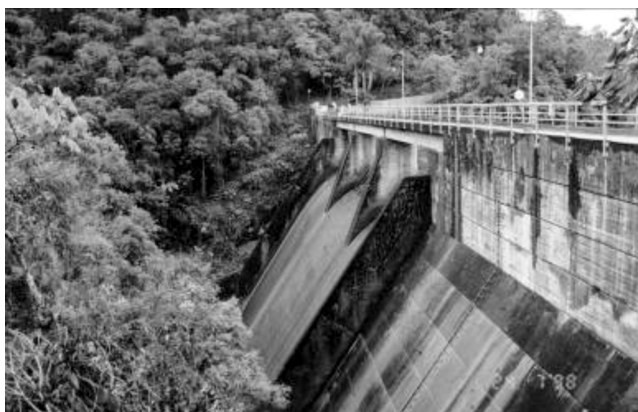
Figure 1: Downstream face of the Guaricana hydroelectric power plant dam.

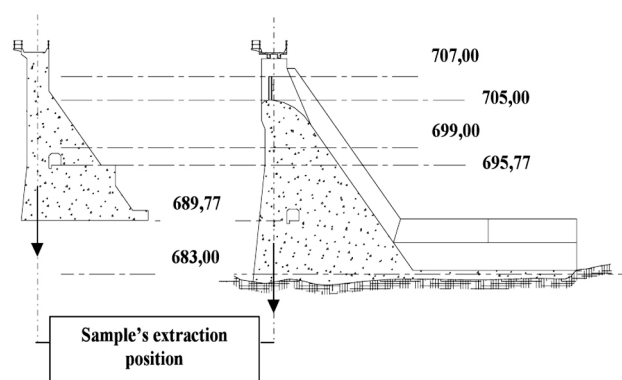
The inspection gallery, elevations, and partial schematic views are illustrated in Fig. 2. The figure also shows vertical lines from where the concrete samples were pneumatically extracted from top to valley in the center and left sides of the dam.

Figure 2: Schematic view of the dam Guaricana. The elevations are measured from sea level, in meters.
