The use of Shearography technique to evaluate polymeric composite repairs – case study

Mauro Eduardo Benedet¹, Analucia Vieira Fantin¹, Daniel Pedro Willemann¹,
Armando Albertazzi Gonçalves Júnior¹, Claudio Ramos Schmitz¹,
Ana Lúcia Fampa Seabra d'Almeida², Sérgio Damasceno Soares²,
Luiz Daniel Montenegro Lana², Valber Azevedo Perrut²

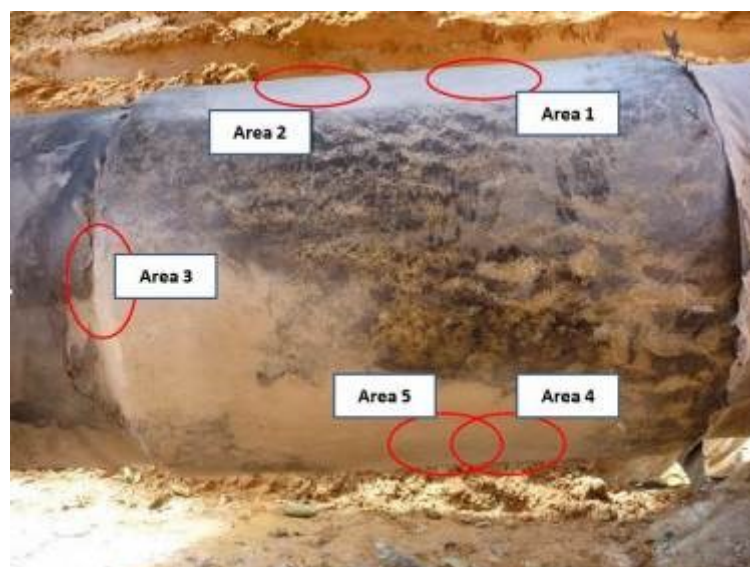
Figure 3: Regions measured with shearography system.

Repair A is a glass fiber composite repair which was laminated in an 18” tube of the trunkline of a gas pipeline. This repair had 22 layers with thickness ranging between 15 and 20 mm and had been in service for over six years. This repair was applied to restore structural integrity of a dented region of the pipeline. For this inspection, only five areas of about 220 mm x 140 mm were evaluated by shearography (areas 1 and 2 at the top of the repair, area 3 at its edge and areas 4 and 5 near to dented region). These areas are highlighted in Figure 3. The surface of the repair was cleaned and painted with matt white paint before the inspections.

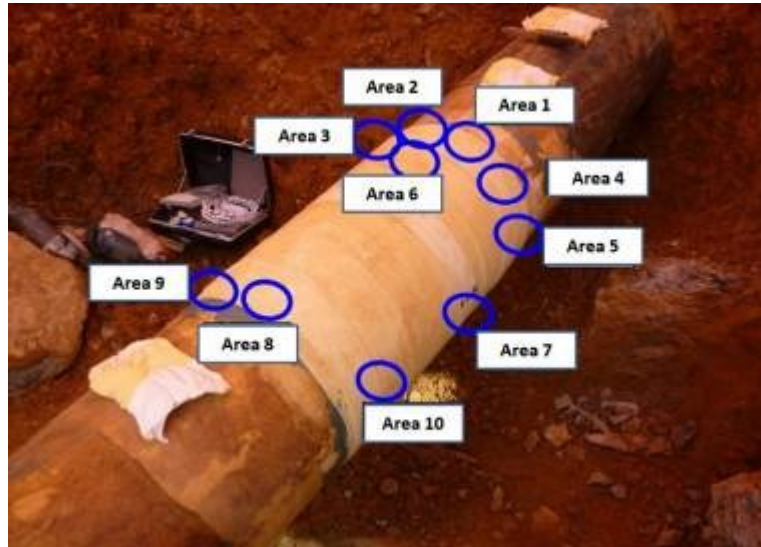
Figure 4: Regions measured by the shearography system.

The second glass fiber repair was applied in a 20” tube of the trunkline of another gas pipeline. This repair had been in service for approximately 4 years and its thickness was about 10 mm. Repair B was also put in order to restore structural integrity of a dented region. Due to the short time available for inspection, only ten areas of approximately 220 mm x 140 mm were inspected with the shearography system (Figure 4). The surface of the repair was cleaned and painted with matt white paint before the inspections.

All areas inspected at Repair B presented several points of localized lack of adhesion between interface of composite repair and steel pipe. Since only ten points were inspected, it was not found sufficient evidence of widespread debonding. However, the repair removal was easily performed after the shearography inspection. The time to remove Repair B from the pipeline was about 16 minutes and this reduced time corroborates the inspection results. Also, it was observed that the pipe surface presented general corrosion. Compared with Repair A, Repair B removal was very easy due to the lower adhesion between composite repair and steel pipe.

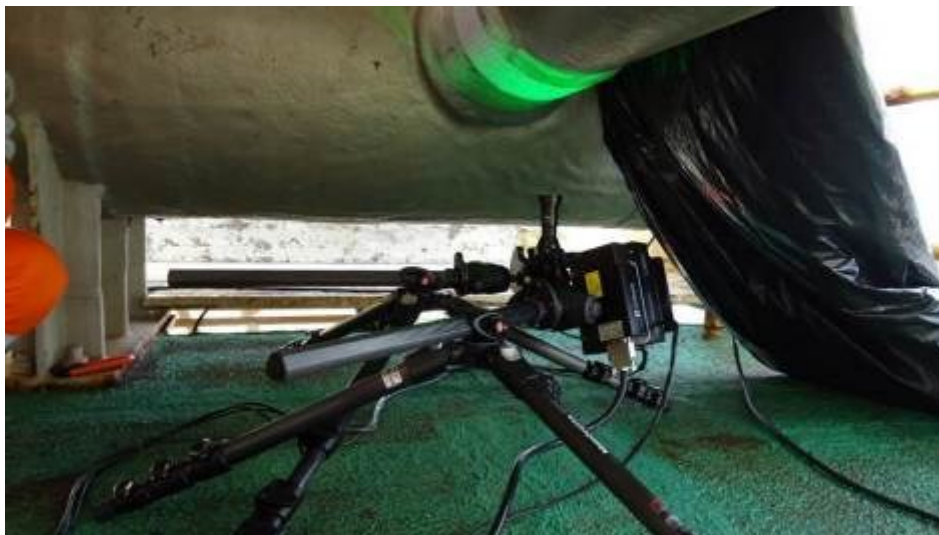
Figure 5: Shearography inspection at a composite repair in an offshore platform. The carbon fiber tripod can be observed.

It was observed that the tripod allows a greater viewing area, but it is indicated in cases of extremely low vibrations. On the other hand, the collar clamping system allows the inspection of repairs localized in a reduced space between pipes and/or with higher vibration levels, but it has a smaller viewing area. Table 2 shows the maximum vibration levels for a specific shearography sensor attached to the collar clamping during the inspections in the offshore platform. New optomechanical designs are being experimented in order to withstand higher levels of vibrations.

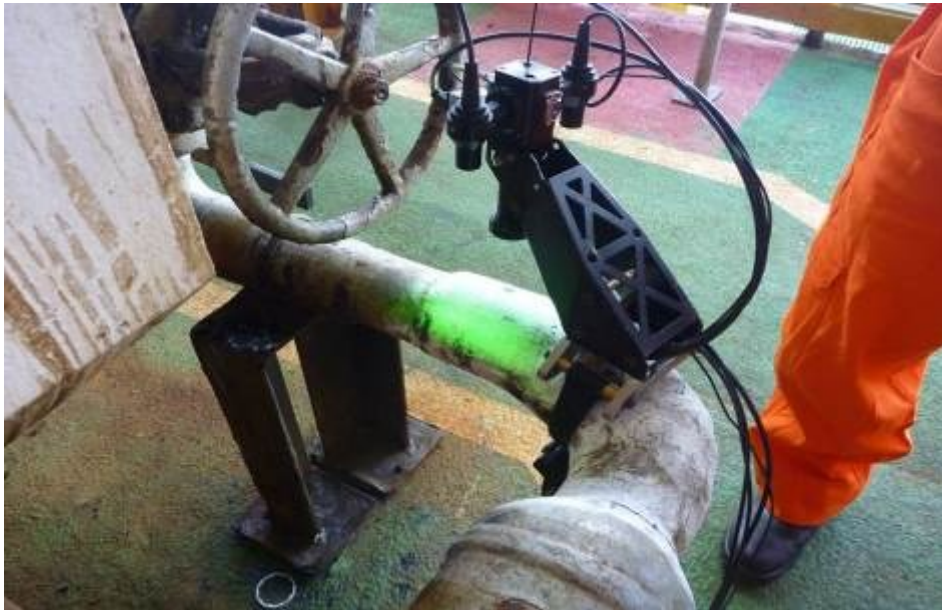
Figure 6: Shearography inspection of a composite repair in an offshore platform. The collar system was used to clamp the shearography device to the repair.
