Corrosion Resistance of a Steel Under an Oxidizing Atmosphere in a Fluid Catalytic Cracking Regenerator

In the present work, the corrosion resistance of an ASTM A 387 G11 steel was evaluated under two conditions: an oxidizing atmosphere in a fluid catalytic cracking regenerator of a petroleum processing unit and a simulated atmosphere in the laboratory, at temperatures of 650 °C and 700 °C. The characterization of the phases present in the oxidized layer was carried out by X-ray diffraction (XRD), optical microscopy (OM) and scanning electron microscopy (SEM) with X-ray energy dispersive analysis (EDS). Severe corrosion was observed after exposure to both the real and simulated conditions, with formation of several iron oxides (Fe_2O_3 , Fe_3O_4 and FeO) in the product scale layer, as well as a slight inner oxidation and sulfidation of chromium in the substrate. Internal nitridation of the silicon and the manganese was observed only in the real condition, probably related to the long-term exposure inside the regenerator.

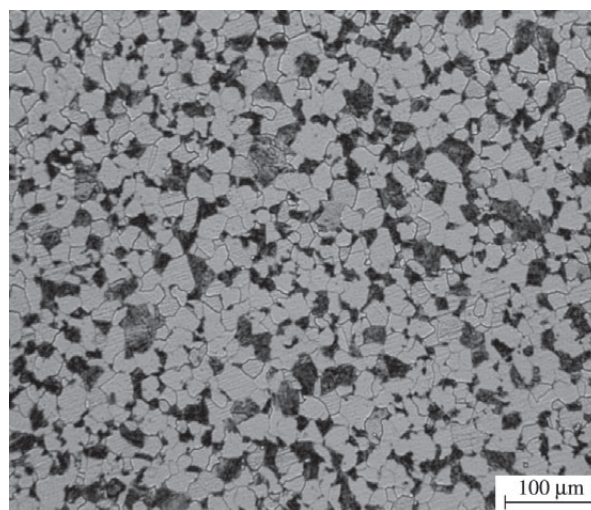
Figure 2. Micrography of the G11 steel sample before degradation. Etching: Nital 2%.

The original microstructure of the ASTM A 387 G11 before the corrosion degradation is presented in Fig. 2. It is constituted by ferrite and pearlite, with a fairly homogeneous grain size.
