# Metallurgical and Mechanical Examination of Fatigue-Induced Fracture in a Conveyor Drum Shaft

This work investigates the fatigue failure mode of a shaft used in a conveyor system for mining applications through visual inspection, metallographic examination, fracture analysis, and mechanical testing. It was observed that a misalignment of about 5° between the shaft and the conveyor drum system promoted intensive contact with the parts. The combination of misalignment and overload was the leading cause of the localized plastic deformation, which resulted in the shaft fracture. A metallurgical examination revealed ferritic and pearlitic microstructures for an AISI 4140 grade steel. This suggested that the heat treatment on the steel was not adequate for the application. Therefore, it can be inferred that no preventive or corrective maintenance inspections were performed during the shaft's operational production period.

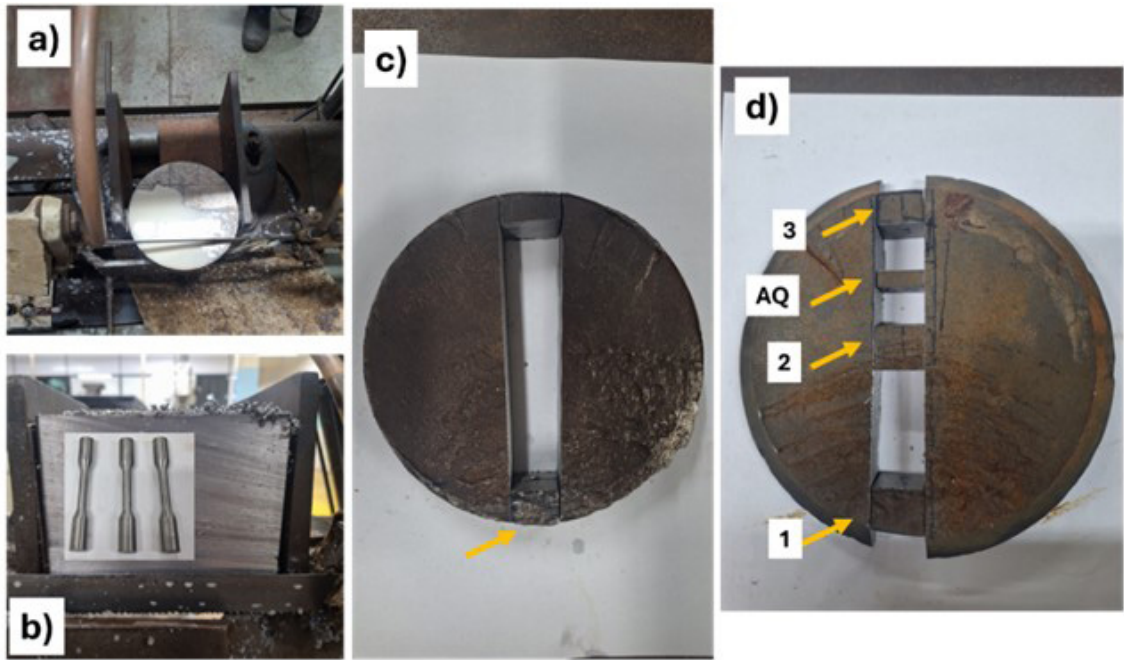
Figure 4. Images of the sample cutting procedures for mechanical testing and failure analysis: a) Beginning of refrigerated cuts on the samples, b) Region used for the preparation of tensile and impact test specimens, c) Removal of the fracture face from the SSSP for microstructural examination, and d) Fractured face of the ISF for fractography, samples 1, 2 and 3, and chemical analysis (CA).
