# Effects of reprocessing on chemical and morphological properties of guide wires used in angioplasty

**Objective:** To investigate the influence of the reprocessing technique of enzymatic bath with ultrasonic cleaning and ethylene oxide sterilization on the chemical properties and morphological structure of polymeric coatings of guide wire for regular guiding catheter.

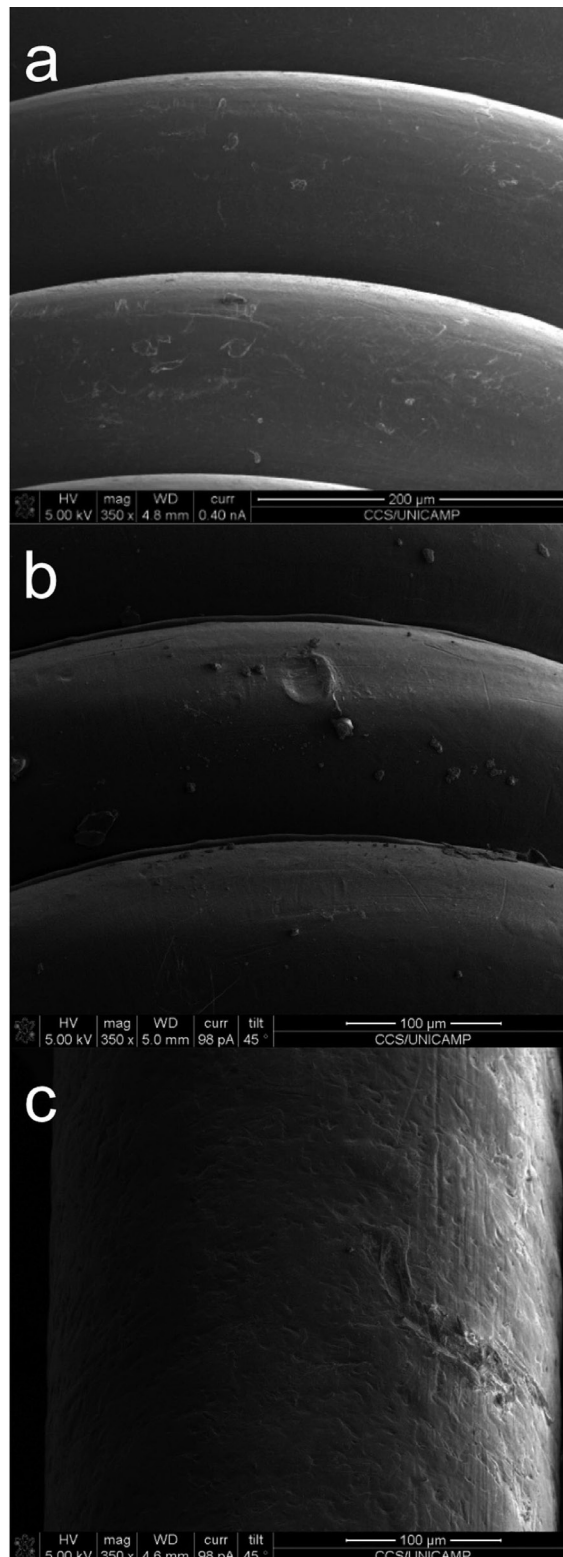
The SEM images of surfaces of the polymeric coatings of pristine guide wires A, B, and C are shown in Figure 1. Fairly uniform surfaces are revealed by the three micrographs. The small irregularities observed in the three pictures are typical of pristine guide wires and were considered normal.

Fig. 1 – SEM pictures of guide wire catheter samples A, B and C. All surfaces with few small irregularities, considered normal for this material. Small artifacts from the manufacturing process are seen in Figure B.
