Current condition of the exposed concrete façades reinforcement of the Vilanova Artigas building: modern architectural heritage

Adriana de Araujo^a Claudia de Andrade Oliveira^b Tatiana Regina da Silva Simão^{b,c} ^aInstituto de Pesquisas Tecnológicas do Estado de São Paulo – IPT, São Paulo SP, Brasil^bFaculdade de Arquitetura e Urbanismo – FAU, Universidade de São Paulo – USP, São Paulo, SP, Brasil^cInstituto Federal São Paulo – IFSP, São Paulo, SP, Brasil

How to cite: A. Araujo, C. A. Oliveira, and T. R. S. Simão, “Current condition of the exposed concrete façades reinforcement of the Vilanova Artigas building: modern architectural heritage,” *Rev. IBRACON Estrut. Mater.*, vol. 14, no. 1, e14113, 2021, <https://doi.org/10.1590/S1983-41952021000100013>

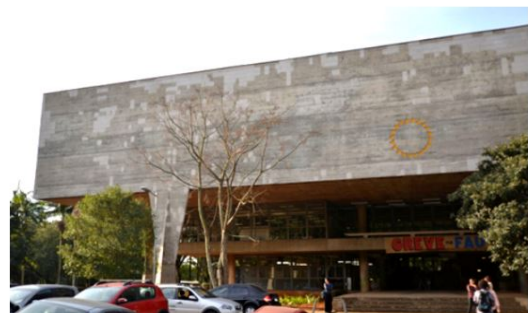
The building turned 50 years of service in 2019. There are no records about any preventive maintenance performed on its façades within the 4 decades that succeed its inauguration (1969-2012). There are punctual records of replacement of the walls-bearing pad system: in 1981 (Pillar P3, NE façade) and 2000 (Column P48, SW façade -). In 2009-2010, flashings were installed on the top of wall to prevent rain water penetration. Signs of deterioration of the exposed concrete, stemming from reinforcement corrosion, were reported in 1999, during inspection that preceded the replacement of the wall-bearing pad system on pillar P48. The inspection report was the first document containing recommendation for structural patch repairs on the façades. In 2004, Simões [22] performed visual inspection in the building and identified several regions of the façades with disaggregation, pathological manifestation characterized by detachment of the concrete cover, indicating worsening deterioration of the reinforcement. In November 2012, an extensive intervention campaign started to repair the outer surface of the façades, together with other repair services in the roof and interior of the building. The campaign was completed in April 2015. Figure 1b shows the patch repairs of the main façade, performed in 2013-2014.

Figure 1. (a) Building placement with direction of Northeast (NE), Southeast (SE), Southwest (SO) and Northwest (NO) façades; (b) and partial view of the main façade (SW). (Photo: Authors' collection, 2016).
