The collapse of Real Class building

R. J. C. RIBEIRO ^a
r2engenharia@gmail.com

D. R. C. OLIVEIRA ^a
denio@ufpa.br

Abstract

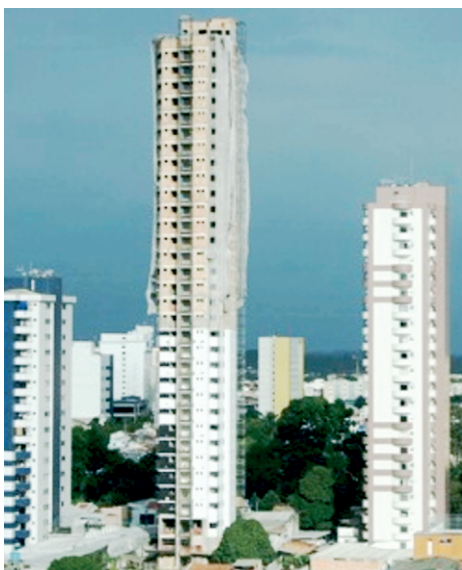
Figure 1
Real Class building

The residential building Real Class (Figure 1) was located in an urban area in the central part of Belem city. The description for the region of the building, according to the code regarding the wind speedy [5], is of a flat urban terrain with vertical obstacles not exceeding 10 m. The building had 35 floors distributed in four areas of common use (underground, ground, level 1 and level 2), 30 pattern floors and a roof, totaling a height of 104.7 m, with maximum values of 26.8 m in length and 13.9 m wide in plan, resulting in a projection area of 298.4 m².

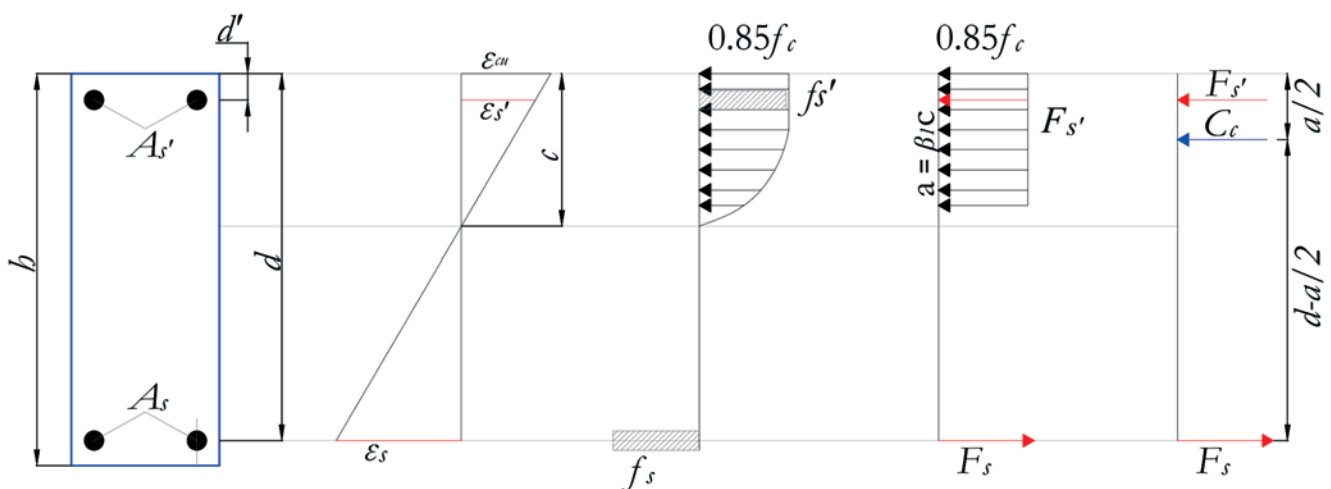
Figure 12
Simplifications for cross sections check

The safety of the columns was assessed through interaction diagram constructed using the assumptions of strain compatibility with concrete and steel with limitation of concrete strain (ϵ_{cu}) at 3,5 ‰ and steel strains (ϵ_{su}) at 10 ‰, according to the recommendation of NBR 6118 [10]. Figure 12 shows the simplifications for the calculation of the cross sections strength and for compression stress rectangle. The construction of such diagram can be seen in the literature [14], and admitting the height of the compression rectangle (a) equivalent to 0.80 (β_1) of the height of the neutral line (c) [10].

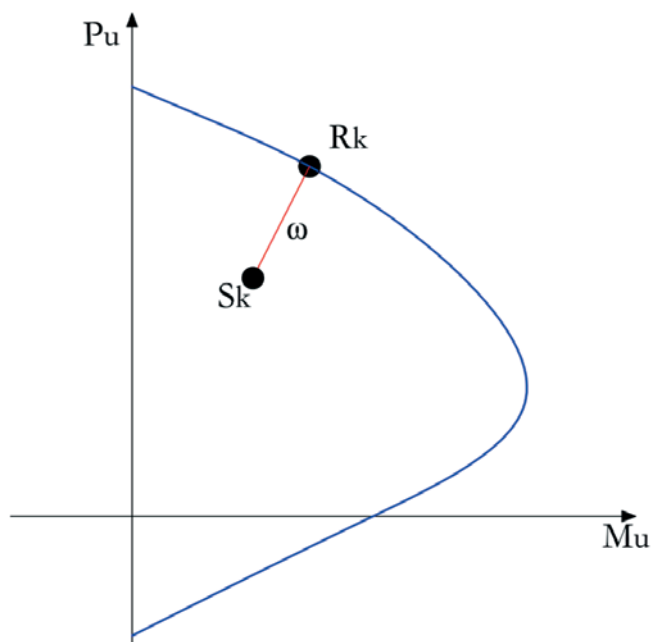
Figure 13
Safety margin for columns cross sections

qualitative way was to adopt the safety margin (Equation 4), which in the case of the columns (Figure 13) represents the resistance reserve of the element (ω) under a load (S_k) for a resistance (R_k) [15]. The diagrams prepared for conformity assessment of the structural design used values of 35 MPa for concrete compressive strength (f_c) and 500 MPa for the yielding stress (f_y) of CA - 50 steel. For the diagram developed to evaluate the moment of collapse the IRC results for concrete ($f_c = 29$ MPa) and the GAEMA - UFPA technical report on steel strength ($f_y = 573$ MPa) were used. To obtain the calculation resistance (R_d), the strength reduction coefficients used for steel ($\gamma_s = 1,15$) and concrete ($\gamma_c = 1,40$) were used for normal combinations and the coefficients $\gamma_s = 1,15$ and $\gamma_c = 1,20$ for the construction combinations.
