Evaluation of the Effects of Fluids Upon the Flexural and Parallel-plate Loading Behavior of Glass Fiber Reinforced-vinyl Ester Resin Matrix Composite Pipes

Ademi Nobeto da Silva^a, Guilherme Sampaio Mori^a, Jose Roberto Moraes d'Almeida^{a,b*}

Keywords: glass fibers composites, environmental aging, mechanical properties, parallel-plate test

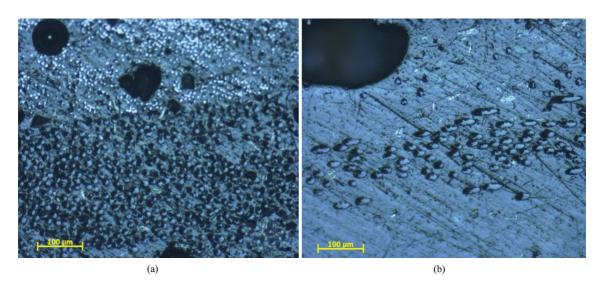
Figure 2. Uneven distribution of fibers along the composite pipe wall. a) Fiber rich region, and b) Resin rich areas and large voids can be observed.

Figure 2 shows the common aspects of the composite's microstructure. One can see that a heterogeneous fiber distribution exists along the thickness of the composite's wall. Resin rich areas and voids are observed, and these areas are sources of weakness for this composite. The voids can act as stress raisers and serve as points for fluid accumulation. Resin rich areas are regions with low strength inside de composite serving as crack initiation points.

However, inhomogeneity of fiber distribution is, maybe, the leading factor behind the results presented at Figure 5. If a resin rich area, such as the one showed at Figure 2, is close to the outer layers of the composite, failure will be greatly favored when a three point bending test is performed, since the maximum stress is attained only at the outer layer, and occurs just at the single point under the central support. Therefore, any local variation of the fiber volume fraction or the presence of a high void content or resin rich areas can have a significant effect on the result obtained. It is important to highlight here that the tubes from where the specimens were machined are 2 m long, and after the microstructural analysis performed, large variation of the fiber distribution is likely to be found along the tube's length. This spatial variation of fiber and resin on a real commercial product

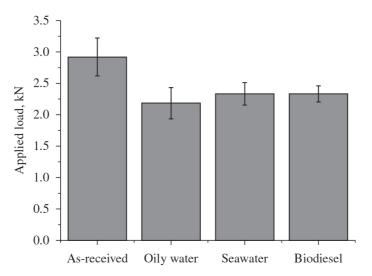
Figure 3. Load necessary to reduce the specimen's diameter by 10% of its original value.

Figure 3 shows the compressive loads necessary to reduce the diameter of the parallel-plate loading specimens

by 10% before and after aging. One can see that all aging media affected the behavior of the composite, and a load bearing capacity reduction varying between 20-30% was noted. Using the *t*-Student test with a significance level of 0.05 the average values of the aged composites are not significantly different among each other, but they are significantly different in respect to the as-received composite.

where *b* and *t* are, respectively, the width and the thickness of the ring specimen. From Equation (1) it is clear that the value of *E* decreased for the aged specimens, since the load *P* decreased, as shown in Figure 3, and the other variables at Equation (1) are geometrical constant parameters (*I* and *r*), and ΔL was an experimental constant parameter – all the rings were loaded to produce a 10% reduction of their original diameter. The calculated values of *E* for the
