Heat treatment analysis of ASTM A106 steel spheroidization and erosive wear at high temperatures

Keywords: erosive wear, ASTM A106GrB steel, boiler pipes.

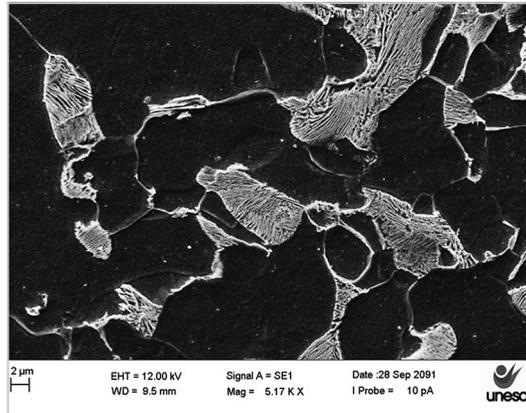
Figure 1 shows that ferrite and perlite are the main phases present in the normalized ASTM A106GrB steel.

Figure 1 - Scanning electron microscopy image of the normalized ASTM A106GrB steel.

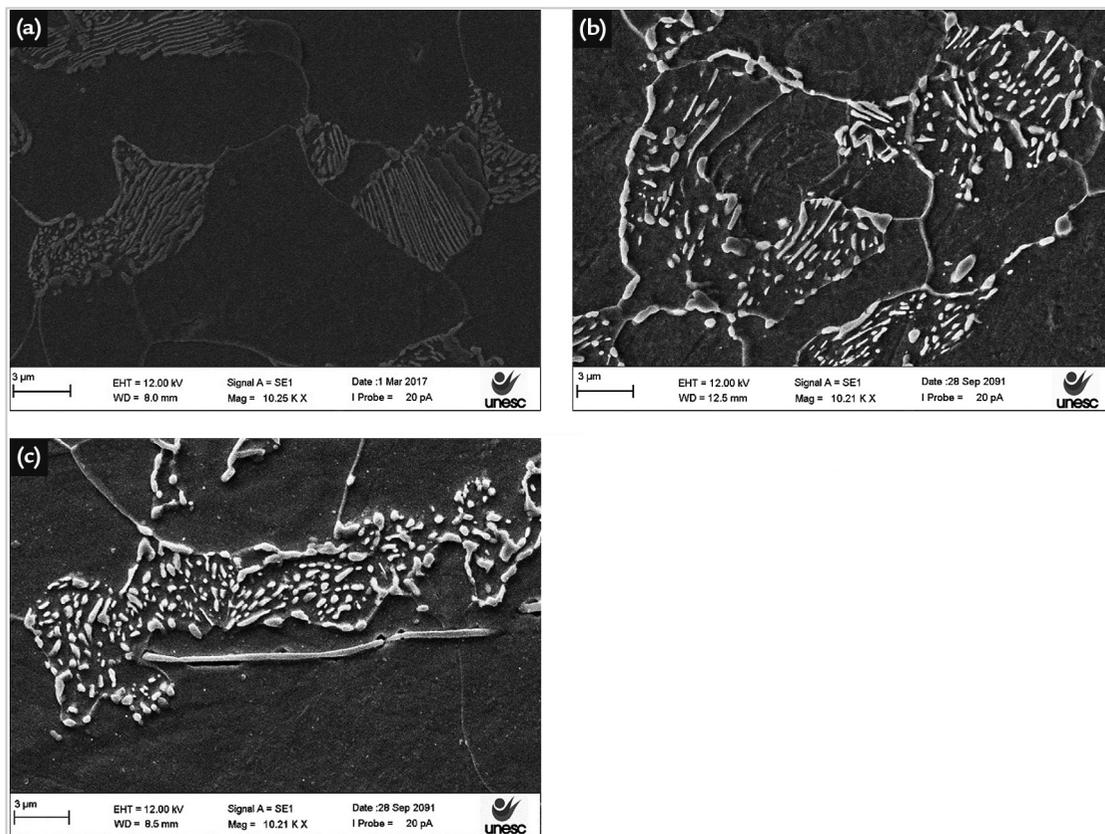
Figure 2a shows that the car-

bide spheroidization started within 50 h at 530 °C. When the time of the heat treatment was increased to 100 h, the number of carbides that were

spheroidized increased (Fig 2b). Carbides coalesced after 200 h of heat treatment at 530 °C (Fig 2c).

Figure 2 - Microstructural evolution during the spheroidizing heat treatment of the ASTM A106GrB steel at 530 °C. a) 50 h; b) 100 h; c) 200 h.

Table 3 shows that 523 and 555 carbides/mm² were spheroidized, respectively. This suggests that the fragmentation of the perlite occurred under these conditions. Additionally, the number of carbides decreased to 431 carbides/mm² and the carbide size increased to 0.40 μm during 200 h of heat treatment at 530 °C.

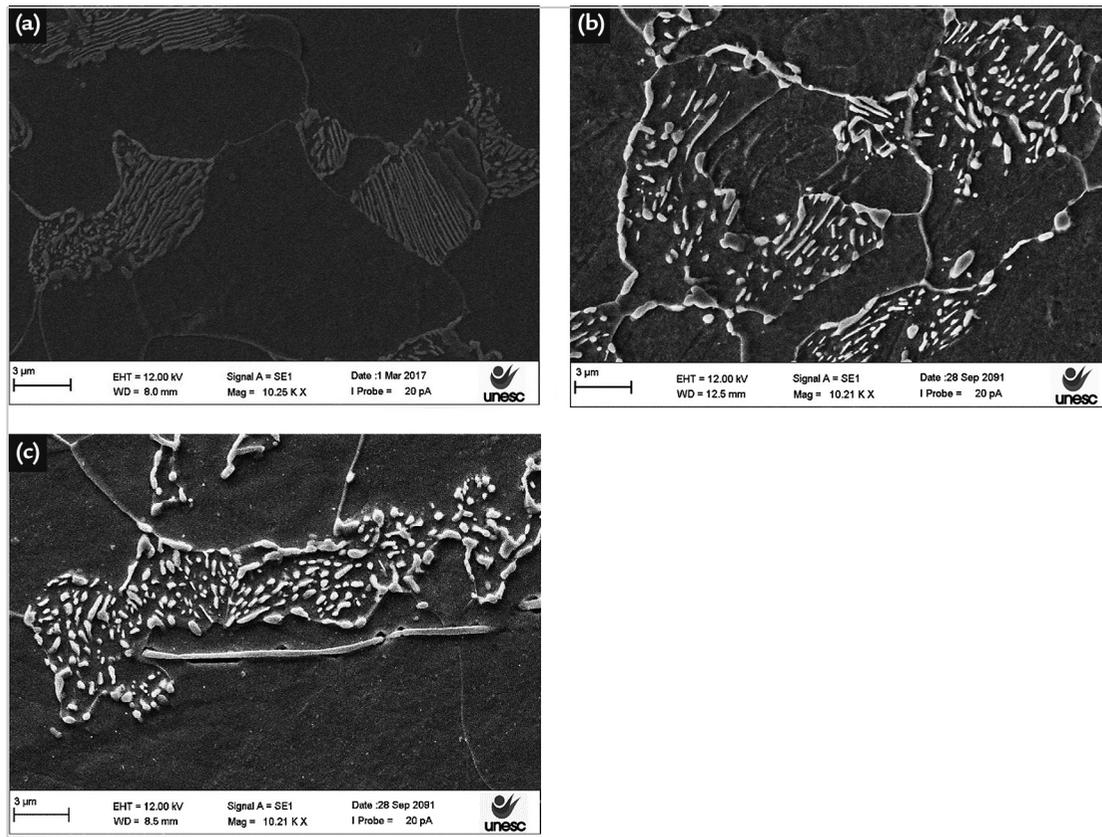
Fragmentation of the perlite occurred up to 50 h into the treatment when using a 630 °C heat treatment during spheroidization (Figure 3a). Fig 3b and 3c show that a reduction in the number of carbides occurred as the heat treatment time increased. Table 3 shows the carbide sizes of 0.48 and 0.52 μm for 100 and 200 h

of heat treatment, respectively. The results demonstrate that when the heat treatment temperature increased from 530 to 630 °C, the carbide size increased from 0.4 to 0.52 μm. In addition, the spheroidization degree increased. Subsequently, the circularity of the carbides (from 0.56 to 0.71) is demonstrated.

Figure 3 - Microstructural evolution during the spheroidizing heat treatment of the ASTM A106GrB steel at 630 °C. a) 50 h; b) 100 h; c) 200 h.

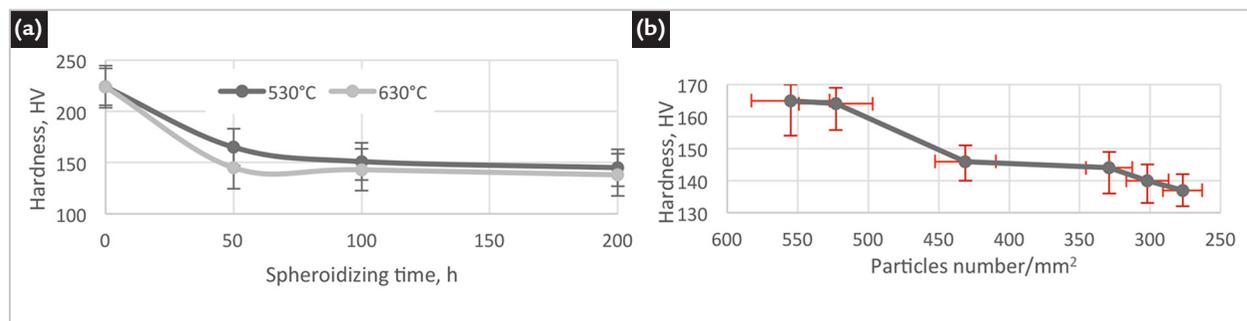
Figure 4a shows the variation in the hardness of the ASTM A106GrB steel for different heat treatment conditions (i.e., temperature and time) during spheroidi-

zation. Fig 4b shows the relationship between the carbide particles and steel hardness. Hardness values of 145 and 165 HV were obtained for 50 h at 530

and 630 °C, respectively. Table 3 shows a decrease in the number of carbide particles to 523 and 431 particles/mm² at 530 and 630 °C for 50 h, respectively.

Figure 4 - a) Influence of heat treatment on the steel hardness; b) influence of the number of particles on steel hardness.

A non-linear relationship between carbide particles and hardness was observed. Furthermore, when the heat treatment time was increased during spheroidization, the steel morphology and number of carbide particles changed, which indicated that steel hardness reduces when heat treatment for less than 50 h. According to Karadeniz (2008), particle coalescence occurs slowly in the final stages after the initial

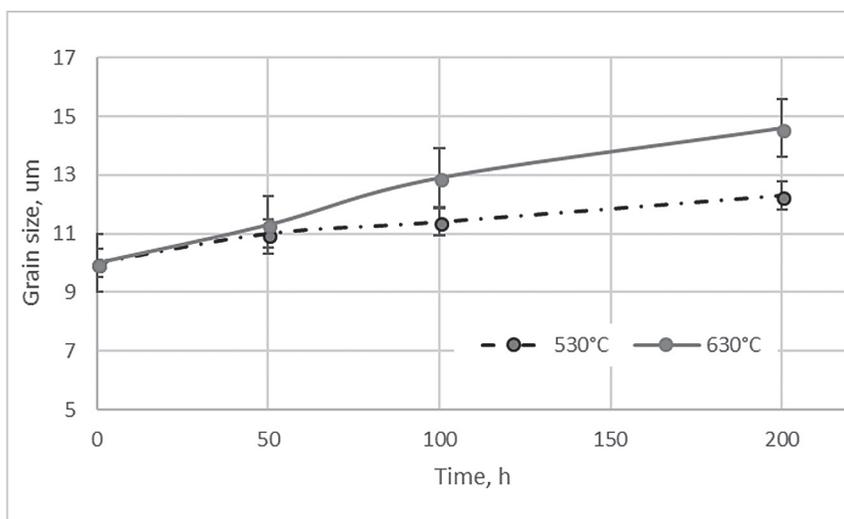
Figure 5 shows the relationship between ferritic grain size and duration of heat treatment. The heat treatment at 630 °C for 200 h produced a larger final grain size because using a higher temperature benefited the carbon diffusion process (Pawlak, 2016). However, when the growth rate of the

ferritic grains increased, the carbide number decreased. This is because the lower number of carbides that block grain boundary growth (Islam, 2017), reduce the mechanical strength of steel. Additionally, the error bars show that there is only a statistical difference for 200 h of heat treatment. The fragmentation of the carbides and coalescence occurred during 50 and 100 h of heat treatment.

Figure 5 - Evaluation of the heat treatment temperature on the ferritic grain size.

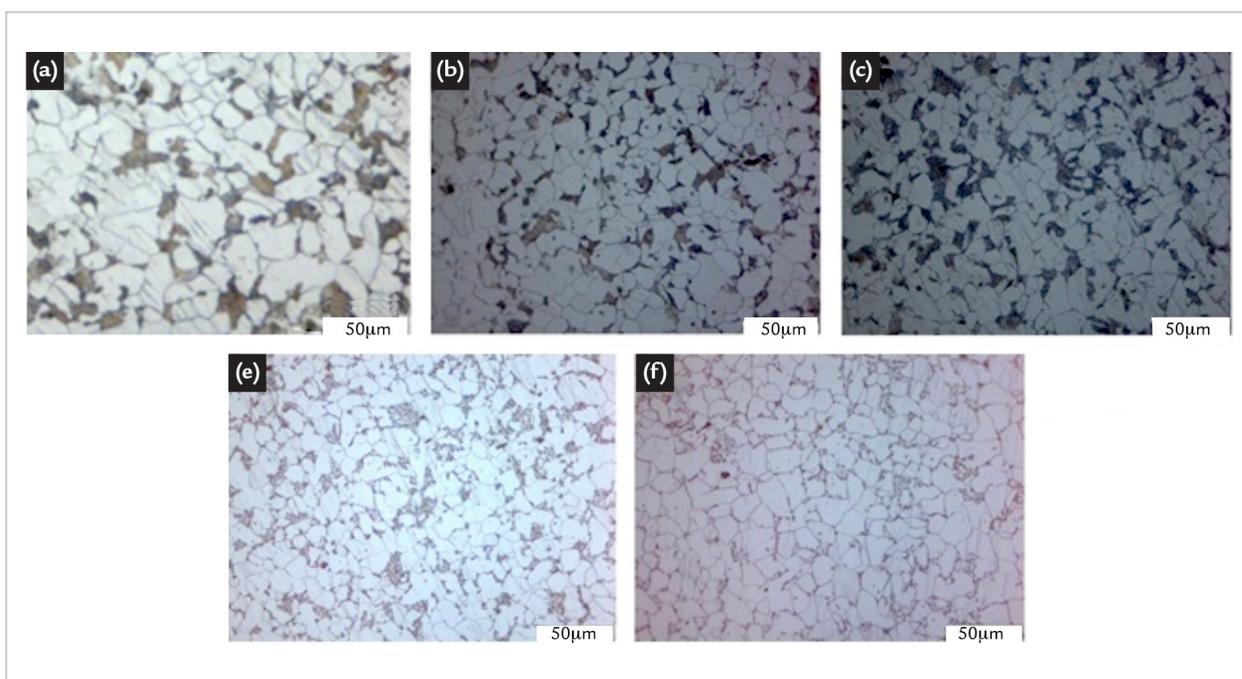
Figure 6 displays steel microstructure images obtained using optical microscopy at different heat treatment times and temperatures. There was no

change in the steel microstructures for the 530 °C heat treatment. However, when the heat treatment temperature was increased to 630 °C, the carbide

particles fragmented in 50 h (Fig 6d). Additionally, Fig 6e shows that the steel microstructure is perlite with spheroidal carbides.

Figure 6 - a) Normalized microstructure of the ASTM A106GrB steel; heat treatment at b) 530 °C for 50 h; c) 530 °C for 200 h; d) 630 °C for 50 h; and e) 630 °C for 200 h.

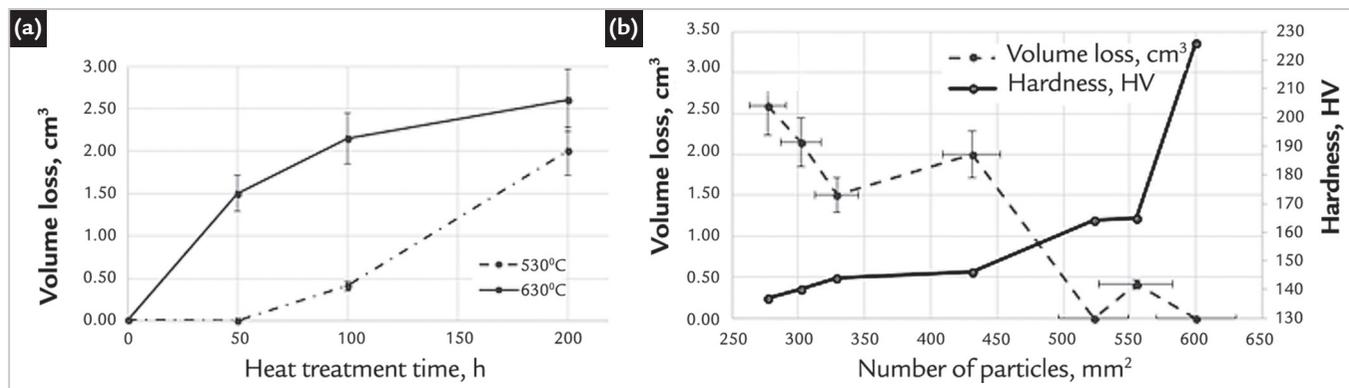
Figure 7a displays volume loss versus time of the heat treatment during spheroidization. When the duration and temperature were increased during spheroidization, the wear rate increased. The heat treatment at 530 °C for 200 h achieved a spheroidization degree of 0.56 and a volume loss of 2 cm³. However,

the heat treatment at 630 °C for 200 h achieved a spheroidization degree of 0.71 and a volume loss of 2.52 cm³. The largest volume loss was related to the heat treatment over a longer time and at a higher temperature (630 °C and 200 h). Fig 7b shows the volume loss versus the number of carbides in the

spheroidized steels. Higher volume losses occurred in the samples that had fewer carbide particles. Therefore, the heat treatment performed over a longer time and at a higher temperature increased the coalescence and diffusion of carbon, which reduced the number of carbides and steel hardness.

Figure 7 - Evaluation of a) the temperature and time on the volume loss; b) the number of particles on the volume loss and steel hardness at 530 and 630 °C for 50, 100, and 200 h.

Fig 7a also demonstrates that the highest erosive wear resistance occurred during the initial stage (normalized steel). The wear process

increased from the beginning of the heat treatment during spheroidization and caused a decreased of the hardness from 226 to 165 HV. According to

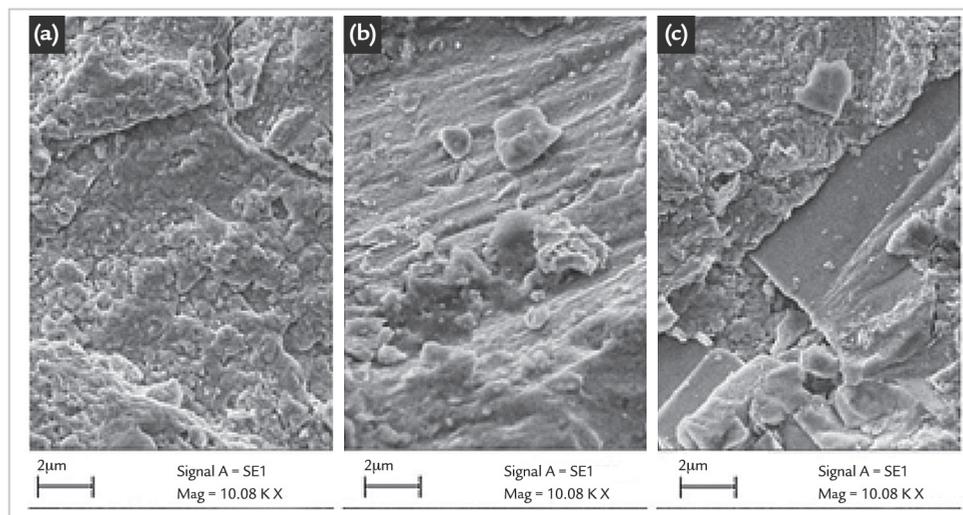
Figure 8 shows the SEM images of the sample surfaces before and after the erosion tests. The normalized steel (Fig 8a) showed no scratches or craters on the surface, which verifies the absence of

mass loss due to the erosion test. However, Fig 8b and 8c show that the samples that were subjected to the heat treatment during spheroidization had several scratches or craters on the surface. Additionally,

plastic deformation was detected on the surface. According to Hong *et al.* (2015), the increase in heat treatment temperature decreases the erosion resistance because of the increase in the steel grain size.

Figure 8 - Image of the steel surfaces after the erosion tests. a) Normalized steel; b) 630 °C for 100 h; c) 630 °C for 200 h.

The heat treatment during spheroidization at 630 °C for 100 h (Fig. 8c) shows the largest uneven surface owing to lower material hardness. A similar result was obtained by Alam
