Study of the performance of four repairing material systems for hydraulic structures of concrete dams

A. C. M. Kormann¹, K. F. Portella², P. N. Pereira³, R. P. Santos³

Abstract

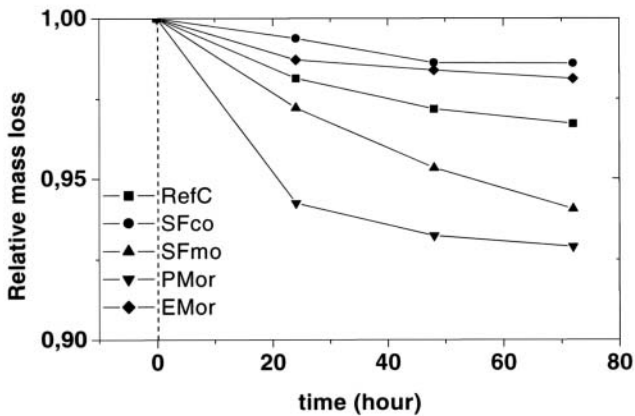
Figure 2: Relative abrasion-erosion underwater mass loss of the RefC|repairing material systems.

Relative abrasion-erosion mass loss from the repairing material systems were compatible with their resistance to compression (presented in Table I), as it can be seen in Fig. 2 to Fig. 5.

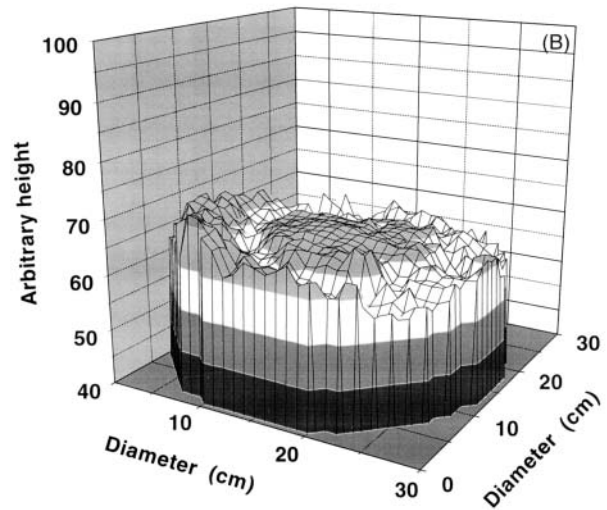
Figure 3: Abrasion-erosion underwater mass loss of the RefC|EMor system: (A) EMor sample photograph after abrasion-erosion; (B) EMor sample schematic 3-D abrasion-erosion mass loss.

SFco resulted as the best material, followed by EMor. Both of them presented a relative homogeneity surface abrasion-erosion mass loss, and the properly mass loss was lower than the RefC sample. In the RefC|EMor system, the mass loss was more detected in the RefC region, while in the RefC|SFco, the loss was distributed in whole sample surface. The difference between them is best viewed in Fig. 3 and Fig. 4.

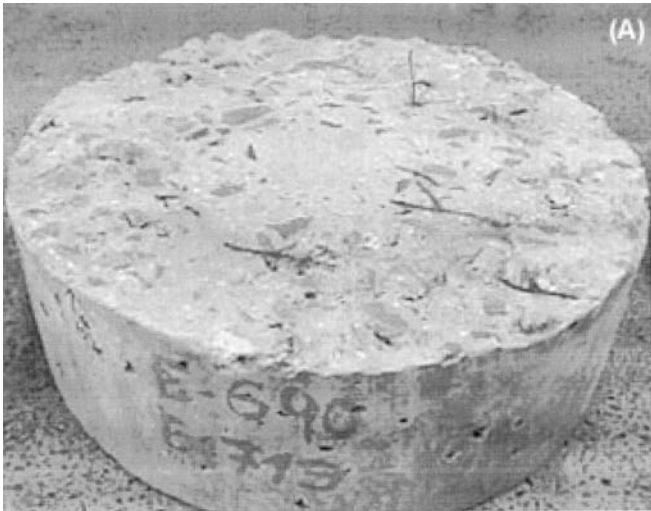
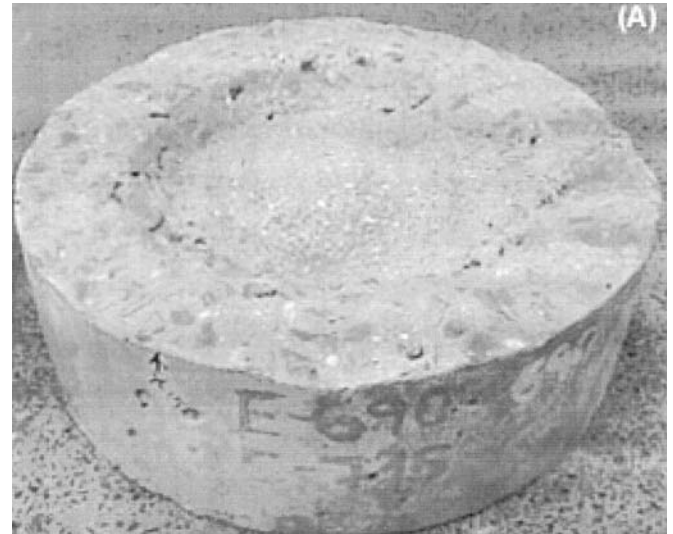
Figure 4: Abrasion-erosion underwater mass loss of the RefC|SFco system: (A) SFco sample photograph after abrasion-erosion; (B) SFco sample schematic 3-D abrasion-erosion mass loss.

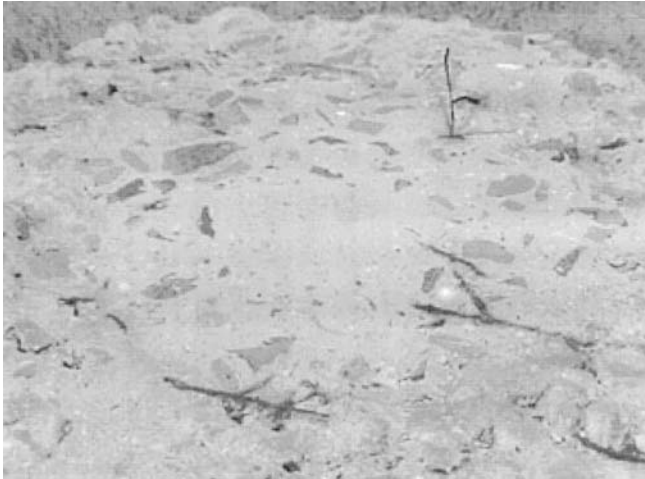
Figure 6: Metal fiber corrosion in RefC|SFco system surface, after humidity exposition.

Besides the good abrasion-erosion resistance, SFco presented intensive metal fibers corrosion, after humidity test.

This may be considered a disadvantage to its use in hydraulic surfaces. Metal corrosion in the concrete mass is followed by abnormal volume expansion and tends to crack the mortar or concrete in service. A continuous surface corrosion mechanism will facilitate the abrasion-erosion process. A detailed photo from the SFco|RefC system surface after humidity exposition is shown in Fig. 6. All the RefC|repairing materials passed in this test.

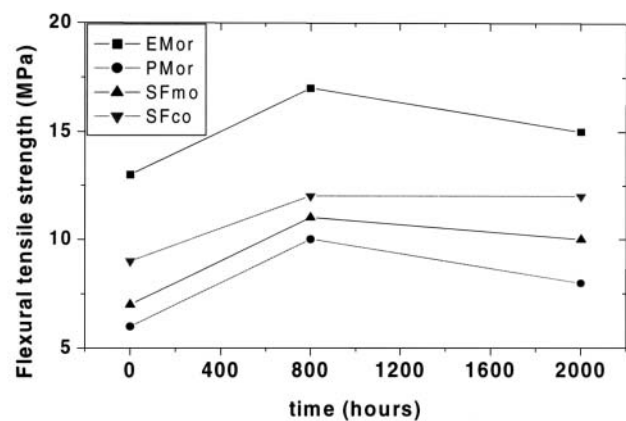
Figure 8: Flexural tensile strength of the RefC|Repairing materials before and during UV light ageing and weather-O-meter chamber tests.

The RefC|repairing materials flexural tensile strength values are plotted in Fig. 8. The test was performed placing the aged sample surface in a tension mode position. In the first 800 hours under UV light, all the aged repairing materials increased

their resistance between 30% to 60%, which is normal for cementitious materials. In other words, the exposing time to radiation was not large enough to cause irreversible damage, especially on the organic structures (polymeric materials), which are more susceptible to this kind of deterioration. The temperature in the chamber (up to the ambient due to the presence of the UV-light) may contribute to these results. The best resistance performance during the ageing process was from the RefC|EMor system, followed by the RefC|SFmo and RefC|SFco systems. The RefC|PMor system presented a lower performance.

Between 800 and 2,000 hours all the RefC|repairing material systems were aged in a Weather-O-meter chamber with controlled temperature, UV radiation and humidity cycles. The RefC|EMor system presented an inferior quality in the flexural tensile strength, compared to the RefC|PMor system. Both of them are more susceptible to this type of ageing process due their organic nature and presented cracking in the interface RefC|repairing materials. SEM images in Fig. 9 shows micrographies alterations during the test, including a
