Evaluation of hydrogen-Induced cracking resistance of the In625 laser coating system on a C-Mn steel substrate

Abstract

Keywords: Inconel 625, laser cladding, C-Mn steel API5CT, HIC resistance, pitting.

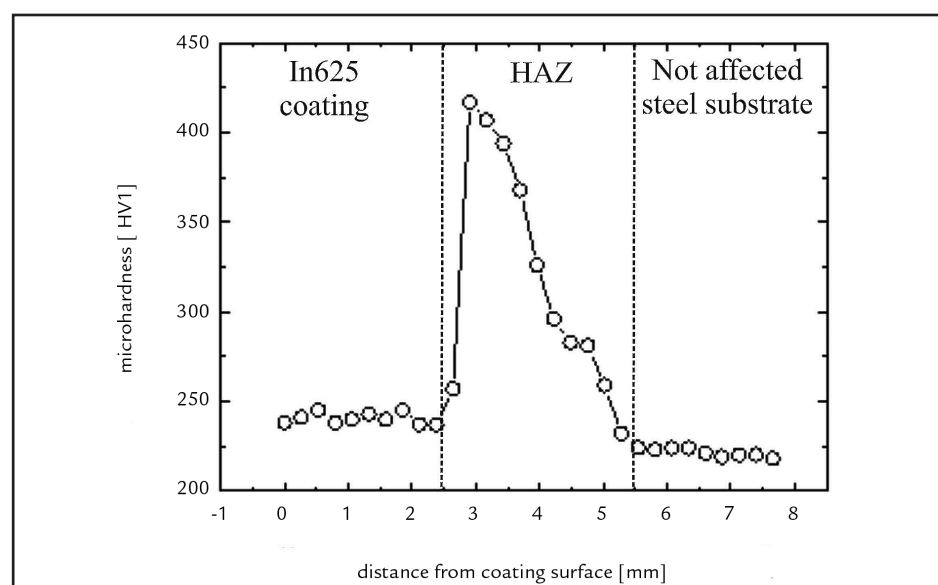
Figure 3
Microhardness profile of the coating/substrate cross section.

Microhardness measurement along the cross section of the deposited coating, prior to corrosion, is shown in Figure 3.

On the other hand, a peak of microhardness (417HV1) was observed in the heat affected zone (HAZ).
