ORIGINAL ARTICLE

Non-destructive tests for performance evaluation of self-healing concrete by addition of methyl methacrylate-containing microcapsules

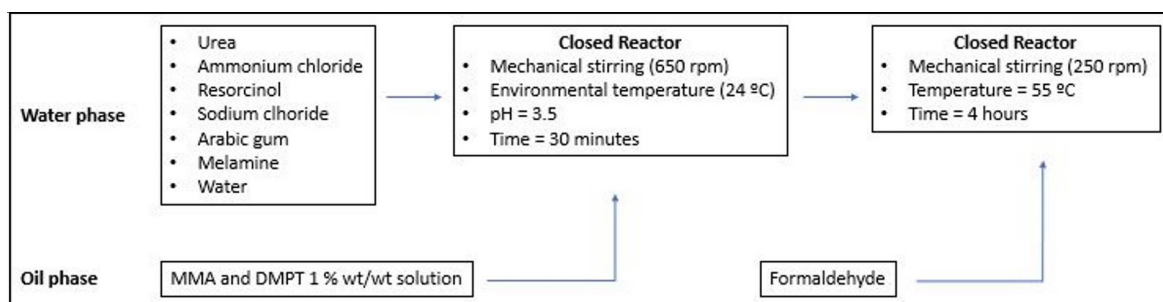
The PUFM microcapsules containing a solution of MMA and DMPT 1% (mass of MMA / mass of DMPT) functionalized with APTES, were obtained through an “in situ” emulsion polymerization process. The process was developed by Aoki and Cotting [18], and it is described in the deposited patent WO2014/032130 A1. The Figure 2 shows the microcapsules' synthesis scheme. After the production stage, the microcapsules were vacuum filtered, washed with distilled water and ethyl alcohol and, finally, functionalized.

Figure 2. Scheme of the microcapsules' synthesis.

The functionalization routine consisted of placing the microcapsules in the hydrolyzed silane solution where they were left for 60 minutes under moderate agitation and a temperature of 40 °C. After this procedure, the microcapsules were washed with alcohol, vacuum filtered and stored in distilled water.

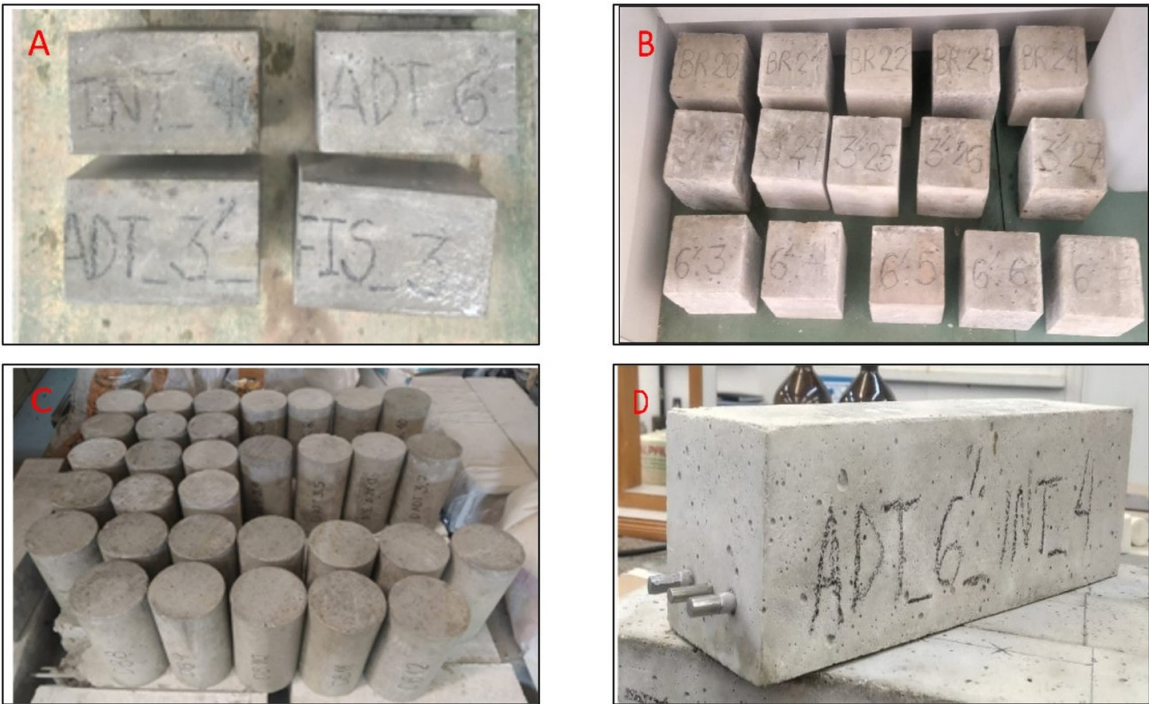
To carry out the concrete properties and self-healing investigation tests, three types of specimens were cast. The Table 1 lists the specimen types and the tests they were submitted. The whole molding procedure was done in accordance with the Brazilian Association of Technical Standards ABNT NBR 5738 [20]. The images A, B, C, and D of Figure 3 illustrate each specimen type.

Figure 3. Illustration of the specimens: (A) prismatic; (B) cubic; (C) cylindrical; (D) Prismatics and reinforced.

As it can be seen in Figure 3D, the reinforced specimens were equipped with 3 steel rod bars. One central bar of stainless steel 316 L used as counter electrode (CE) and two side bars of carbon steel used as working electrodes (WE). The stainless-steel rebar had a contact area with the concrete equal to 64.8 cm², while each carbon steel rebar had a contact area equal to 50.26 cm². This difference in areas is necessary to make electrochemical tests feasible. The delimitation of the contact area of the carbon steel rebars with the concrete was made using the high-performance epoxy paint Interbond 998 PB. Figure 4 schematically illustrates the arrangement of steel rods in concrete specimens.

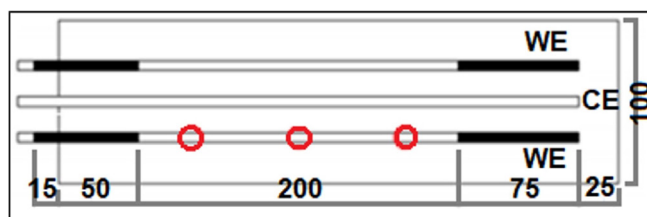
Figure 4. Schematic section of the lower longitudinal face of the prismatic and reinforced specimens. Dimensions in mm.

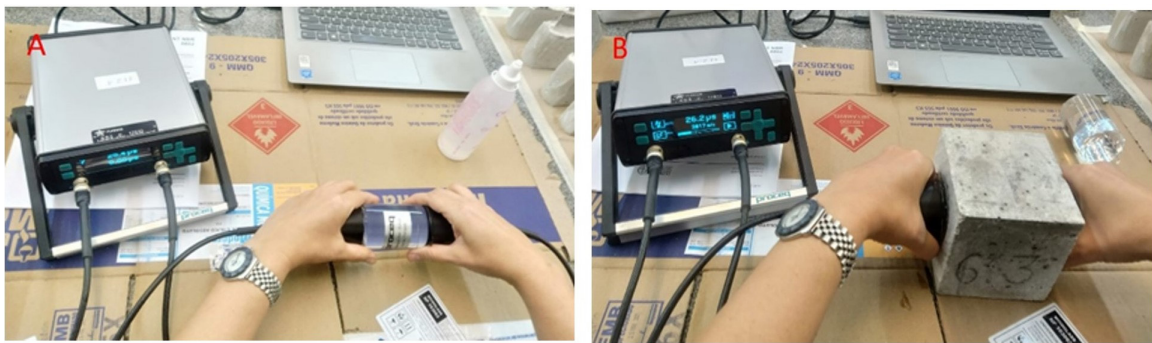
The UPV tests were performed in triplicate (three specimens from each group were analyzed) and following the guidelines established by the Brazilian Association of Technical Standards ABNT NBR 8802 [28]. For generating and reading the ultrasonic pulses, a Proceq equipment model Pundit lab+ connected to a computer and controlled by the software Pundit Link's wave form display, a pair of transducers and suitable coupling paste for shear wave readings, wave frequency of 250 kHz and a 25 µs calibration bar were used. Figure 5A and 5B show the calibration of the equipment and one of the tests being conducted, respectively.

Figure 5. Equipment for UPV measurements being (A) calibrated and (B) used in the specimens.

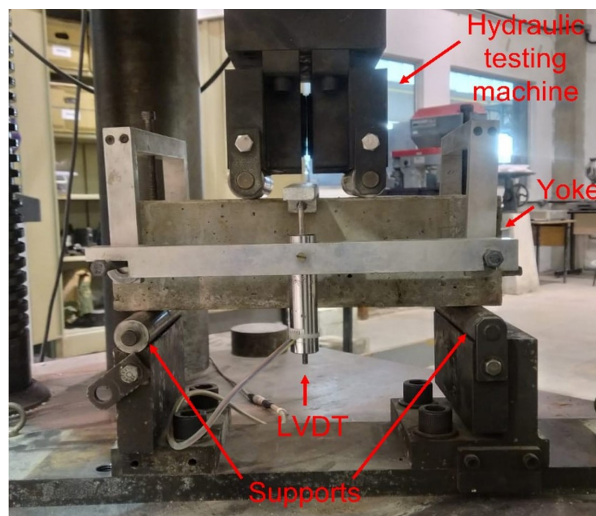
The flexural tensile tests performed to cause fissures and, consequently, stimulate the beginning of self-repairing process were conducted in a SHIMADZU servo-hydraulic universal testing machine, model UH – 2000kN XR, with appropriate support and force application devices. A linear displacement sensor (LVDT - Linear Variable Displacement Transducer) was used to monitor the strain of the specimen due to the application of loading and it was positioned with the aid of a yoke (LVDT sensor support). The ABNT NBR 12142 [29] was used as normative basis, and adaptations were made to a better fit with the research needs. The loading application rate was 0.9 MPa/min. The specimens were

positioned on the equipment with the longitudinal face, which contains the rebars, facing downwards and the two supports of the equipment were positioned 2.5cm from the vertical faces of the specimens. Figure 6 shows the apparatus assembled and ready to run a flexural tensile test.

Figure 6. Prismatic specimen at the SHIMADZU universal testing machine ready to start the flexural test.

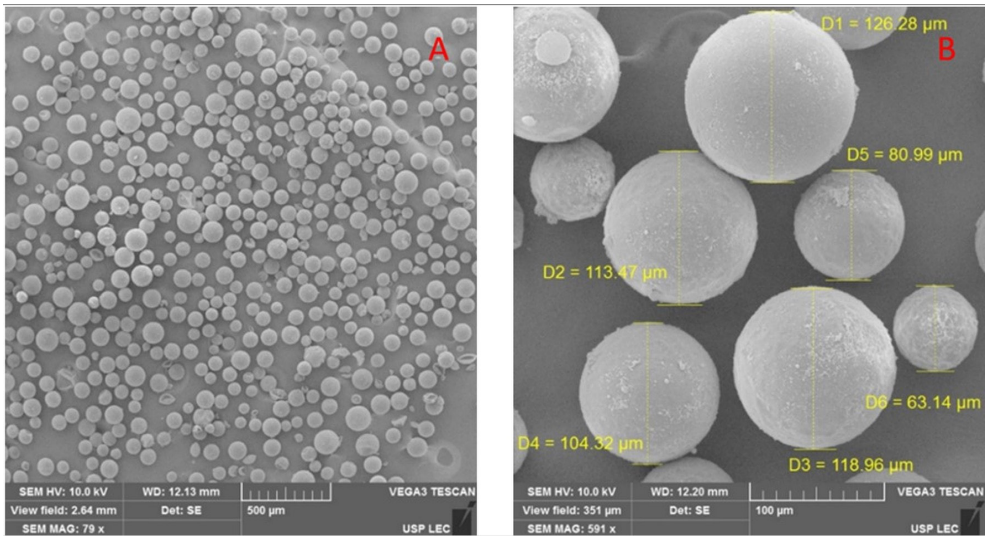
The images revealed that the obtained microcapsules have a well-defined rounded shape with an average size distribution between 60µm and 120µm. In addition, it was observed no agglomeration tendency for the microcapsules, what makes their dispersion in concrete matrix easier.

Figure 7. Images of microcapsules obtained by SEM: (A) Overview and (B) Approximate view with detail of measurements.

The PUFM microcapsules containing the solution of MMA and DMPT 1% (mass of DMPT / mass of MMA) obtained according to the procedure described in Section 3.2 were characterized for morphology by scanning electron microscopy. Images A and B of Figure 7 show an overview and an approximated view of a representative sample of microcapsules, respectively.

Comparing the particles sizes indicated by SEM and laser diffraction analysis, it can be seen that a major part of microcapsules presents diameters from $60\mu\text{m}$ to $167\mu\text{m}$. The dimensions of microcapsules obtained in this work are similar to those observed in other studies developed on the same topic [33], [34].

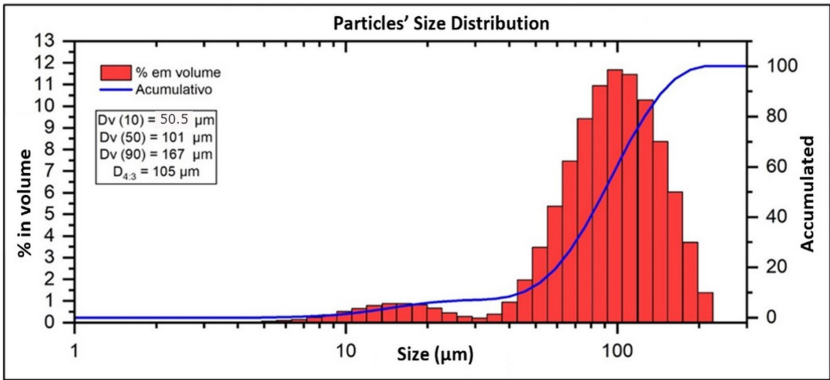
To assess their size distribution, the microcapsules were evaluated by the laser diffraction method. The Figure 8 presents a histogram of volumetric distribution and a curve of accumulated values. In the histogram, two populations of microparticles can be seen (bimodal distribution), one of low and another of high volumetric intensity. The population with low volumetric intensity presents microcapsules with sizes between 6µm and 30µm while the one of high intensity is composed by microcapsules between 40µm and 110µm.

Figure 8. Volumetric distribution histogram and cumulative value curve of synthesized microcapsules.

The average volumetric diameter $D(4,3)$ found using this technique was equal to $105\mu\text{m}$. The volumetric diameters $D_v(10)$, $D_v(50)$, and $D_v(90)$ showed that 10% of the sample’s volume is composed of microcapsules with diameters up to $50.5\mu\text{m}$, 50% of the sample’s volume has diameters up to $101\mu\text{m}$ and 90% of the sample’s volume has diameters up to $167\mu\text{m}$, respectively. It is important to clarify that large microcapsules are positive in this case, as it means a higher availability of healing agent to fill up fissures.

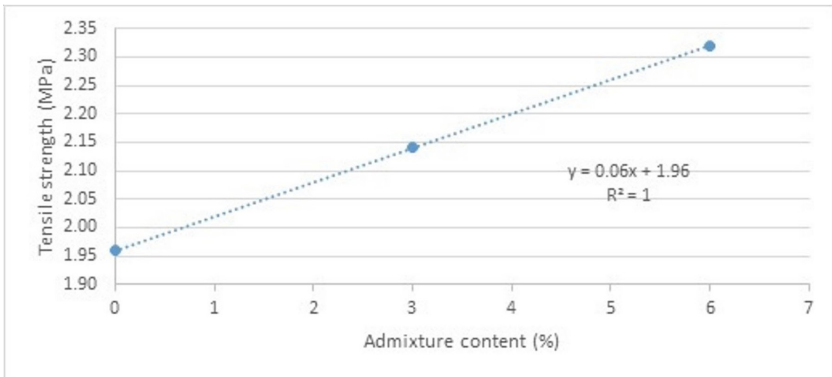
Analyzing the results presented by Table 10, it was possible to verify that the p value obtained in the ANOVA test was superior to 0.05 (5%) what means that there was not a statistical valid difference among the numbers compared. Despite that, observing the tensile strength mean values of the systems under evaluation, it was possible to note that as the microcapsules content increased the tensile strength also increased, vide Figure 9.

Figure 9. Correlation between tensile strength and admixture content

This behavior was also observed in the compressive strength results. Thus, such trend can also be related to the previous commented presence of APTES. In addition, confronting compression, and tensile strength results, it was possible to verify, for all systems under investigation, that the tensile strength values represented around 10% of their respective compressive strength result, as it can be seen in Table 11. This fact showed that the tensile strength values increased proportionally to the compression strength.

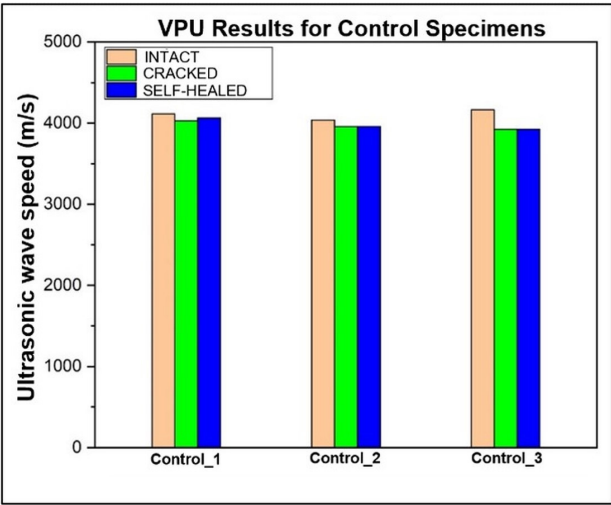
Analyzing the *Control* system data exposed by Table 12 and Figure 10, it was possible to note that the highest values were verified when the three specimens were intact, as expected. On the other hand, after inducing the fissures by applying 80% of concrete samples’ ultimate compressive strength load, a drop in the waves speed was observed (vide Fissured column in Table 12). Such decreasing on speed is explained by the presence of fissures which worked as discontinuities in the concrete matrix, hindering the waves’ travel through the samples. Analyzing the results of the specimens CONTROL_2 and CONTROL_3, two days after the compression tests (vide Self-repaired column in Table 12), it was possible to verify that there was not variation in the speed of the waves when comparing them with the fissured situation. This fact showed that the control specimens did not present self-healing ability, as expected. The sample CONTROL_1 presented a different behavior. It can be explained by the heterogeneity of the concrete mentioned by other authors as an obstacle to the good reproducibility of the tests performed on concrete [45], associated with some variation in the positioning of the transducers between one reading and another. Despite this, the set of results leads to the conclusion that there was no self-repairing of the *Control* specimens.

Figure 10. UPV results obtained for specimens with no admixtures (Control).

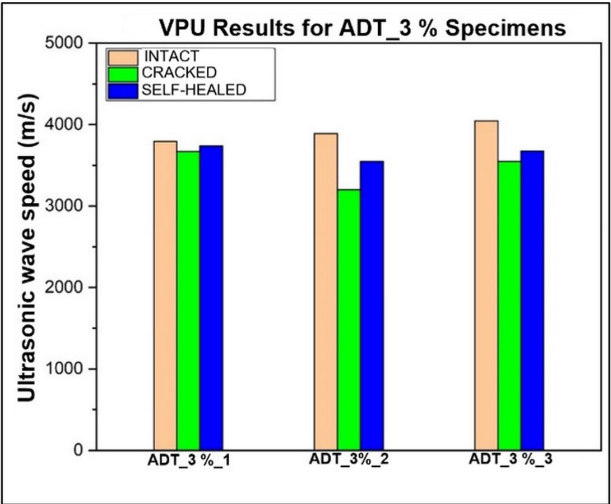
The results obtained for the specimens with 3% of addition are shown in Figure 11 and Table 12. The highest values of ultrasonic wave speed were obtained for the intact condition, followed by the self-repaired and fissured. The higher speeds obtained for the self-repaired condition in comparison to the fissured state showed that a self-repairing activity took place. However, the fissures were not completely sealed. This affirmation was made based on the difference observed between the values of the intact and self-repaired conditions. Once they were not equal, the wave speed recovery was not total.

Figure 11. UPV results obtained for specimens with 3 % addition.

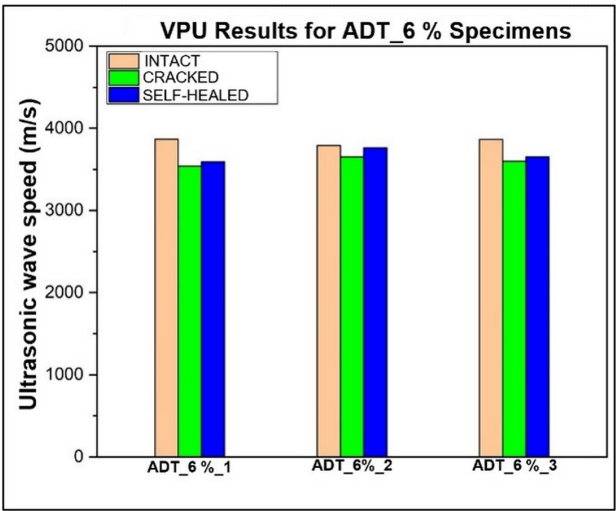
The ADT_6% system results are exposed in Figure 12 and Table 12. Analyzing this data set, it was also possible to verify self-repairing activity. However, the damage recovery was less pronounced than the one observed for the ADT_3 % system. This result could also be associate to the possible rupture of capsules during the mixing process which had reduced the effectiveness of self-healing system.

Figure 12. UPV results obtained for specimens with 6 % addition.

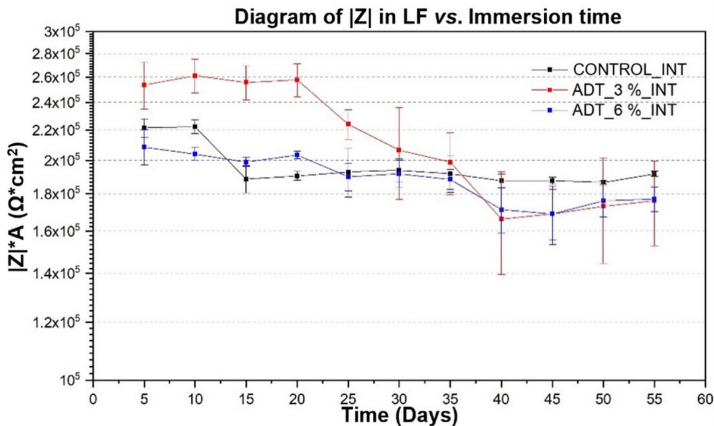
The EIS results obtained for the three systems in the INTACT condition were plotted in a diagram that shows the progression of impedance modulus ($|Z|$) at a frequency of 10^{-2} Hz over the time (Figure 13). The option for analyzing the $|Z|$ at low frequencies was made because, in this way, it was possible to observe the reinforcement’s electrochemical behavior. It is important to point out that higher impedance modulus at low frequencies (LF) means better corrosion resistance of the embedded carbon steel rebars (reinforcements).

Figure 13. EIS results of the three systems evaluated in the INTACT condition.

Analyzing Figure 13, it was possible to verify that in the INTACT condition the group ADT_3% presented mean values of $|Z|$ higher than the other groups during the first 25 days. Furthermore, this group did not present a downward trend up to 20 days. It means that during this period, the ADT_3% concrete specimens were less susceptible to reinforcement corrosion. However, after this time a gradual decreasing of $|Z|$ was observed, and, after 30 days this group reached its lowest value (numerical equal to the $|Z|$ values of the other groups). On the other hand, the curves referring to the systems *Control* and ADT_6% showed very similar behavior during the whole immersion time. It led to the conclusion that the presence of microcapsules did not negatively impact the concrete's barrier property. This fact is reinforced by the results of the groups containing 3% and 6% of microcapsules which were or better or similar to the results of the group *Control*.

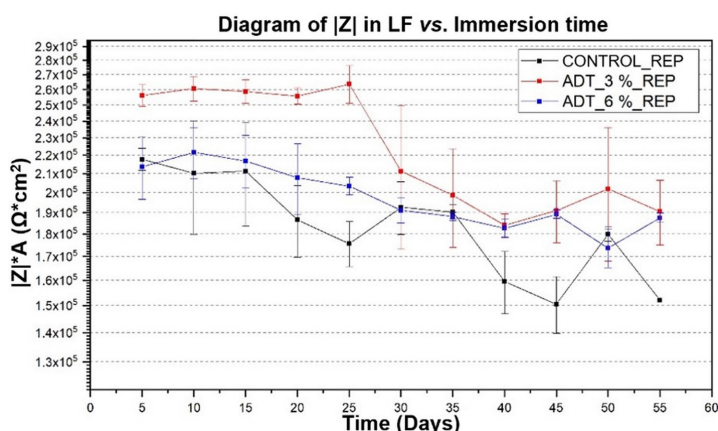
The Figure 14 shows the EIS results for specimens in the REPAIRED condition. The analysis of this diagram showed that the *Control* system presented a downward trend since the beginning of the test. The ADT_6% group also presented a decrease in the values of $|Z|$ over time. However, the ADT_6%'s rate of decrease was less pronounced than the control's one. From the measurements taken at (40, 45 and 55) days, it was possible to verify a better performance of ADT_6% in comparison to the *Control* system.

Figure 14. EIS results of the three systems evaluated in the REPAIRED condition.

The results of the ADT_3% group presented in Figure 14, showed that this system presented the best electrochemical performance among the other groups during the first 25 days of immersion for the REPAIRED condition. Furthermore, it is important to mention that the performances of this system in the INTACT and REPAIRED conditions were very similar, showing that there may have been self-repairing. Another relevant point is that the ultrasound tests showed good self-repairing activity for this system, with recovery factors (RF) above 50 % for two of the three specimens of the triplicate. This fact supports the conclusion that this system presented repairing activity.
