In vitro comparison of peracetic acid and autoclave sterilization in the corrosion of orthodontic pliers: a pilot study

Submitted: October 29, 2019 • Revised and accepted: June 24, 2020

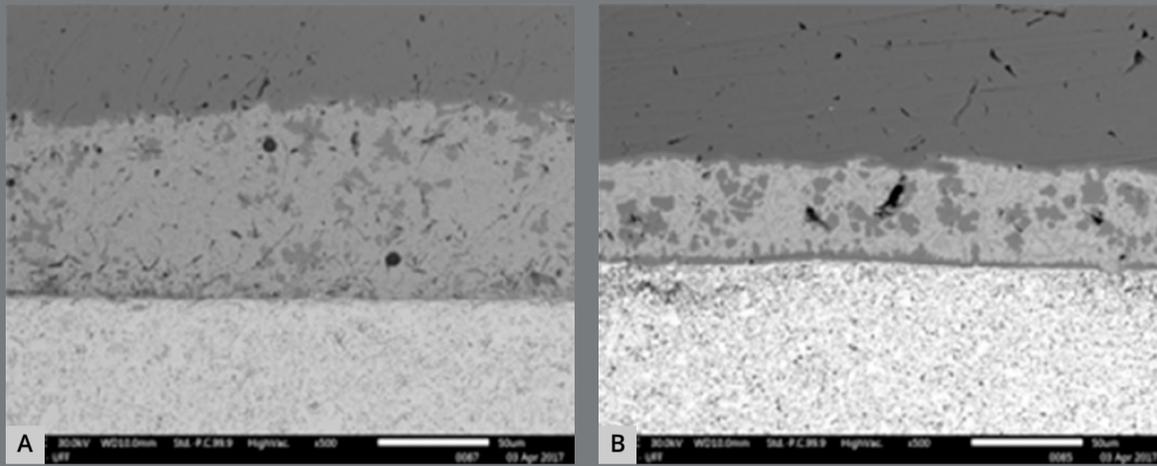
The photomicrographs of the active tips, obtained under 500× magnification during SEM for morphological analysis of the pliers as factory standard, are shown in Figure 1.

The active tip of the cutting pliers of both manufacturers demonstrated three components on their active tip (the numbers below correspond to the regions identified in the photomicrographs of Figures 1, 2, and 3), as follows:

- 1) Stainless steel region, mainly composed by an alloy of iron (Fe) and chromium (Cr), but with other metals, such as nickel (Ni) and carbon (C).
- 2) Silver weld, which is composed of an alloy of silver (Ag), copper (Cu), and zinc (Zn), commonly including other metals, such as manganese (Mn) and tin (Sn).
- 3) Cutting blade, which is mainly composed of tungsten carbide (WC), with a very low content of other components, such as cobalt (Co).

Figure 1: Photomicrographs of the active tips of the control group pliers, at 500× magnification during SEM: **A)** ICE plier; **B)** Quinelato plier.

In the cutting region, a higher percentage of WC was detected in the Quinelato pliers in relation to the ICE ones. Furthermore, for both manufacturers, a heterogeneous surface was observed and showed compacted WC grains held together by a Co matrix; some grains were not covered by the matrix. The ICE pliers presented an even more heterogeneous surface, without a Co matrix in its composition.

Both brands presented the presence of oxygen (O), which causes oxidation to the material, with higher concentrations in ICE pliers (O = 4.4%) than in Quinelato ones (O = 3.1%).

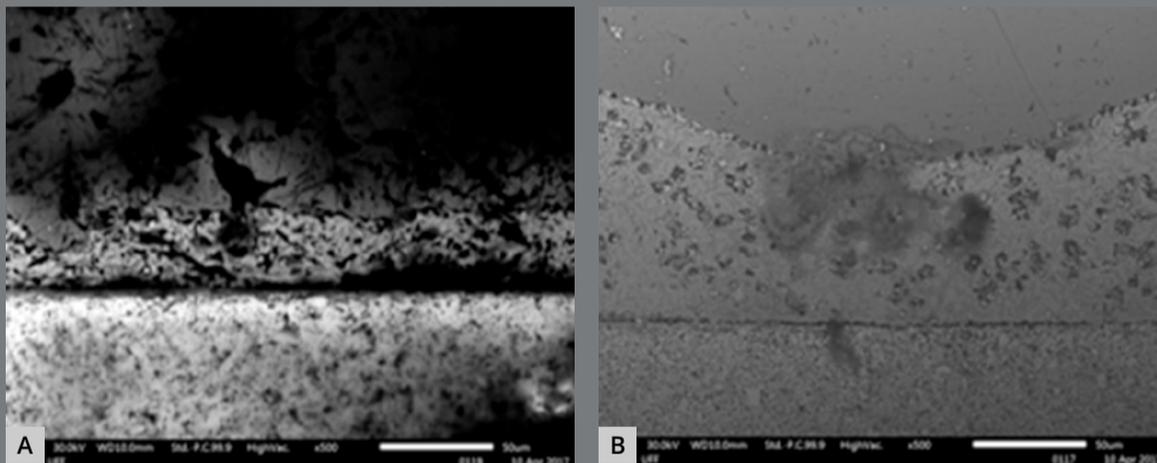
Figure 2: Photomicrographs of the active tips of the autoclave group pliers, at 500× magnification during SEM: **A)** ICE plier; **B)** Quinelato plier.

Photomicrographs of the active tips at a 500× magnification taken during SEM are presented in Figure 2. The results of the EDX analysis of the alloys presented in the autoclave active group of ICE and Quinelato pliers are presented in Tables 2 and 4.

The ICE pliers showed higher concentrations of Fe, Cr, and O in the stainless-steel region, when compared with the control group. This finding demonstrates a degree of surface corrosion, with surface oxide formation (Cr and/or ferrous oxide). In comparison, the Quinelato pliers showed no corrosion, since the presence of O was not detected after 100 autoclave cycles.

In the silver weld region of the ICE pliers, all of the chemical elements exhibited lower percentages in the autoclave group than in the control group. For the Quinelato pliers, the opposite was detected; lower concentrations in the control group were observed, when compared with the autoclave test group.

In the cutting region, lower WC concentrations were detected in the pliers of both manufacturers submitted to autoclave sterilization, although a more significant degree was found in the Quinelato pliers than in the ICE pliers, suggesting that carbide crystals were released into the medium of WC. In addition, the matrix that surrounds the Quinelato brand WC was completely lost after 100 autoclaving cycles.

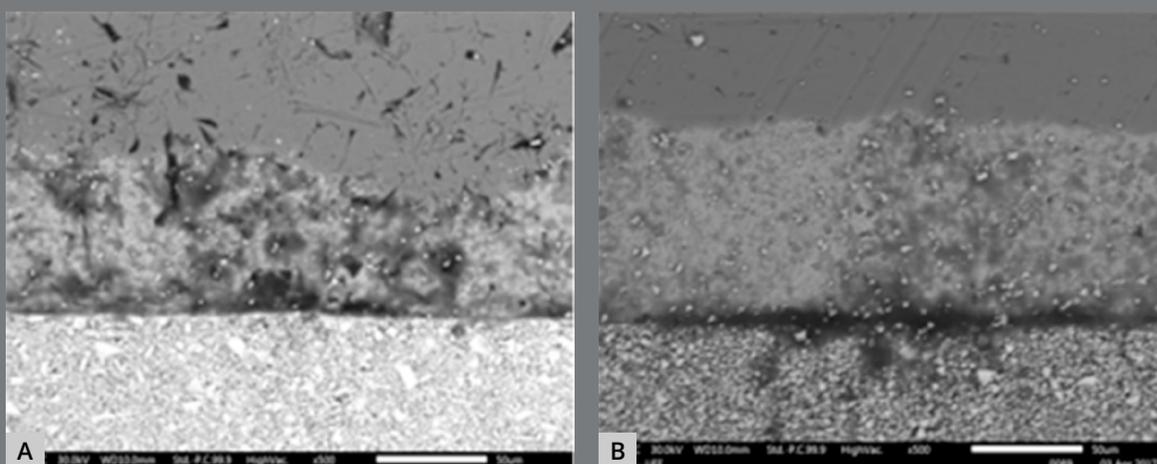
Figure 3: Photomicrographs of the active tips of the peracetic acid group pliers, at 500× magnification during SEM: **A)** ICE plier; **B)** Quinelato plier.

The photomicrographs of the active tips obtained at a 500× magnification in the SEM are shown in Figure 3. The EDX analysis of the alloys present in the active tips of the peracetic acid group of the manufacturers ICE and Quinelato is presented in Table 3 and 4.

After 100 cycles immersed in peracetic acid, it could be noticed oxidation in the stainless steel region of the ICE pliers, with higher concentrations of Fe, Cr, and O (indicating oxidation, in comparison to the control group). In the Quinelato pliers, oxidation was noticed due to an increase in the percentage of O (not because Fe and Cr concentrations).

In the silver solder region, all chemical elements that form this area showed a reduction in the ICE pliers. Conversely, in the Quinelato pliers there was an increase, indicating that oxidation occurred in this region.

In the cutting region, there was a percentage loss of the WC in both brands; however, the Co matrix, present only in the Quinelato brand, was not completely eliminated after peracetic acid immersion.
